## Dasu Hydropower Project

**Subject: Dasu HPP –30<sup>TH</sup> Environmental Progress Report for the Period from April to June 2022**

Environmental Quarterly Progress  
Report

Report Number : 30  
Reporting Period : April to June 2022

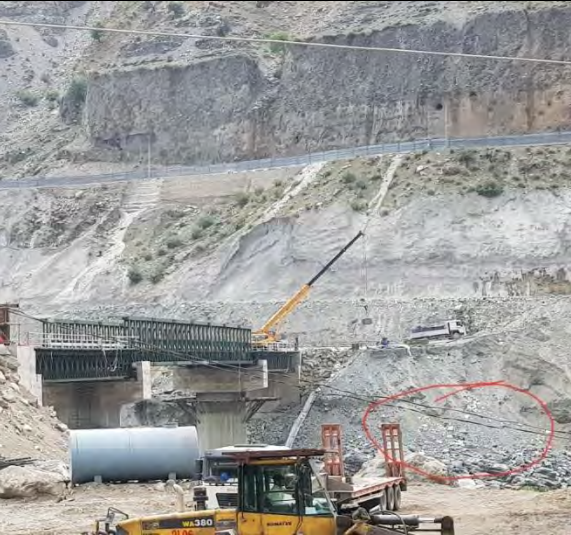
Sr. No	Date and Location of Inspection	EHS observations	Picture	Instructions to the Contractor	Action Taken by the Contractor	Completion Date
50.1	09-04-2022 CR-09	Scattered waste at truss bridge site

The Contractor is instructed to clean the area and place waste bins for waste disposal

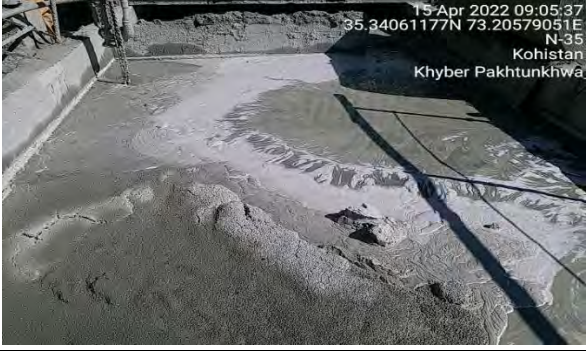
Sr. No	Date and Location of Inspection	EHS observations	Picture	Instructions to the Contractor	Timeline	Action Taken by the Contractor	Completion Date
51.1	15-04-2022 Crush Plant Uchaar	Sedimentation tank full of Sludge

The contractor is consistently committing the noncompliance. The contractor is warned to abide by the contract and regularly clean the sedimentation tanks.	<b>Immediate</b>		
51.2	15-04-2022 Crush Plant Uchaar	Poor Housekeeping

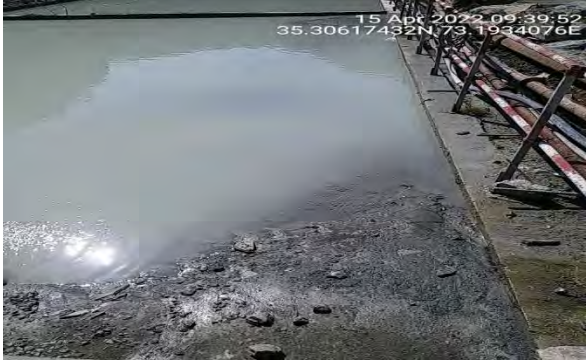
The contractor is instructed to ensure good housekeeping	<b>immediate</b>		
51.3	15-04-2022 CR-9	Sedimentation Tank full from sludge

The contractor is consistently committing the noncompliance. The contractor is warned to abide by the contract and regularly clean the sedimentation tanks.	<b>Immediate</b>

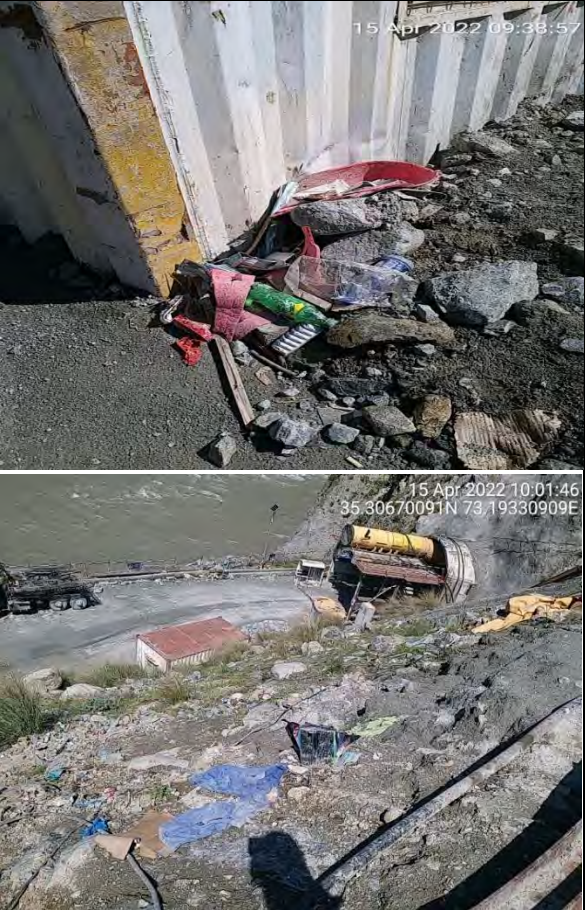
51.4	15-04-2022 Crushing Plant Uchaar	Oil Spill	 	The contractor is instructed to remove the oil spill	<b>immediate</b>		
51.5	15-04-2022 CR-9	Scattered waste at construction site	 	The contractor is instructed to place waste bins and use it for the waste generated at site for onward disposal	<b>immediate</b>

<p>The top photograph shows a close-up of a concrete wall with a yellow-painted base. In the foreground, there is a pile of debris including a red and white plastic bag, a green bag, and some wooden planks. The bottom photograph shows a wider view of a construction site. A river is visible in the background. In the foreground, there is a small building with a red roof, a yellow structure, and various pieces of debris and plastic waste scattered on the ground.</p>

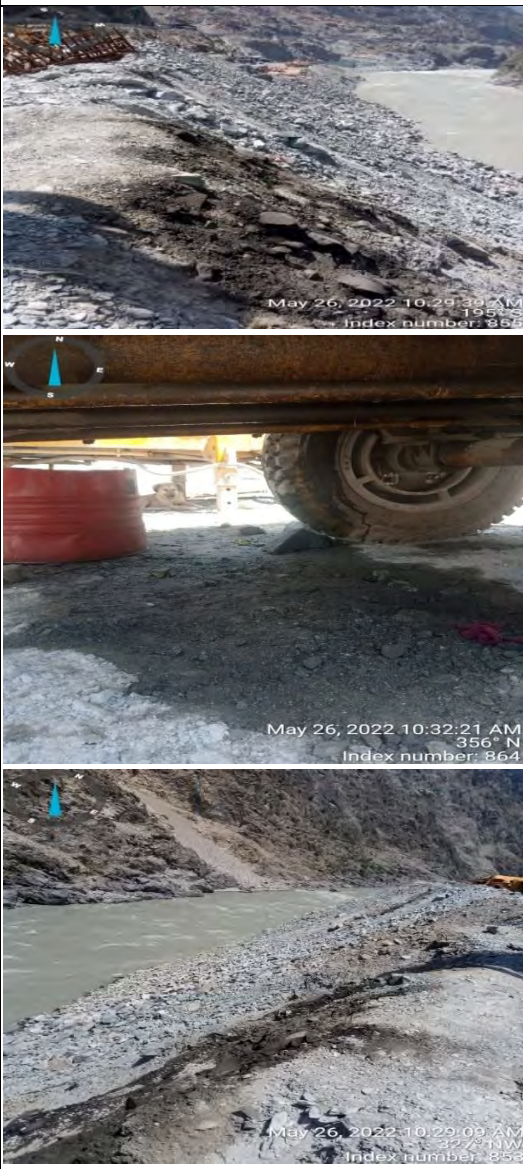
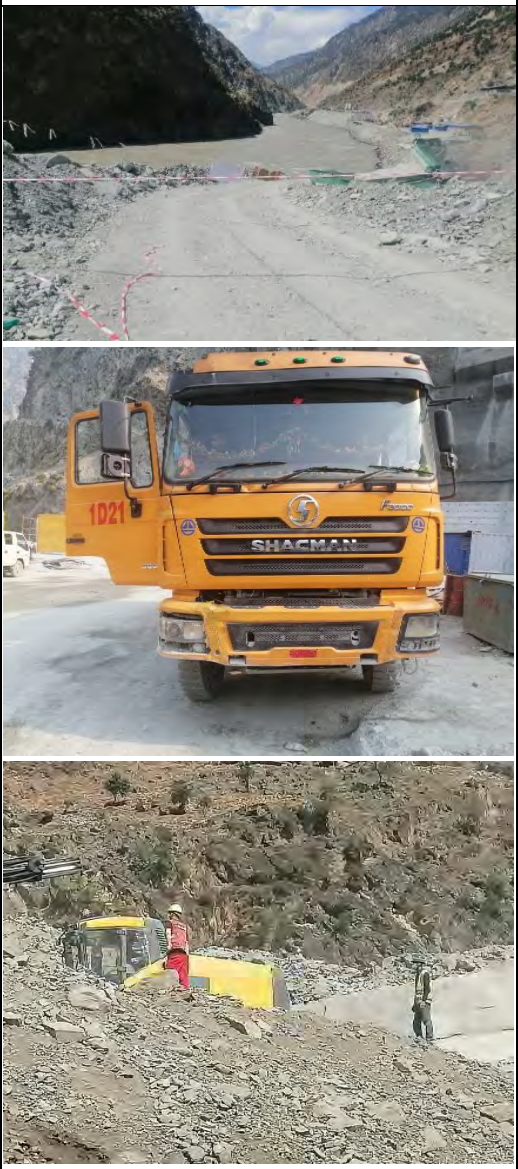
Sr. No	Date and Location of Inspection	EHS observations	Picture	Instructions to the Contractor	Timeline	Action Taken by the Contractor	Completion Date
52.1	26-05-2022 CR-2	Large scale Fuel/ Mobil Oil/ Chemical Spillage	  <p>The 'Picture' column contains three photographs. The top photo shows a spill of dark liquid on a rocky, light-colored slope. The middle photo shows a large, dark pile of debris and rocks. The bottom photo shows a paved area with several orange trucks parked, and a black car in the foreground.</p>	<ul style="list-style-type: none"> <li>Contractor is instructed to replace the soil with clean and fresh soil immediate basis.</li> <li>If needed then use spill kits for oil spill on the site.</li> <li>Dispose of the contaminated Soil.</li> <li>Contractor is also instructed to arrange a training session for the labor and mechanics so that they would understand how not to spill oils/ chemicals/ fuel.</li> </ul>	Immediate	  <p>The 'Action Taken by the Contractor' column contains three photographs. The top photo shows a spill kit (a green and red container) on the ground. The middle photo shows a large pile of debris and rocks. The bottom photo shows a paved area with several orange trucks parked, and a black car in the foreground.</p>

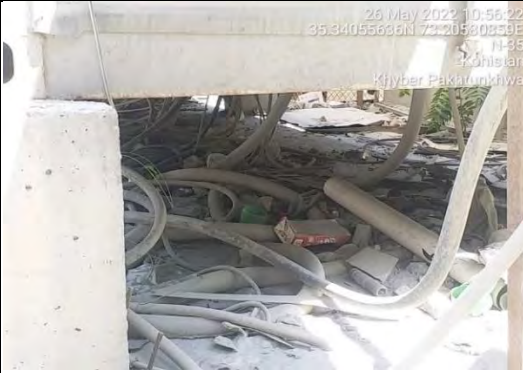
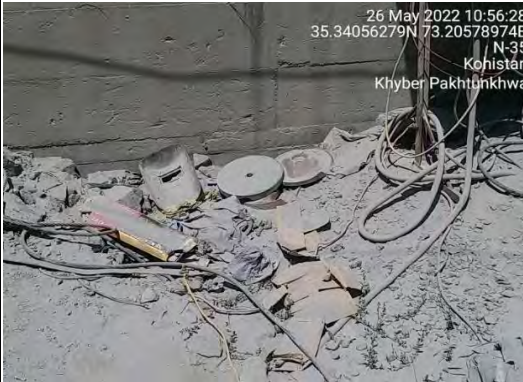
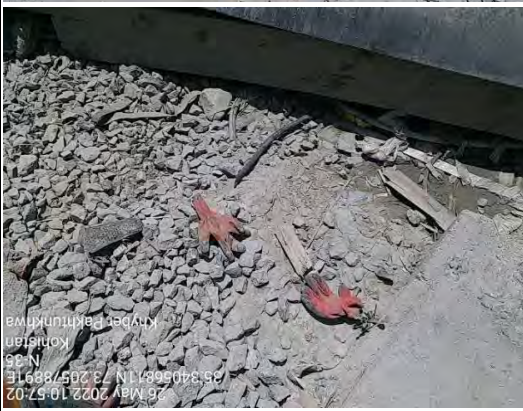
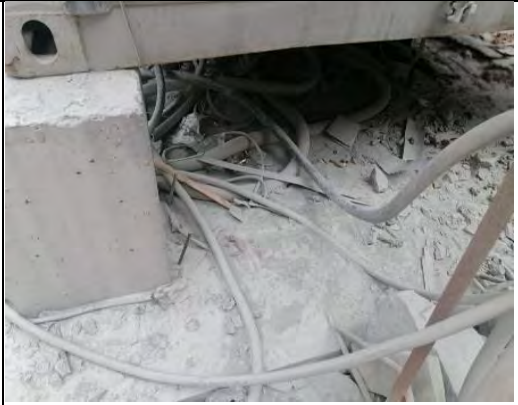
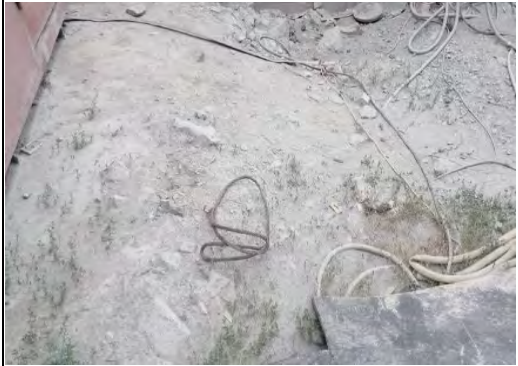
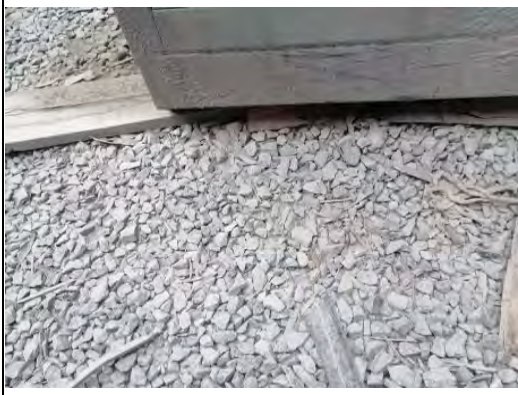
Sr. No	Date and Location of Inspection	EHS observations	Picture	Instructions to the Contractor	Timeline	Action Taken by the Contractor	Completion Date
52.2	26-05-2022 Uchaar crushing Plant	Poor Housekeeping	  <p>May 26, 2022 10:50:05 AM 233° SW Index number: 971 26 May 2022 10:55:21 26 May 2022 10:56:11 35.34054169N 73.20579854E N-35 Kohistan Khyber Pakhtunkhwa</p>	The contractor is instructed to maintain good housekeeping practices at all the construction sites.	Immediate

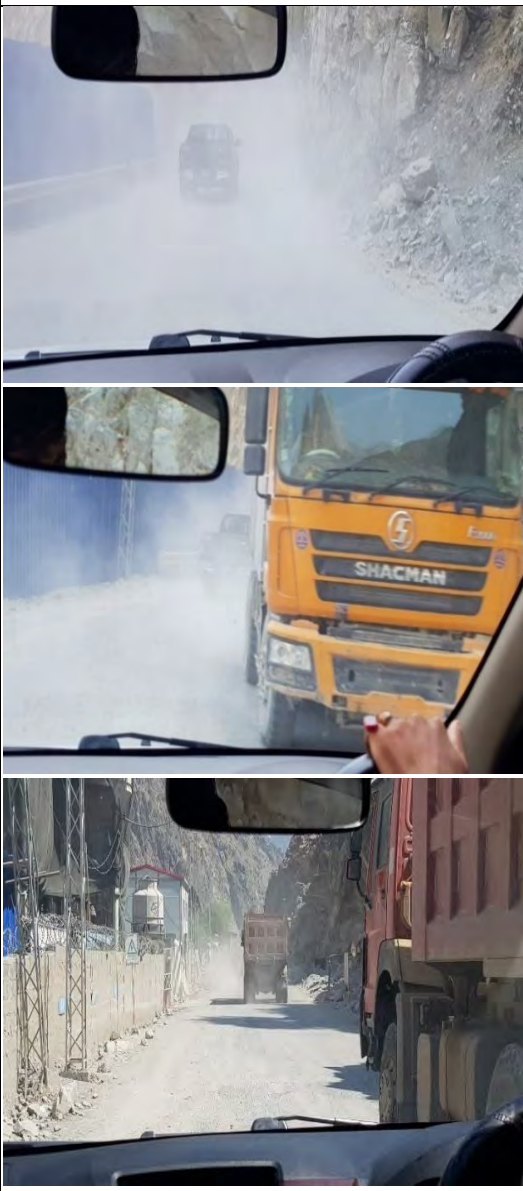
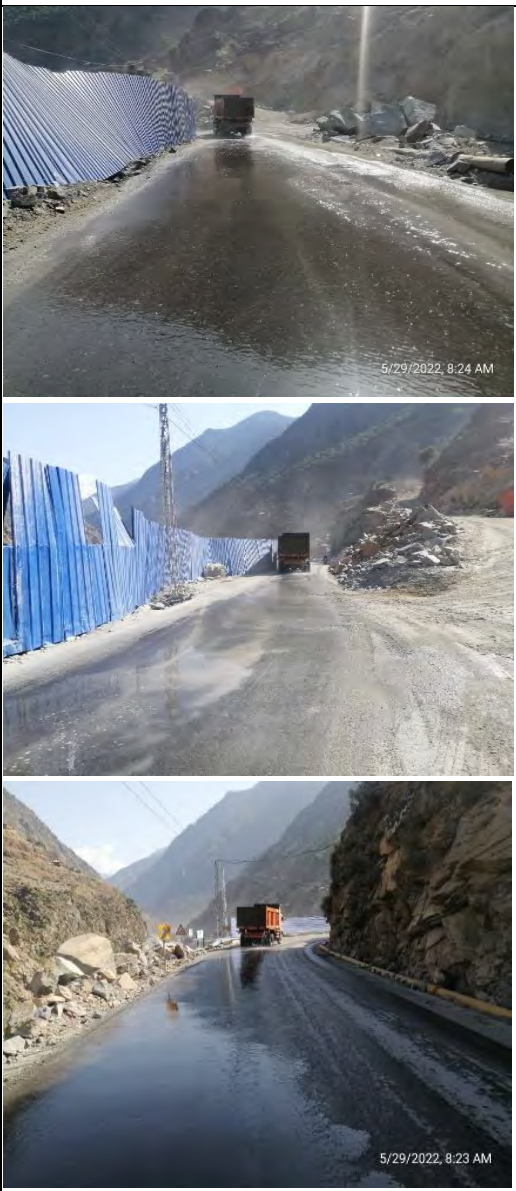
Sr. No	Date and Location of Inspection	EHS observations	Picture	Instructions to the Contractor	Timeline	Action Taken by the Contractor	Completion Date
52.3	26-05-2022 Outside on KKH along fence of CR-09, CR-02 and Uchar Crushing Plant owned by CGGC.	Fugitive Dust Suppression

<p>Fugitive Dust Suppression measures are found inadequate at site especially inside CR-09, CR-02, outside CR-09 up till Uchar Batching plant and Uchar Crushing Plant.</p> <p>Contractor is instructed to Increase the frequency of Water Sprinkling at all allocated Sites.</p> <p>In order to increase absorption of water in soil the Water Tanker should move slowly and the perforation of the shower holes should be increased on the back of Water Tanker</p>	Immediate

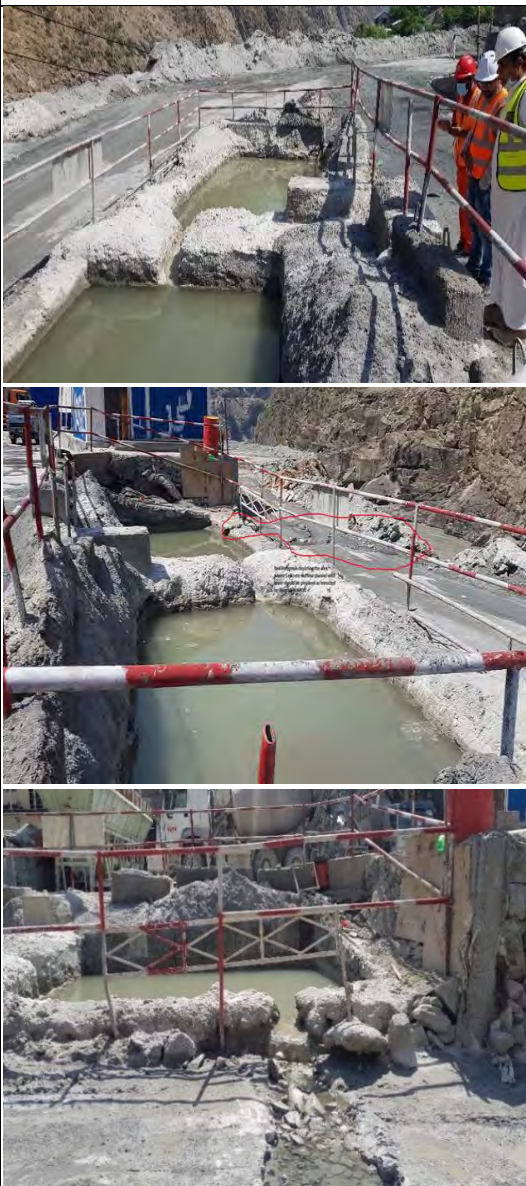
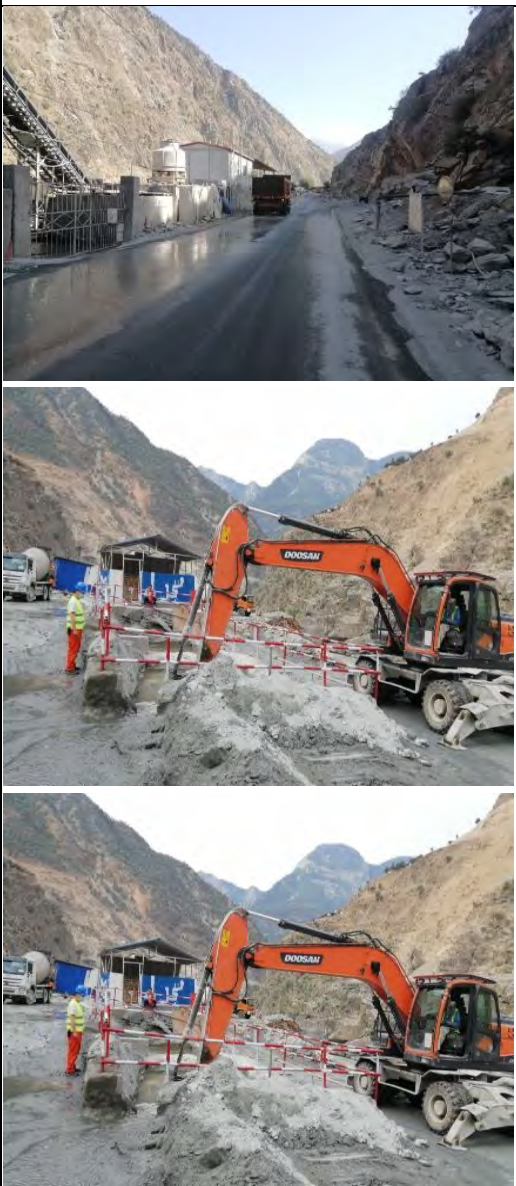
Sr. No	Date and Location of Inspection	EHS observations	Picture	Instructions to the Contractor	Timeline	Action Taken by the Contractor	Completion Date
52.4	26-05-2022 at CR-02	Sedimentation Pond

<p>The contractor is instructed to Add up fresh water intake pipe to this pond and it should be buried under the soil so that moving truck may not damage any of it. As well as the water channel from the outlet of the sedimentation tank up till it is being released to other water body.</p>	3 <sup>rd</sup> of June 2022

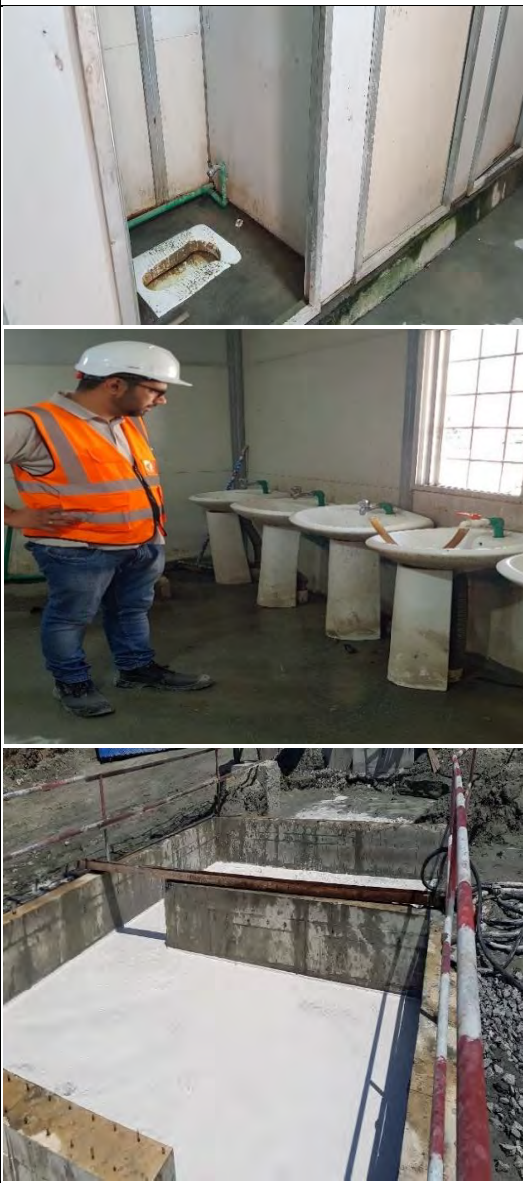
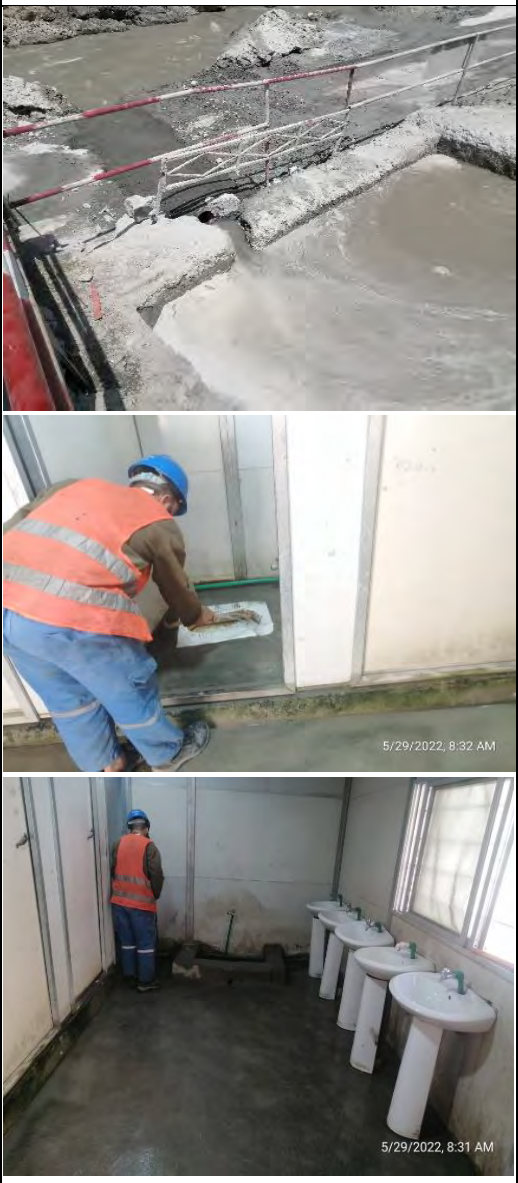
Sr. No	Date and Location of Inspection	EHS observations	Picture	Instructions to the Contractor	Timeline	Action Taken by the Contractor	Completion Date
52.5	26 <sup>th</sup> of May 2022 at CR-02	Poor Hygienic and Maintenance condition of Toilets at CR-02

<p>Cleaning of Staff Toilets at CR-02 is direly needed at priority. There was littering in the Toilets Cigarette butts, used masks Niswar Packaging was seen in the Toilets. Therefore, Contractor is instructed to clean the Toilet at least three Times a day as well as maintain inspection slips on the door to maintain record as well as but a waste bin in the toilet to curb littering in the toilets.</p>	1 <sup>st</sup> of June 2022

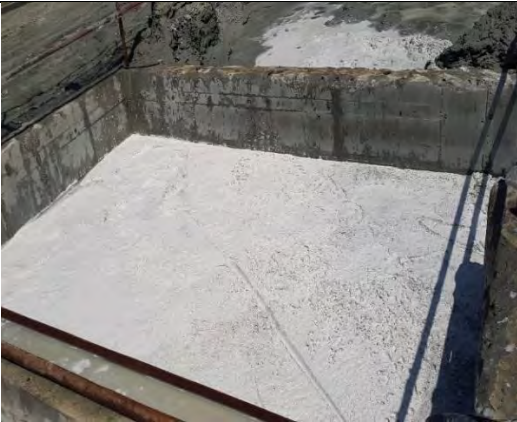
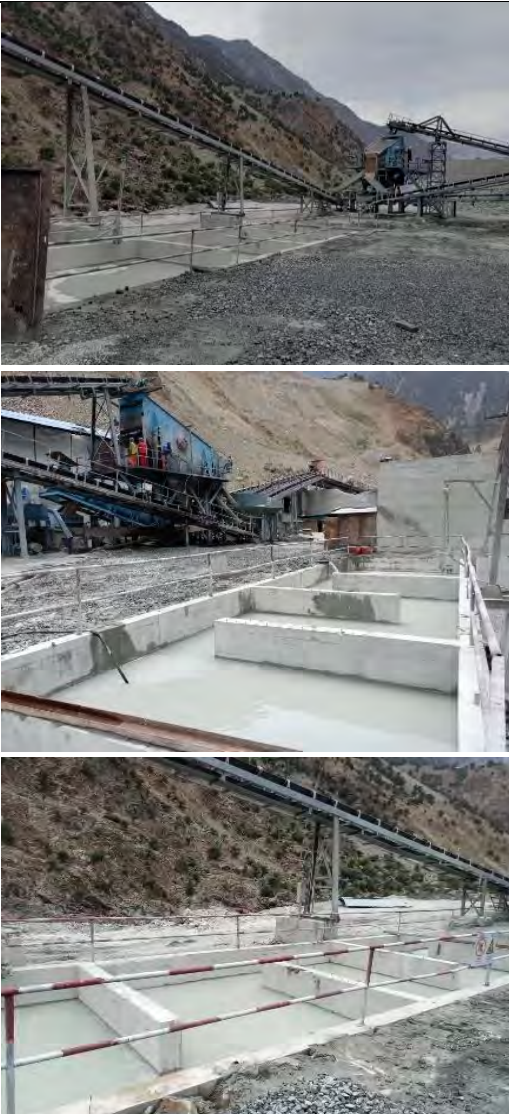
Sr. No	Date and Location of Inspection	EHS observations	Picture	Instructions to the Contractor	Timeline	Action Taken by the Contractor	Completion Date
52.6	Location id at CR-02, Uchar Crushing Plant of CGGC	Sedimentation Tank was full of Sludgy Froth.

<p>Contractor is further instructed to clear the Septic Tank from Sludge as the water is oozing out of the Septic Tanks as well.</p> <p>The Primary and secondary ponds were full of Sludgy froth which was floating on the water which needs to be cleared out on daily basis do that it can be monitored.</p>	1 <sup>st</sup> of June 2022

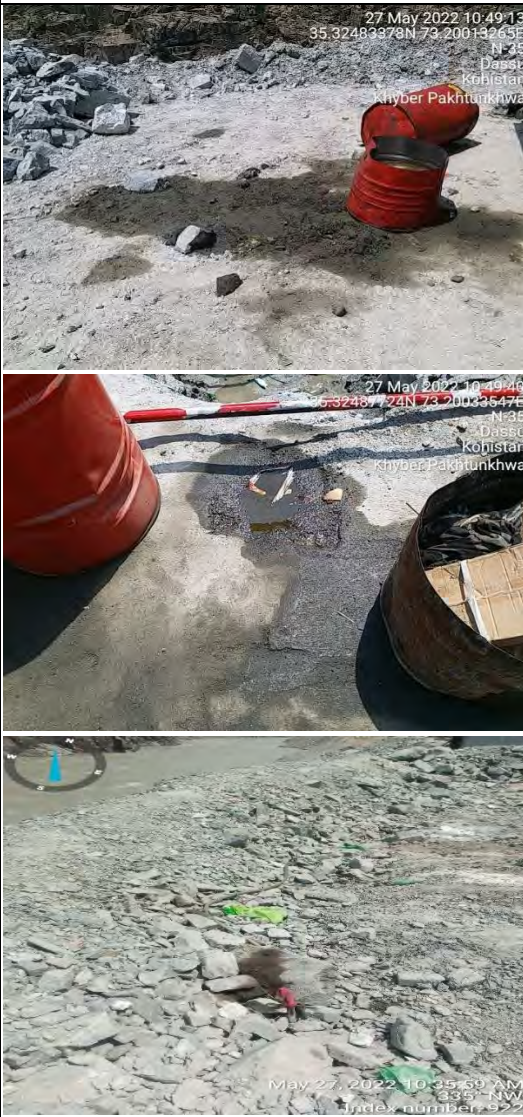
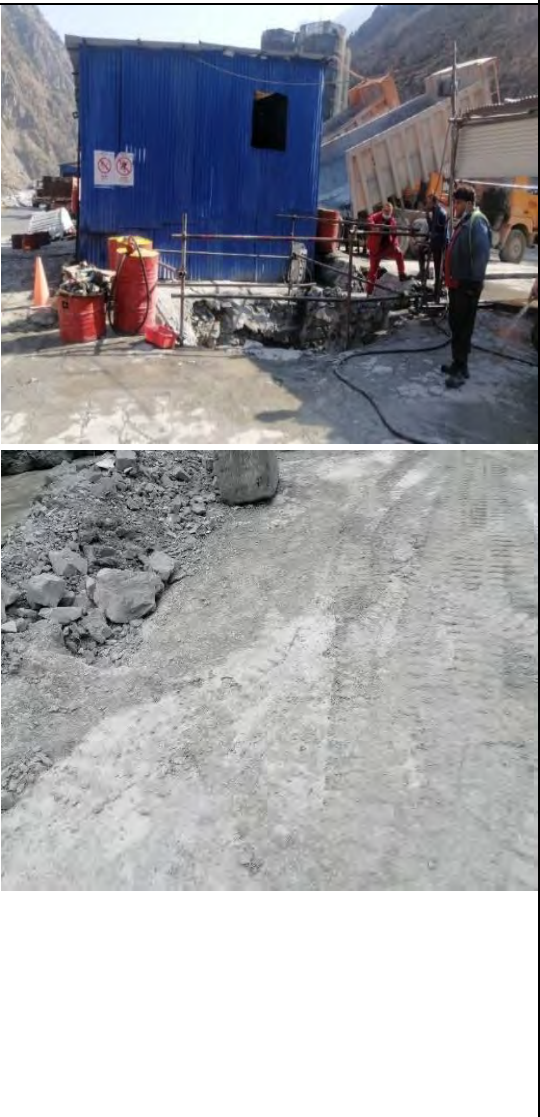
Sr. No	Date and Location of Inspection	EHS observations	Picture	Instructions to the Contractor	Timeline	Action Taken by the Contractor	Completion Date
53.1	27-05-2022 CR-2	Fuel/Oil Spillage

Contractor is instructed to replace the soil with clean and fresh soil immediate basis. If needed then use spill kits for oil spill on the site. Dispose of the contaminated Soil.	Immediate

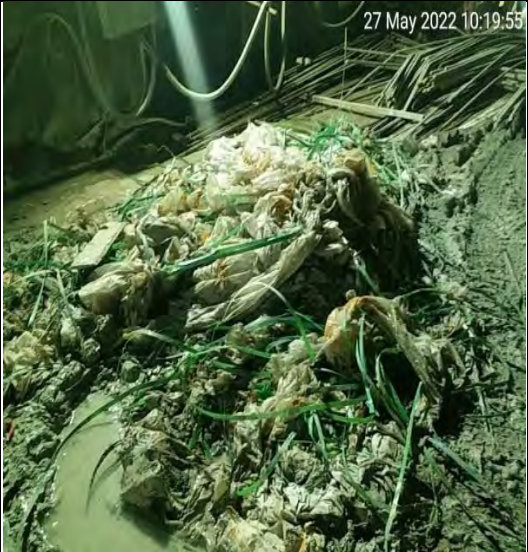
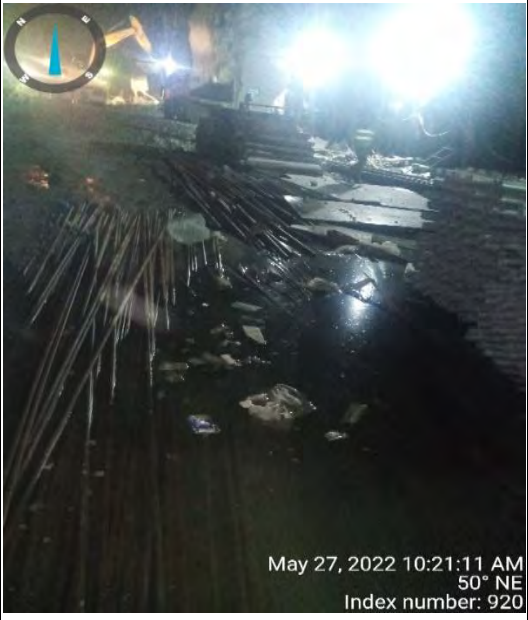
Sr. No	Date and Location of Inspection	EHS observations	Picture	Instructions to the Contractor	Timeline	Action Taken by the Contractor	Completion Date
53.2	27-05-2022 DT-B (Diversion Tunnel-B)	Poor Housekeeping		The contractor is instructed to maintain good housekeeping practices at all the construction sites	Immediate		28-05-2022

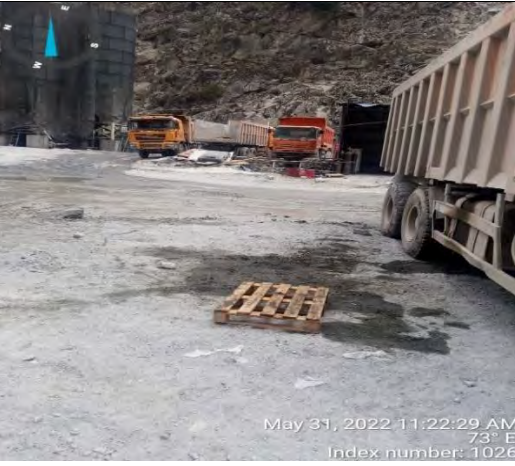
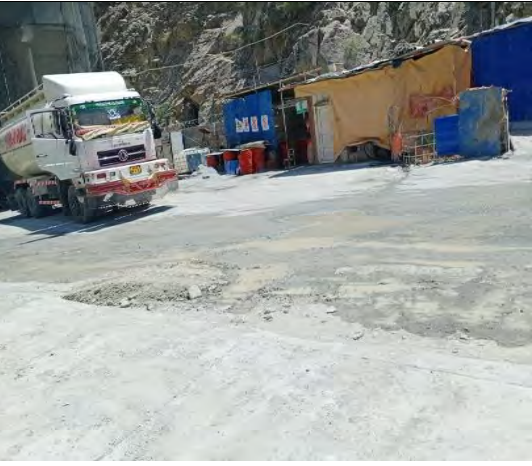
Sr. No	Date and Location of Inspection	EHS observations	Picture	Instructions to the Contractor	Timeline	Action Taken by the Contractor	Completion Date
54.1	31-05-2022 CR-2 and CR-9	Fuel/Oil Spillage	 	<p>Contractor is instructed to replace the soil with clean and fresh soil immediate basis. If needed then use spill kits for oil spill on the site. Dispose of the contaminated Soil.</p>	Immediate	 	05-06-22

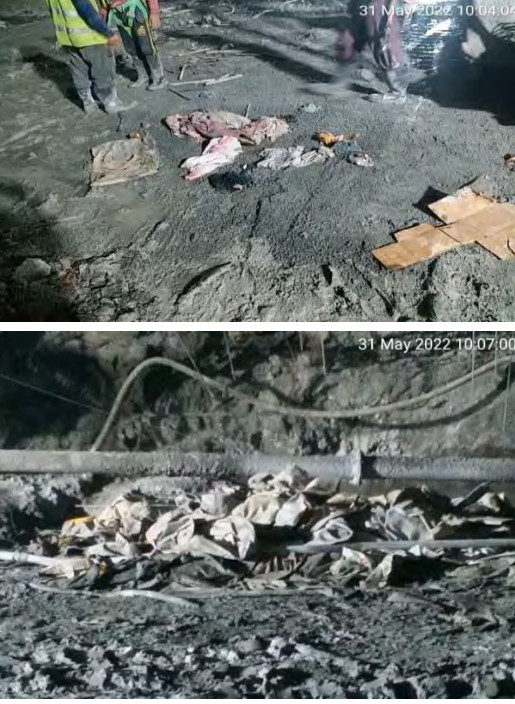
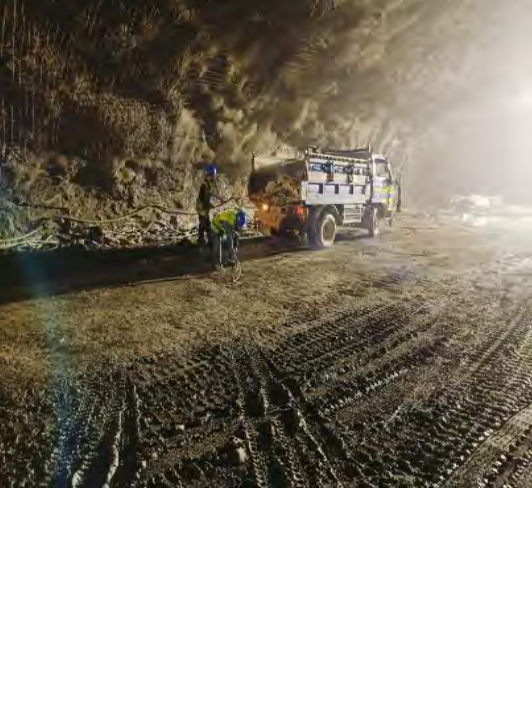
54.2	31-05-2022 Power house	Inadequate Housekeeping in Power House

<p style="text-align: right; font-size: small;">31 May 2022 10:04:04 31 May 2022 10:07:00</p>	The contractor is instructed to maintain good housekeeping practices at all the construction sites. Arrange regular awareness and training session for the Labor and staff to keep good housekeeping.	Immediate

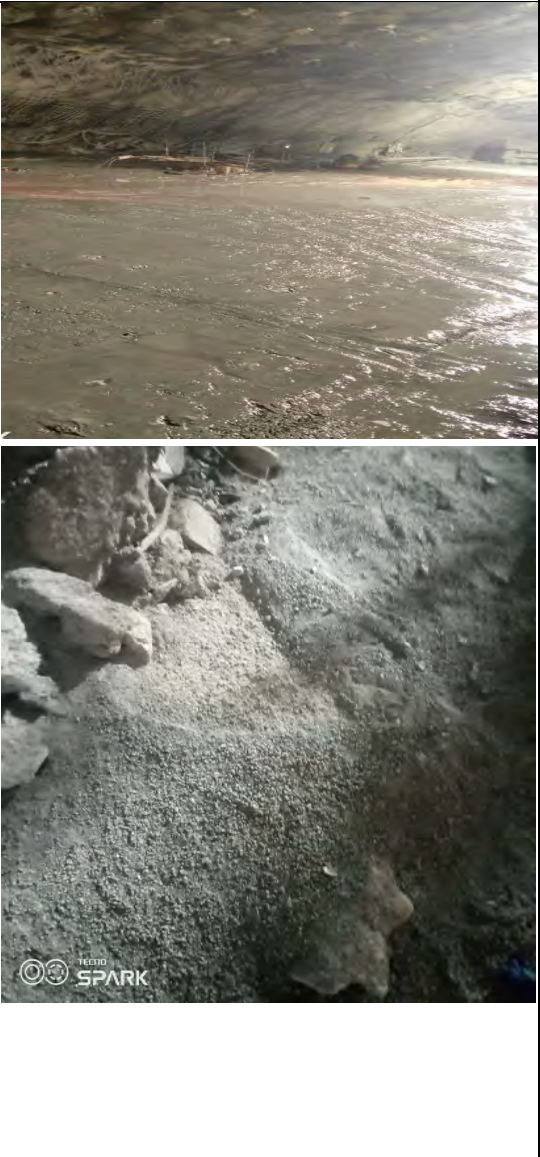
Sr. No	Date and Location of Inspection	EHS observations	Picture	Instructions to the Contractor	Timeline	Action Taken by the Contractor	Completion Date
54.3	31-05-2022 CR-9	Poor Housekeeping	  <p>The 'Picture' column contains three photographs showing cluttered construction sites. The top photo shows a large metal drum and debris next to a blue container. The middle photo shows a pile of waste and debris in a narrow space. The bottom photo shows a messy area with pipes and debris. Each photo has a timestamp: '31 May 2022 10:16:36' and '31 May 2022 10:22:21'.</p>	The contractor is instructed to maintain good housekeeping practices at all the construction sites.		  <p>The 'Action Taken by the Contractor' column contains three photographs showing the same construction sites after cleanup. The top photo shows the area with the metal drum now tidied up. The middle photo shows the narrow space cleaned. The bottom photo shows the area with pipes and debris cleaned. Each photo has a 'TECTO SPARK' logo in the bottom left corner.</p>	05-06-22

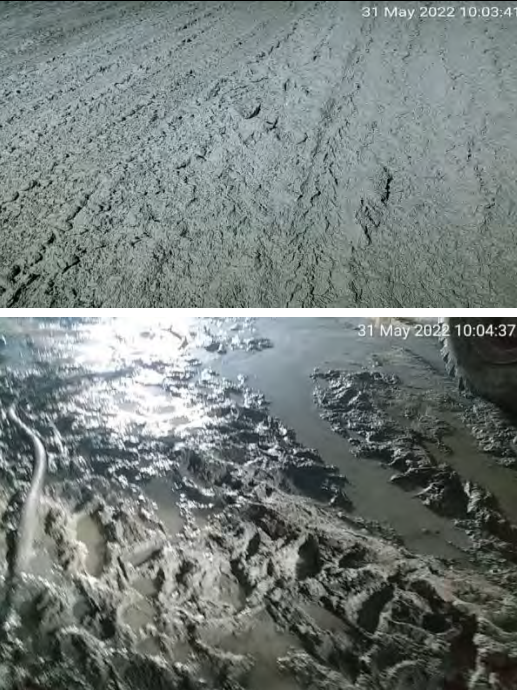
Sr. No	Date and Location of Inspection	EHS observations	Picture	Instructions to the Contractor	Timeline	Action Taken by the Contractor	Completion Date
54.4	31-05-2022 Power house	Sludge

It is instructed the contractor to remove the sludge from site and dispose to the disposal site.		 	
54.5	31-05-2022 CR-9	Workshop waste full of Fuel/Oil

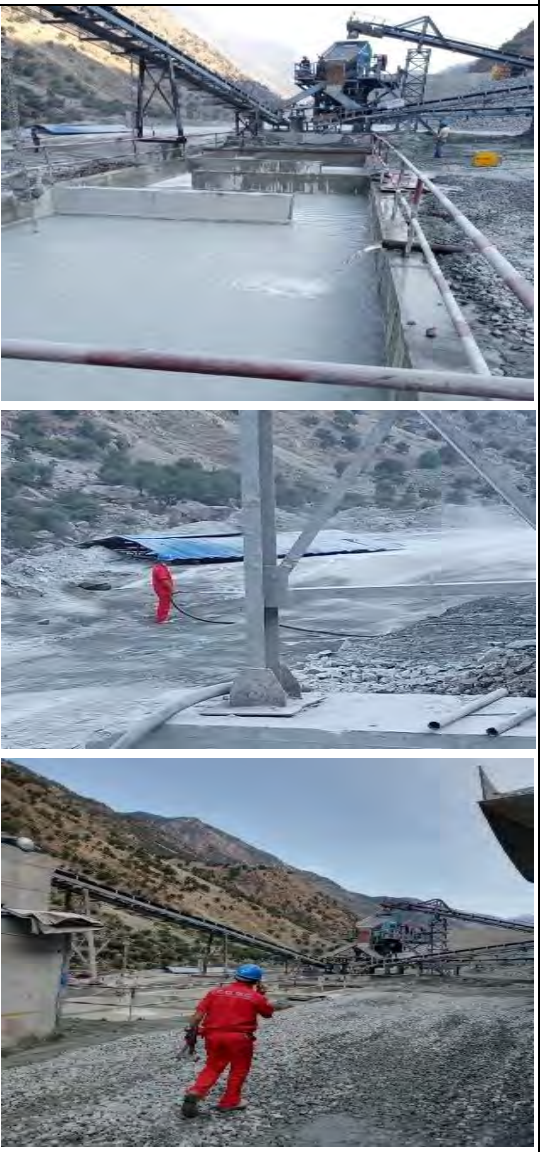
Sr. No	Date and Location of Inspection	EHS observations	Picture	Instructions to the Contractor	Timeline	Action Taken by the Contractor	Completion Date
55.1	03-06-2022 Uchaar Crushing Plant	Sludge Floating on the Water Tank as well as no fresh water input was seen at site. The fresh water pipe was not working.	 	<p>The sedimentation tank of Uchaar crushing plant is full of sludge and the contractor is required to remove the sludge on urgent basis. The sludge was dumped besides the sedimentation tank as shown in pictures. The outside sludge is so much full that it is again flowing into the tank. Contractor is instructed to remove the sludge from site with immediate effect and dispose it at some place far from the sedimentation tank so that it may dry fully in sun light and not entering in the sedimentation tank.</p>

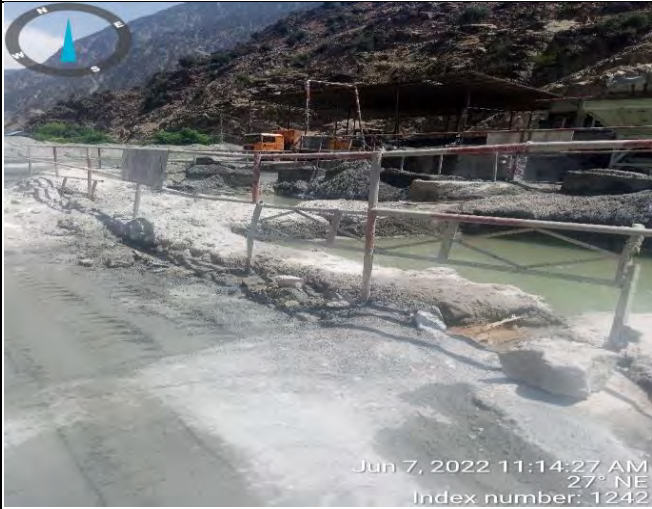
Sr. No	Date and Location of Inspection	EHS observations	Picture	Instructions to the Contractor	Timeline	Action Taken by the Contractor	Completion Date
56.1	07-06-2022 Sedimentation Tank CR 02	Permanent fresh water addition

<p style="text-align: center;">Jun 7, 2022 11:14:27 AM 27° NE Index number: 1242</p>	Contractor is instructed to install permanent fresh water pipe to the sedimentation tank.	<b>Immediate</b>		
56.2	07-06-22 CR 02  Toilets Septic Tank	Septic Tank overflow is causing nuisance

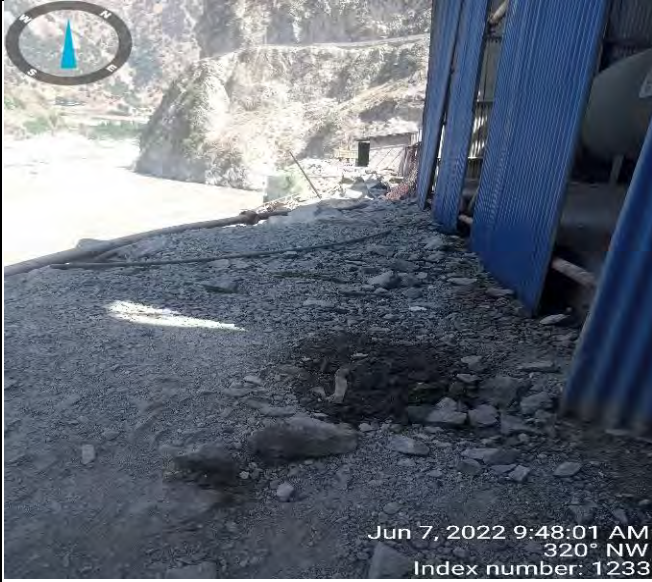
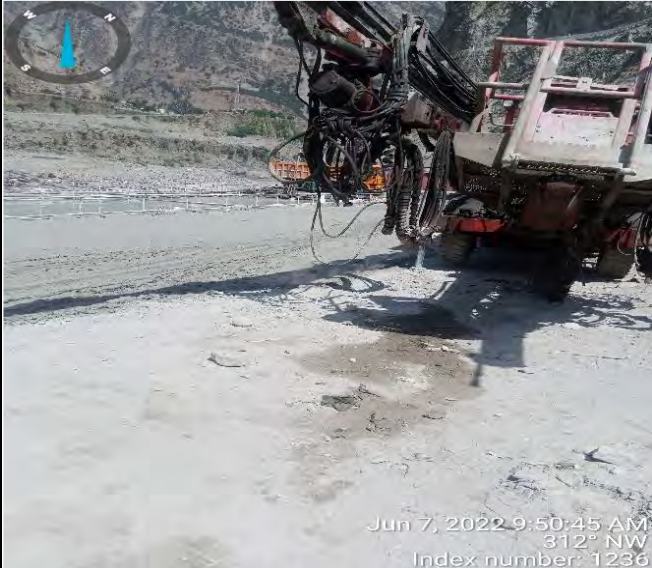
Sr. No	Date and Location of Inspection	EHS observations	Picture	Instructions to the Contractor	Timeline	Action Taken by the Contractor	Completion Date
56.3	07-06-22 CR 09 Behind workshop	Oil spillage

<p style="text-align: right;">Jun 7, 2022 9:48:01 AM 320° NW Index number: 1233</p>	Contractor is instructed to remove the oil spillage and replace the contaminated soil with fresh soil and dispose off the contaminated soil as per SOP's.	Immediate		
	Near sedimentation tank along road	Oil spillage

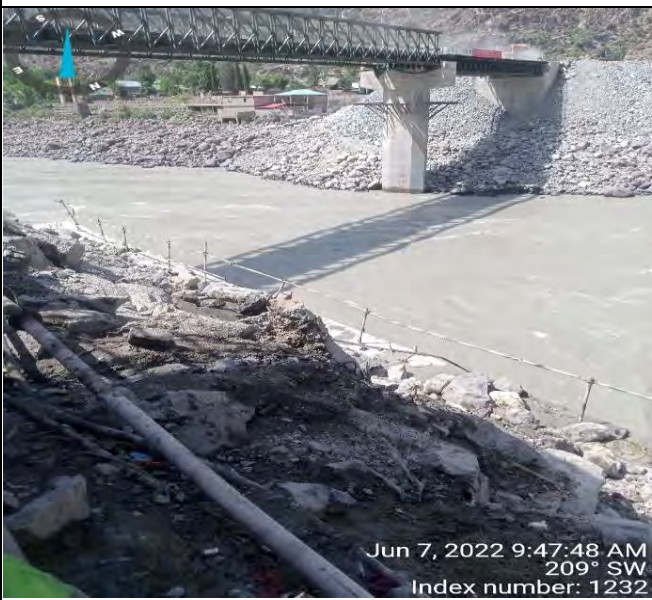
Sr. No	Date and Location of Inspection	EHS observations	Picture	Instructions to the Contractor	Timeline	Action Taken by the Contractor	Completion Date
56.4	07-06-22 CR-09 Workshop Under truss bridge	Garbage and damaged faucets. Pipes

Repair leaking faucets / pipes. And remove the garbage from backyard of Workshops under Truss bridge.	<b>Immediate</b>		
56.5	07-06-22 CR 09	Poor housekeeping

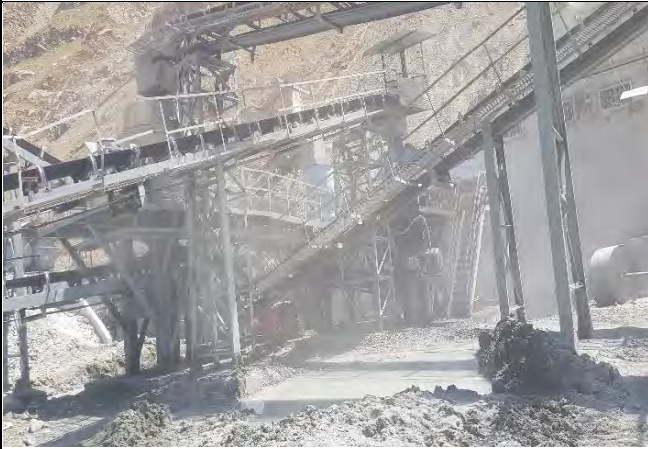
The contractor is instructed to install Wet scrubbing system on the conveyer belt so that the crush material is wet and no dust is generated because the water cannon is not as effective as the approach mentioned above.	<b>Immediate</b>		
56.7	07-06-2022 Crush plant at Uchaar	Sludge in the sedimentation pond and froth is floating on the pond surface.

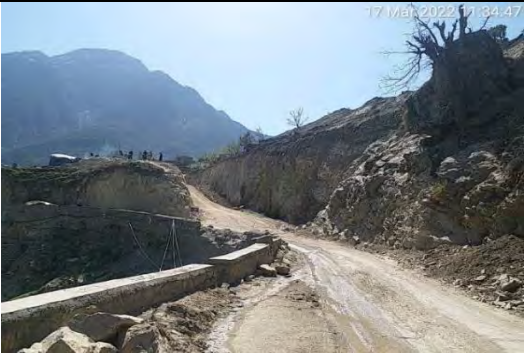
Sr. No.	Date and Location of Inspection	EHS observations	Picture	Instructions to the Contractor	Timeline	Action Taken by the Contractor	Completion Date
11.1	17-03-2022 Komila Bypass End Point	No Water sprinkling

CCECC is instructed to suppress the fugitive dust by Water Sprinkling	Immediate

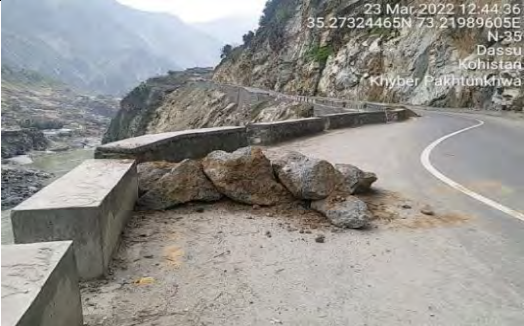
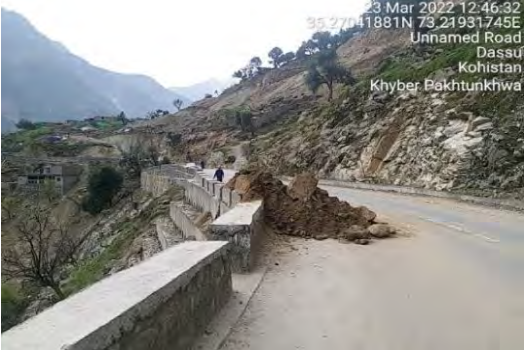
01-04-2022 Water sprinkling has been ensured for dust Suppression.
11.2	23-03-2022 RAR-01	Excavated Material Boulders

Removal of Boulders or excavated soil from the newly built RAR-01. Otherwise it was cause a traffic accident on RAR-01	Immediate

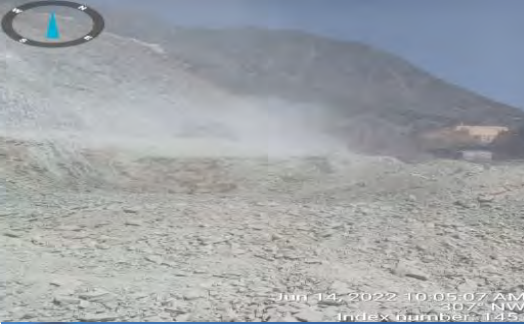
Sr. No	Date and Location of Inspection	EHS observations	Picture	Instructions to the Contractor	Timeline	Action Taken by the Contractor	Completion Date
12.1	14-06-2022 RAR-01 Construction site Komila bypass end point	Heavy dust drill

The contractor is instructed to ensure water sprinkling and all fugitive dust issue should be resolved as the site is near residential area it might cause public nuisance and grievances by the community.	Immediate

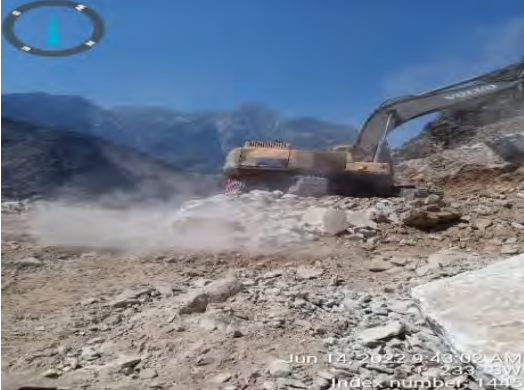
12.2	14-06-22 RAR-01 Construction site Komila bypass end point	Fugitive Dust

The contractor is instructed to ensure Water sprinkling at all working faces of the RAR-01 Komila Bypass.

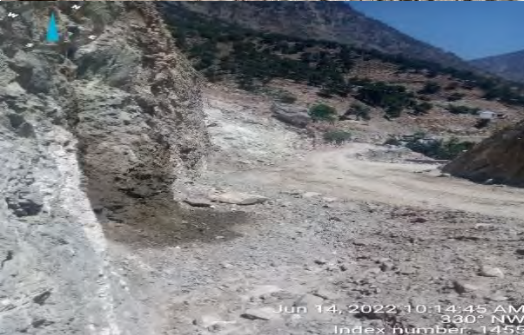
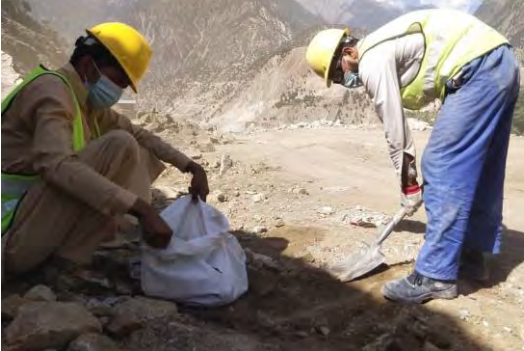
12.3	14-06-22 RAR-01 Komila bypass end point	Oil Spillage

Contractor is instructed to replace the contaminated soil with fresh soil and dispose off the contaminated soil as per SOP provide in ECPs

Contractor has removed the contaminated soil and area filled with fresh soil.

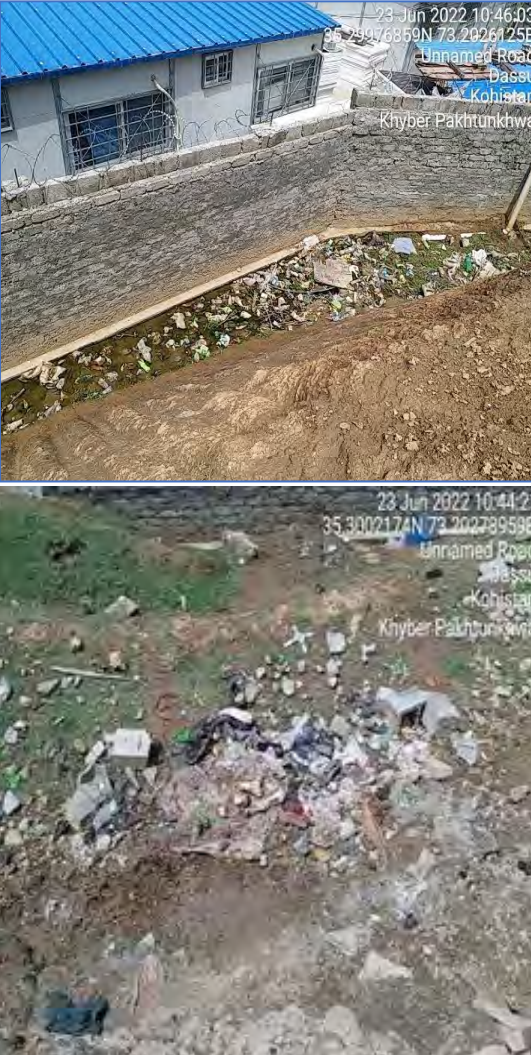
Sr. No	Date and Location of Inspection	EHS observations	Before Rectification Picture	Action Taken by the Contractor	After Rectification picture
33.4	23-6-2022 Labour camp	Bad Drainage system	   	<p>Remove the scattered waste from site and dispose off at designated site</p> <p>Open the chocked drainage pipe and operationalized the drainage system</p>	   
33.5	23-6-2022	Improper waste disposal

<p>Remove the scattered waste from site and dispose off at designated site</p>

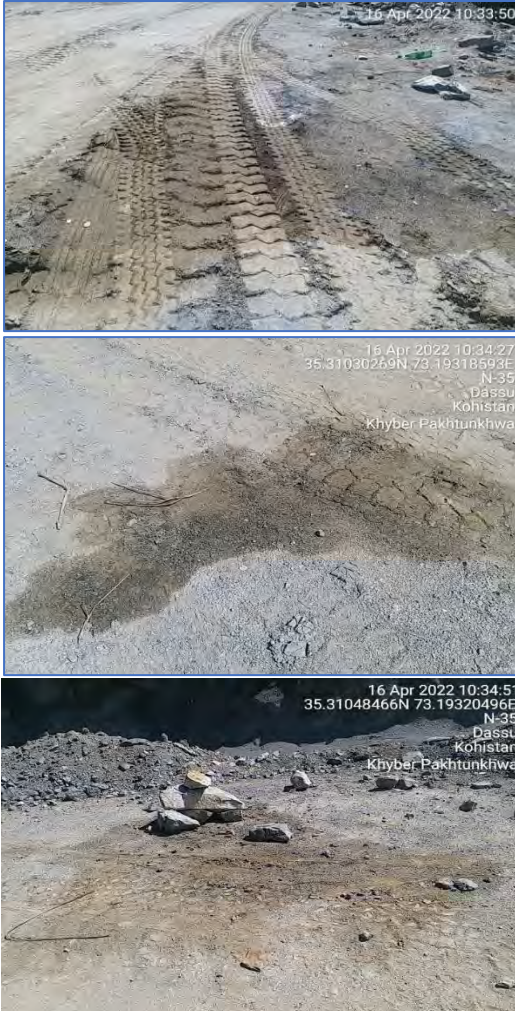
Sr. No	Date and Location of Inspection	EHS observations	Picture	Instructions to the Contractor	Timeline	Action Taken by the Contractor	Completion Date
16.1	16-04-2022 Khushi RV site	Oil Spills at site

The Contractor is instructed to remove the oil spills from the site and as regularly instructed to use drip trays while refueling at site.	Immediate	  <p>The contractor has removed the contaminated soil from the ground and put the new soil on the excavated area.</p>	17.4.2022

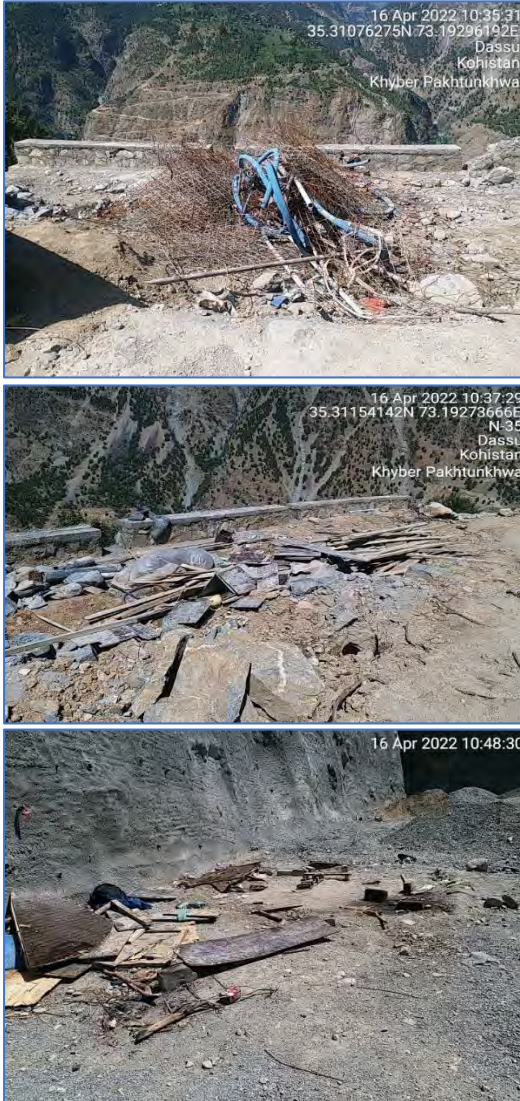
Sr. No	Date and Location of Inspection	EHS observations	Picture	Instructions to the Contractor	Timeline	Action Taken by the Contractor	Completion Date
16.5	16-04-2022 Khushi RV site	Poor housekeeping Construction waste at site

<p>16 Apr 2022 10:35:31 35.31076275N 73.19296192E Dasu Kohistan Khyber Pakhtunkhwa</p> <p>16 Apr 2022 10:37:29 35.31154142N 73.19278665E N-35 Dasu Kohistan Khyber Pakhtunkhwa</p> <p>16 Apr 2022 10:48:30</p>	The contractor is instructed to ensure good housekeeping at the construction site	immediate

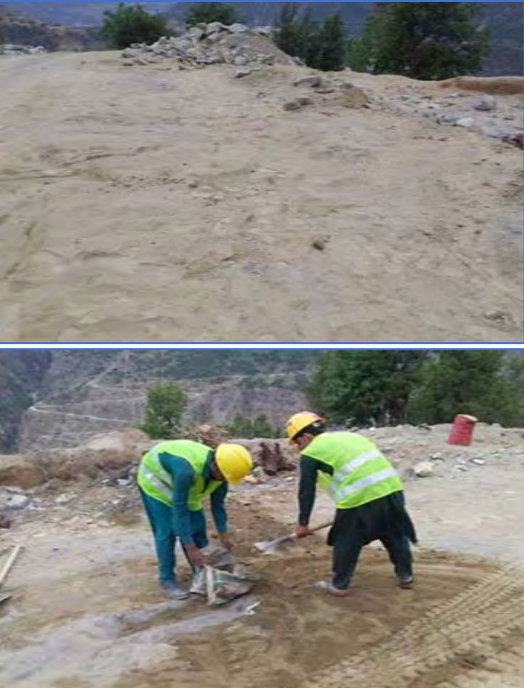
Sr. No	Date and Location of Inspection	EHS observations	Picture	Instructions to the Contractor	Action Taken by the Contractor
18.1	21-05-2022 Khushi RV site	Oil Spills at site	 	<p>Contractor is instructed the contractor to remove the spill from site and replace the soil.</p> <p>Contractor is further instructed to use dipping tray &amp; Spill Sheet whenever they are replacing the oils in their machinery/ equipment/vehicles.</p> <p>Contractor is also instructed to arrange on-site training for its staff with agenda: " How to deal with oil/ chemical spillage".</p>

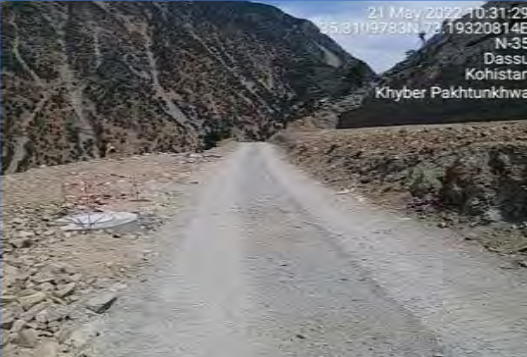
18.2	21-05-2022 Khushi V site	Fugitive Dust at on the road connecting LBRV &12.

<p>Contractor is instructed that to ensure the water sprinkling at site at least 3 to 4 time a days during the summer season.</p> <p>It is expressed with great concern that this issue a long awaited, and repeated in a number of monthly meetings, several walkthrough reports but still not complied properly.</p>

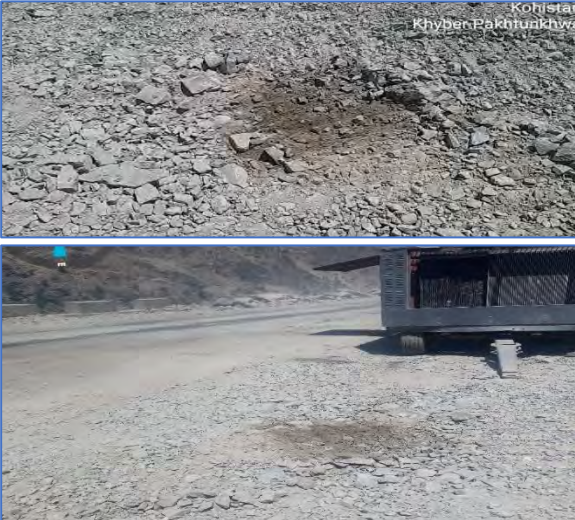
Sr. No	Date and Location of Inspection	EHS observations	Picture	Instructions to the Contractor	Timeline	Action Taken by the Contractor	Completion Date
1.2	01-06-2022 KKH-02	Spillage of oil

<p>Contractor is instructed to replace the soil with clean and fresh soil immediate basis. If needed then use spill kits for oil spill on the site. Dispose of the contaminated Soil.</p>	Immediate		
1.3	01-06-2022 KKH-02	Dust
