## Dasu Hydropower Project

**Subject: Dasu HPP –30<sup>TH</sup> Environmental Progress Report for the Period from April to June 2022**

Environmental Quarterly Progress  
Report

Report Number : 30  
Reporting Period : April to June 2022

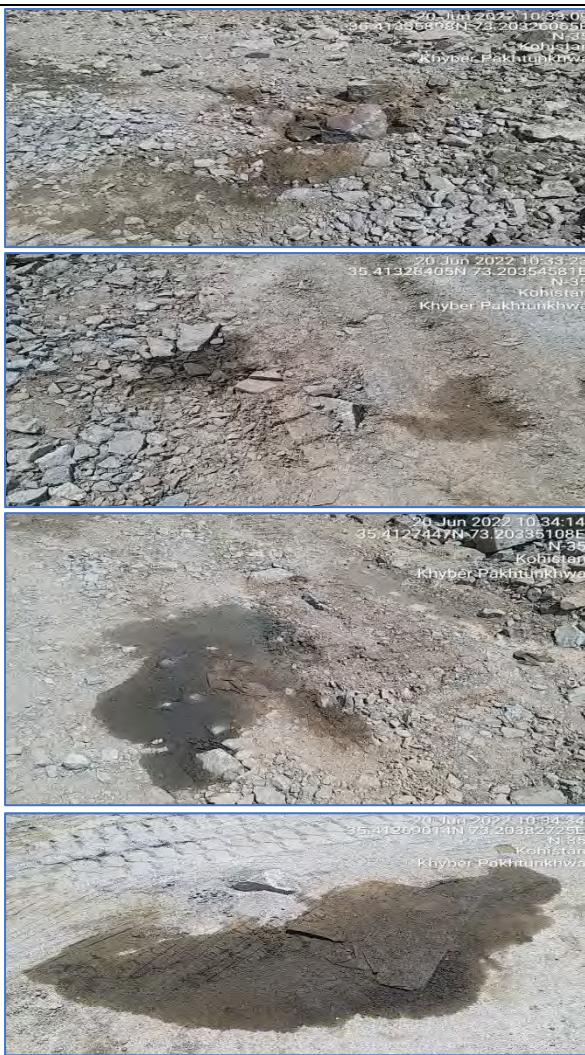
**Table 9.6: Walk-Through Inspection Report No. 2**

Sr. No	Date and Location of Inspection	EHS observations	Picture	Instructions to the Contractor	Timeline	Action Taken by the Contractor	Completion Date
2.1	20-06-2022 KKH-02	Oil Spillage

Contractor is instructed to remove the contaminated soil and replace it with fresh soil and Dispose of the contaminated Soil as per agreed mitigation measures given in ECP's.	Immediate

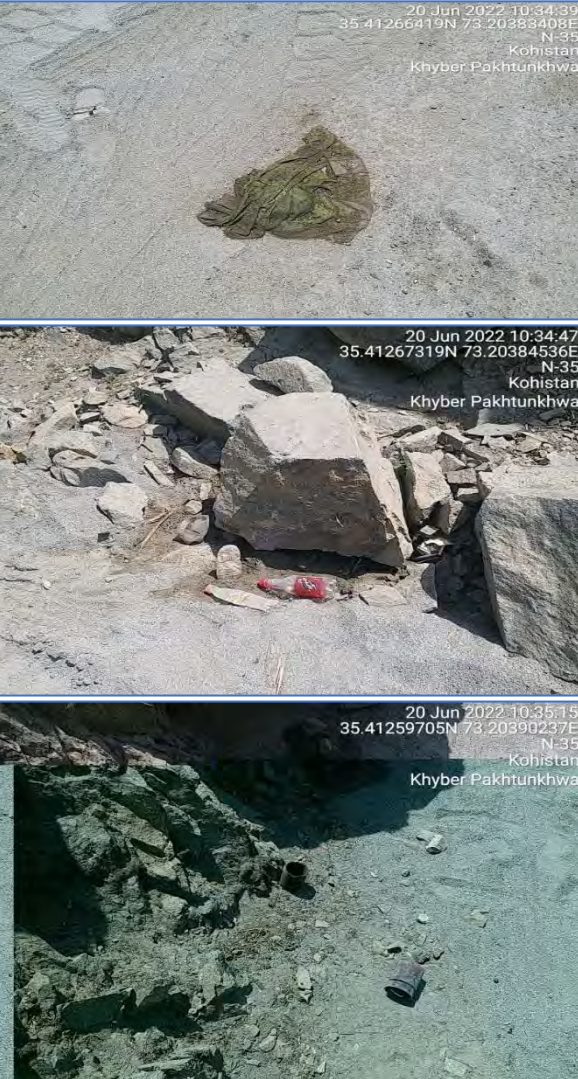
Sr. No	Date and Location of Inspection	EHS observations	Picture	Instructions to the Contractor	Timeline	Action Taken by the Contractor	Completion Date
2.2	20-06-2022 KKH-02	Poor housekeeping

<p>20 Jun 2022 10:34:39 35.41266419N 73.20388408E N-35 Kohistan Khyber Pakhtunkhwa</p> <p>20 Jun 2022 10:34:47 35.41267319N 73.20384536E N-35 Kohistan Khyber Pakhtunkhwa</p> <p>20 Jun 2022 10:35:15 35.41259705N 73.20390237E N-35 Kohistan Khyber Pakhtunkhwa</p>	Contractor is instructed to maintain good housekeeping of site.
