Dasu Hydropower Project

Subject: Dasu HPP –31st ENVIRONMENTAL PROGRESS REPORT FOR THE PERIOD FROM JULY TO SEPTEMBER 2022

Environmental Quarterly Progress Report

Report Number : 31
Reporting Period : July to Sep 2022

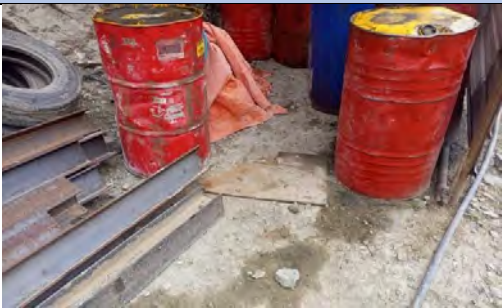
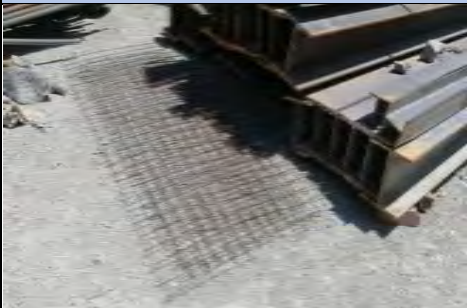
Sr. No	Date and Location of Inspection	EHS observations	Picture	Instructions to the Contractor	Timeline	Action Taken by the Contractor	Completion Date
57.1	13-07-2022 MW -01 & MW 02 CR-02	Oil Spillage

Contractor is instructed to replace the contaminated soil with fresh soil and dispose of the contaminated soil as per SOPs provided in EMMP and ECP's.	Immediate

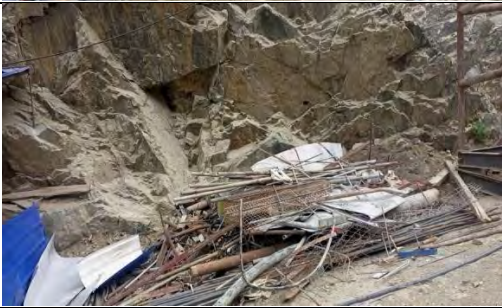
57.2	13-7-22 CR-02	Poor Housekeeping

The contractor is instructed to maintain good housekeeping practices at all the construction sites as per SOPs provided in EMMP and ECP's.	Immediate

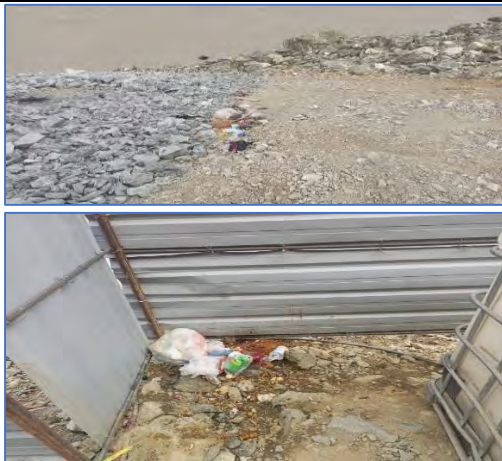
57.3	13-07-2022 CR-02	Solid waste

The contractor is instructed to dispose off the solid waste at proper disposal site rather than Littering it. Provide waste bins at all working sites.

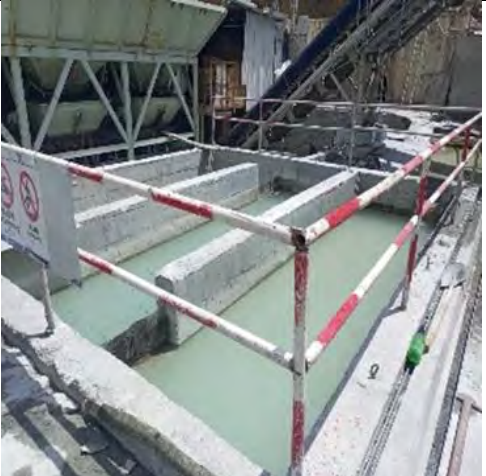
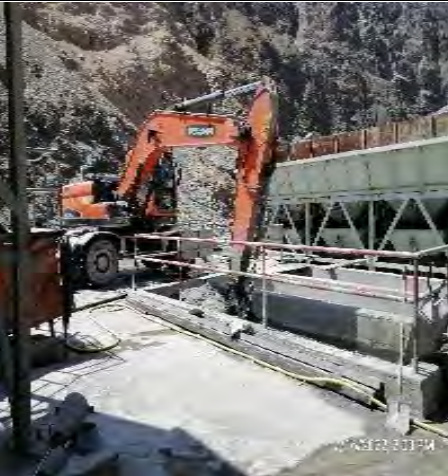
Sr. No	Date and Location of Inspection	EHS Observations	Picture	Instructions to the Contractor	Timeline	Action Taken by Contractor	Completion Date
58.1	15-07-2022, CR2 batching plant	High turbidity in Water

Contractor is instructed to add the fresh water in the sedimentation pond	immediate

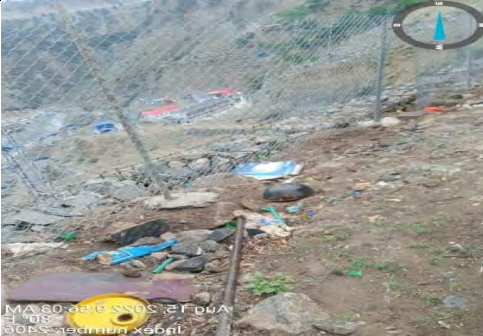
Sr. No	Date and Location of Inspection	EHS observations	Picture	Instructions to the Contractor	Timeline	Action Taken by the Contractor	Completion Date
59.1	15-08-2022 Switch yard	littering

The contractor is instructed to place waste bins at the site and educate the workers to use the bins	immediate

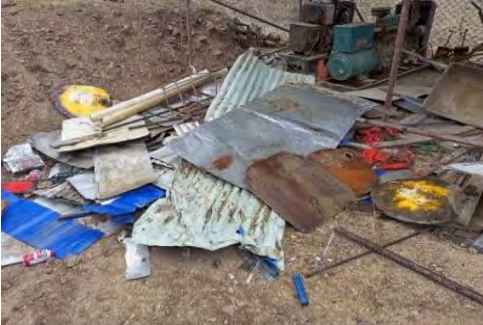
15-08-2022
59.2	15-08-2022 Switch yard	inadequate housekeeping

The contractor is instructed maintain good housekeeping on site and manage construction material properly. This recyclable waste can be sent to local vendor.	immediate

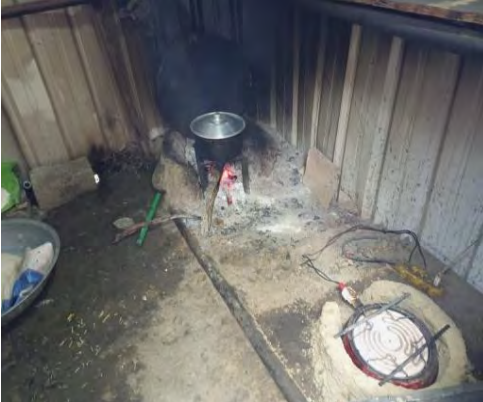
15-8-2022
59.3	15-08-2022 Switch yard	Fuel wood

The contractor is instructed to stop usage of fuelwood and to provide LPG for cooking and heating purposes	immediate

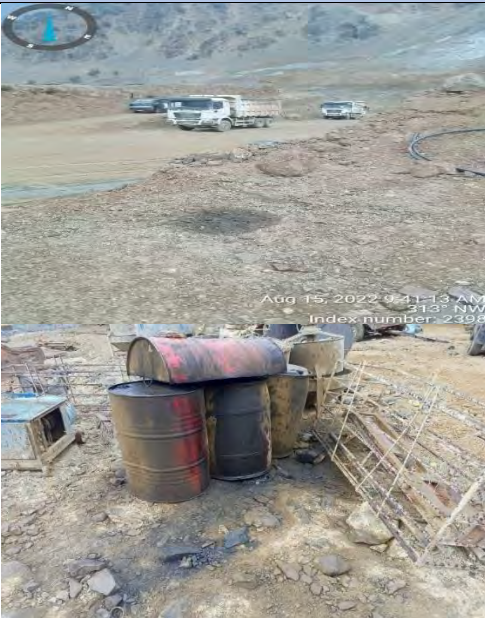
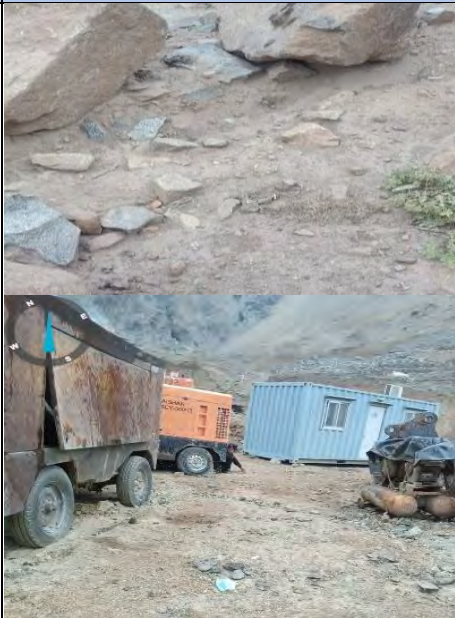
Sr. No	Date and Location of Inspection	EHS observations	Picture	Instructions to the Contractor	Timeline	Action Taken by the Contractor	Completion Date
59.4	15-08-2022 Switch yard	Oil spill

1.The contractor is instructed to remove the oil spill from the site by replacing fresh soil and dump properly 2. The contractor is instructed to make a proper concrete paved storage area (with small boundary) for the storage of Oil so that the soil may not contaminate continuously.	22-8-2022

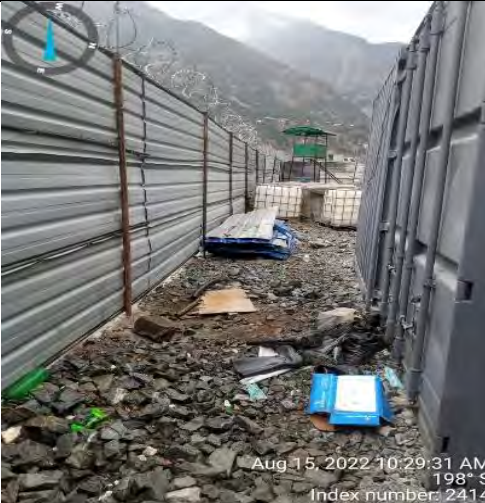
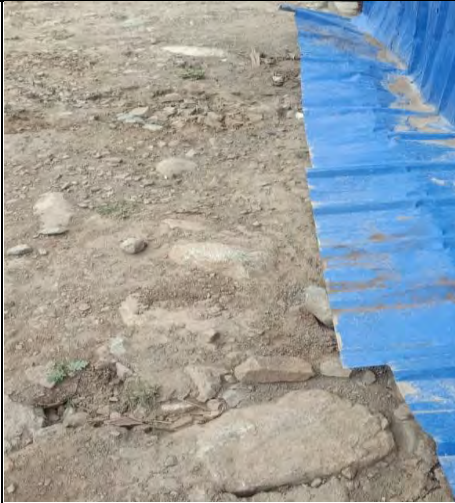
15-8-2022
59.5	15-08-2022 CT-02	Oil spill

The contractor is instructed to remove the oil spill from the site by replacing fresh soil and dump properly	immediate

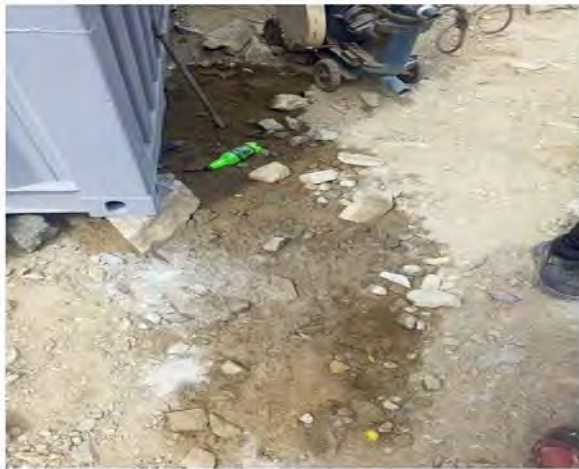
30.3	30-07-2022 K4	Oil spill

Contractor is instructed to remove the contaminated soil with clean and fresh soil. Use spill kits for oil spills (If Needed) on the site. Dispose of the toxic Soil as per ECP: Waste Management.	Immediate		
30.4	30-07-2022 K4	Heavy dust

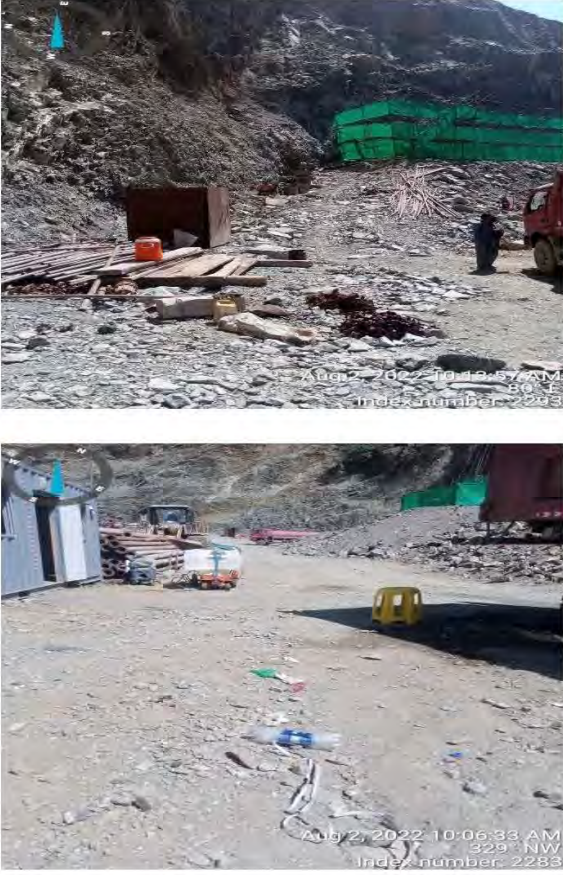
Sr. No	Date and Location of Inspection	EHS observations	Picture	Instructions to the Contractor	Timeline	Action Taken by the Contractor	Completion Date
31.1	02-08-2022 K4	Inadequate housekeeping

Contractor is instructed to keep construction material properly and maintain good housekeeping on site.	Immediate

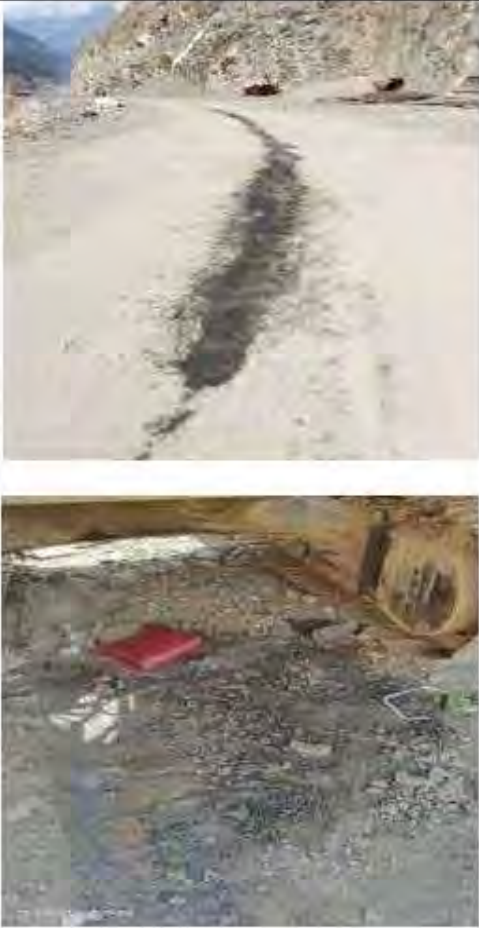
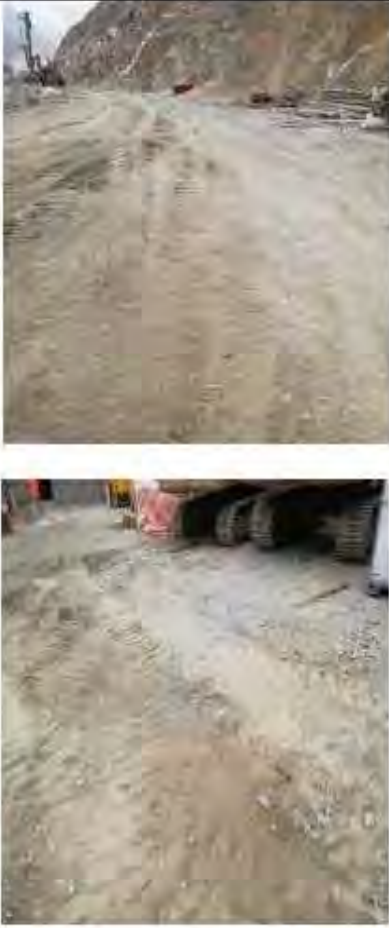
Sr. No	Date and Location of Inspection	EHS observations	Picture	Instructions to the Contractor	Timeline	Action Taken by the Contractor	Completion Date
32.1	13-09-2022 K4 Tunnel Portal	Fuel/ Oil Spills

Contractor is instructed to replace the contaminated soil with clean and fresh soil Use spill kits if needed. Dispose off the contaminated soil as per SOP's provided in ECP's/ EMAP	Immediate

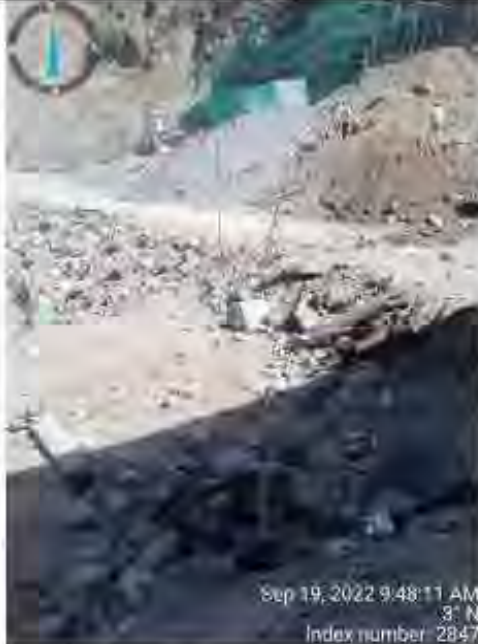
Sr. No	Date and Location of Inspection	EHS observations	Picture	Instructions to the Contractor	Timeline	Action Taken by the Contractor
33.1	19-9-2022 K4 tunnel	Fuel wood is used to Cooking and heating

The contractor is instructed that open burning is strictly prohibited and usage of fuel wood at the site. Provide the LPG cylinder for heating and cooking purposes	Immediate	Site Engineer and in charges have been instructed to avoid wood burning or cooking activities at working sites

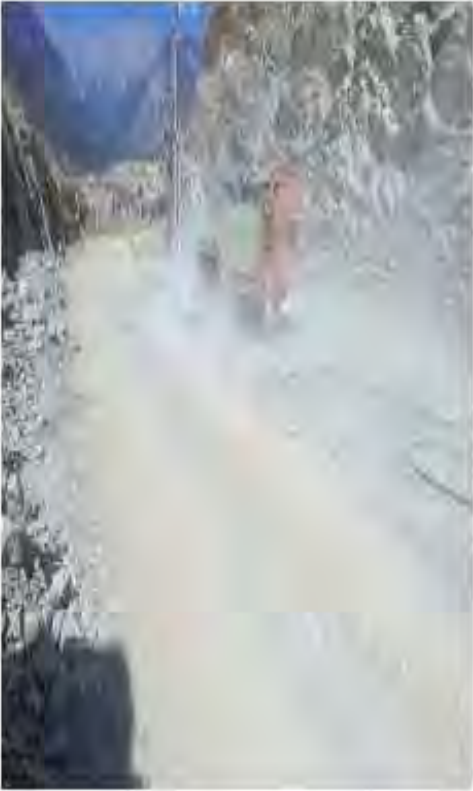
33.2	19-9-2022 K4 tunnel Near camp	Heavy dust

<p>Crawler hydraulic drill's exhaust is not functional</p> <p>The contractor is instructed to maintain all equipments in good working order in accordance with manufactures maintenance procedures.</p>	immediate	  <p>Drill operator is informed to install dust collector, exhaust vacuum or water sprinkling hose to minimize dust pollution</p>
------	-------------------------------------	------------	---	---	-----------	--

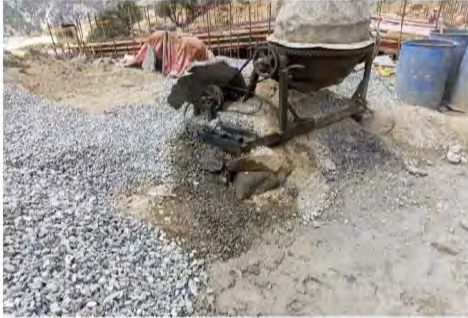
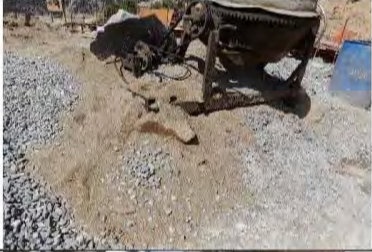
Sr. No	Date and Location of Inspection	EHS observations	Picture	Instructions to the Contractor	Timeline	Action Taken by the Contractor	Corrective Action	Completion Date
11.1	28-07-2022 Grid Station	Oil spill

The contractor is instructed to remove the oil spill by replacing soil and the contaminated soil dump in a drum temporary and follow spill protocols and use spill kits, (if required).	Immediate	Contractor remove the contaminated crush with fresh sand OHS officer also instructed the site supervisor to repair engine if it continuously spill oil.

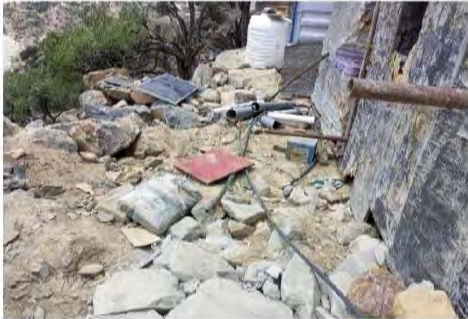
04-08-2022
11.2	28-07-2022 grid station	Poor housekeeping

Contractor is instructed to maintain good housekeeping at construction site.		Contractor remove all solid waste that is scatared on site

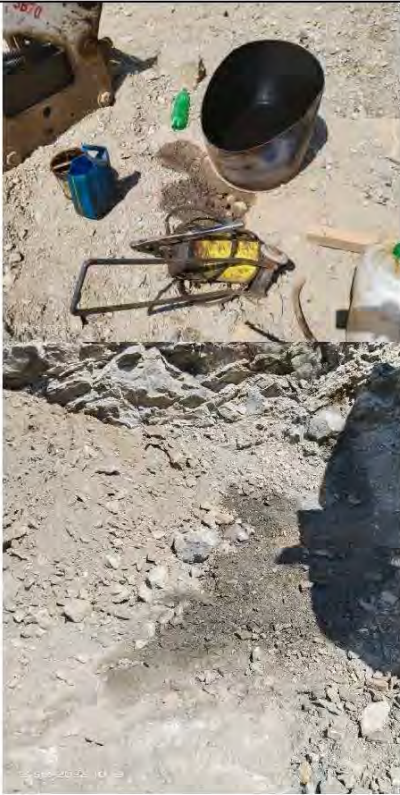
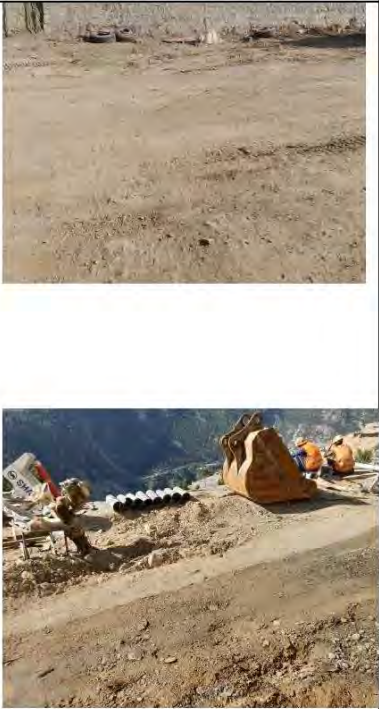
Sr. No	Date and Location of Inspection	EHS observations	Picture	Instructions to the Contractor	Timeli ne	Action Taken by the Contractor	Rectification pictures	Completion Date
13.1	13-09-2022 Grid station	Oil spill

The contractor is instructed to remove the oil spill by replacing contaminated soil and Disposing Contaminated soil as per SOP's provided in ECP's and EMAP.	Imme diate	Contractor remove oil tank place in open area and strictly warned to mechenic to cover oil tank and place in designated place

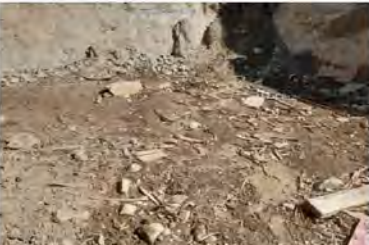
13.2	13-09-2022 Grid station	Inadequate housekeeping	 	Contractor is instructed to maintain good housekeeping at construction site.	Immediate	Contractor remove solid waste from site.

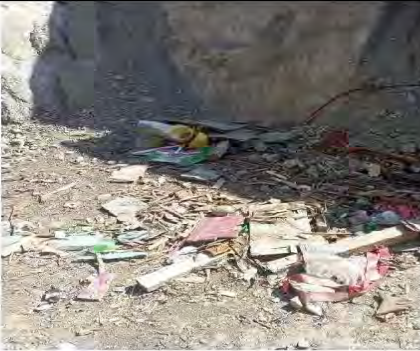
Sr. No	Date and Location of Inspection	EHS observations	Picture	Instructions to the Contractor	Timeline	Rectification Pictures	Action Taken by the Contractor	Completion Date
14.1	22-09-2022 grid station	littering

The contractor is instructed to place wastebins at the site and educate the workers to use the bins and follow 3R principal	immediate

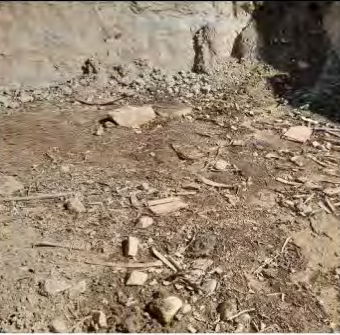
Contractor remove solid waste from site and conduct a training about housekeeping	28/9/22

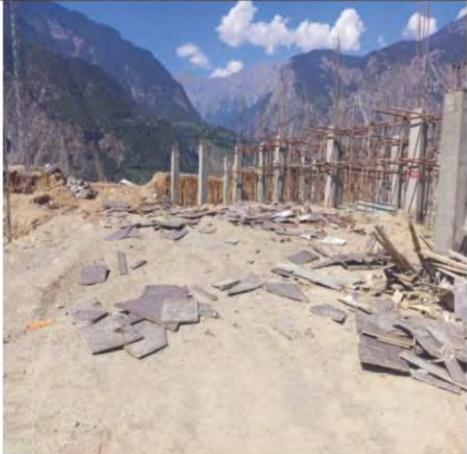
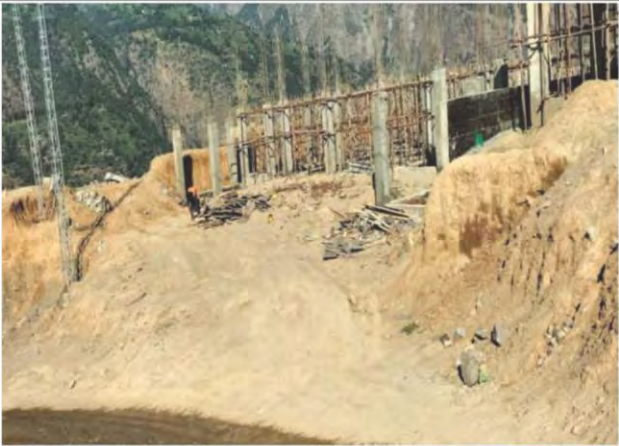
<p>36.2</p>	<p>22-09-2022 labor camp</p>	<p>inadequate housekeeping</p>

<p>These material are there for their frequent use collected the construction material form site and stacking properly to a side.</p>

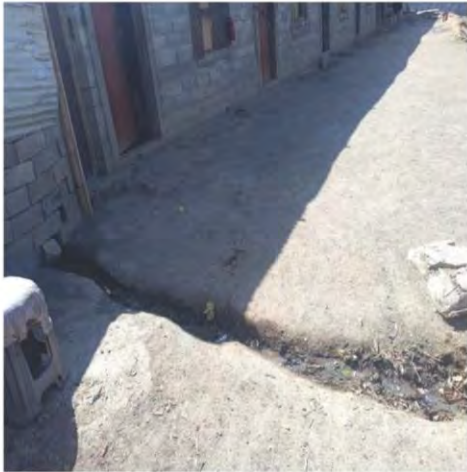
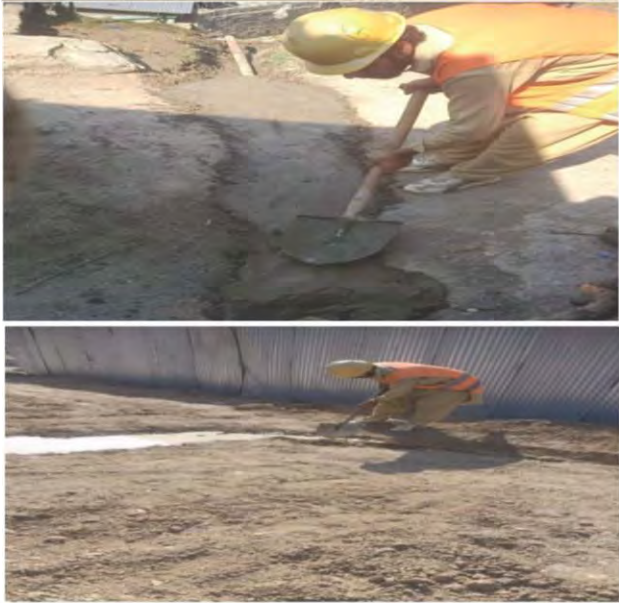
<p>36.3</p>	<p>22-09-2022 labor camp</p>	<p>Untreated water</p>

<p>Install pipe to waste water from ablution place and surface water from back side of labour camp</p>

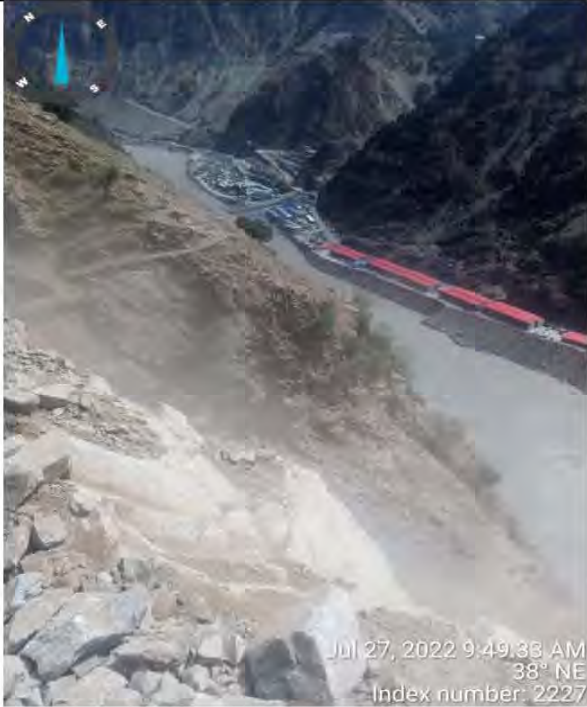
Sr. No	Date and Location of Inspection	EHS observations	Picture	Instructions to the Contractor	Timeline	Action Taken by the Contractor	Completion Date
5.1	27-07-2022 RAR-02	Heavy dust because of spoil disposal down the slope of right bank of Indus river.

Contractor is instructed to haul the excavated material to dumping site and do not roll down in Indus river which cause of generating dust. The dumper are reachable to working face need to perform haulage of excavated material.	Immediate

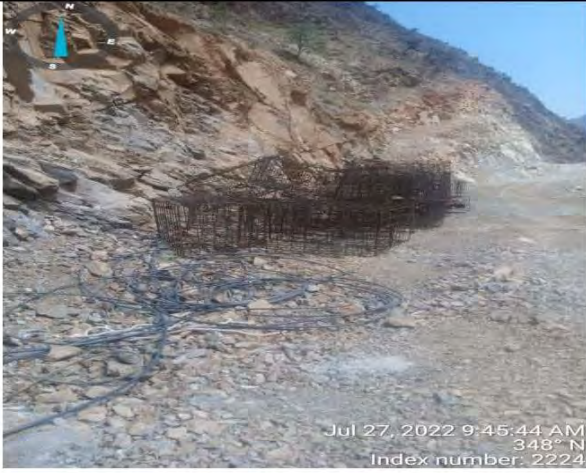
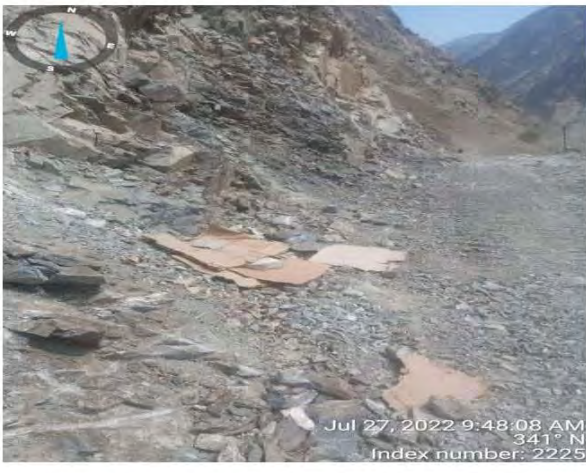
<p>5.3</p>	<p>27-07-2022 RAR-02</p>	<p>Poor Housekeeping</p>

<p>The contractor is instructed to maintain good housekeeping practices at all the construction sites.</p>

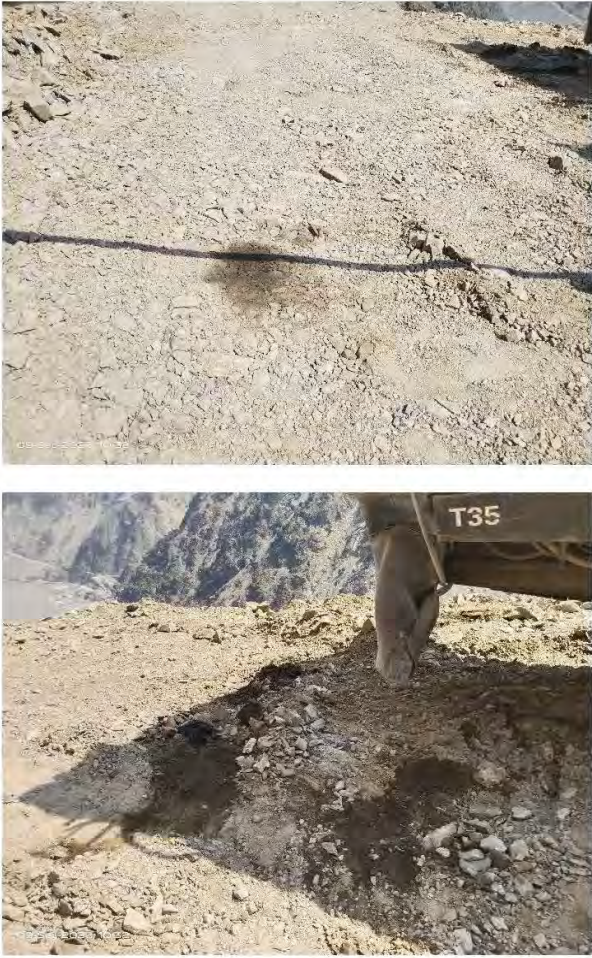
06.2	09-09-2022 RAR-02	Spillage of oil

Contractor is instructed to replace the contaminated soil with clean and fresh soil. If needed then use spill kits for oil spill on the site.	Immediate

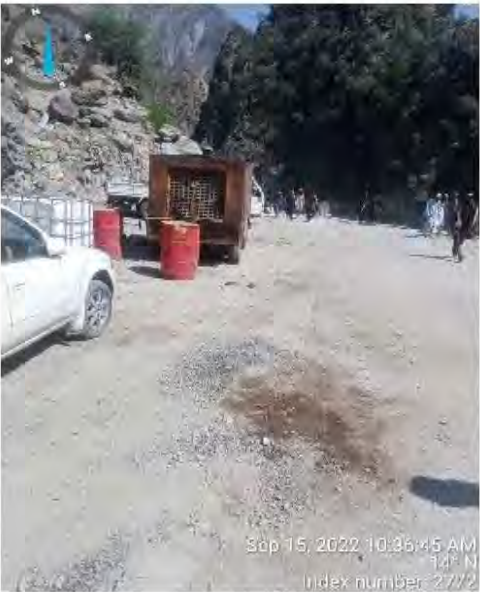
Sr. No	Date and Location of Inspection	EHS observations	Picture	Instructions to the Contractor	Timeline	Action Taken by the Contractor	Completion Date
07.1	15-9-2022 Kandia Bypass	Oil spill

The contractor is instructed to remove the contaminated soil from the site by replacing it with clean and fresh soil and dispose off as per SOP's Provided in the ECP's.	Immediate

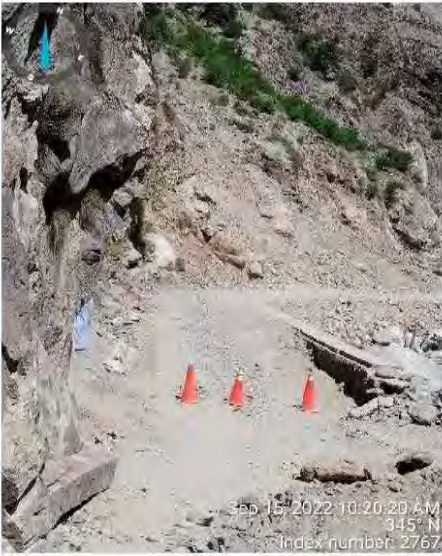
<p>07.3</p>	<p>15-9-2022 Kandia bypass.</p>	<p>Warning sign</p>

<p>The contractor is instructed to display the warning sign and warning board to aware the workers and public that what happen at the site.</p>

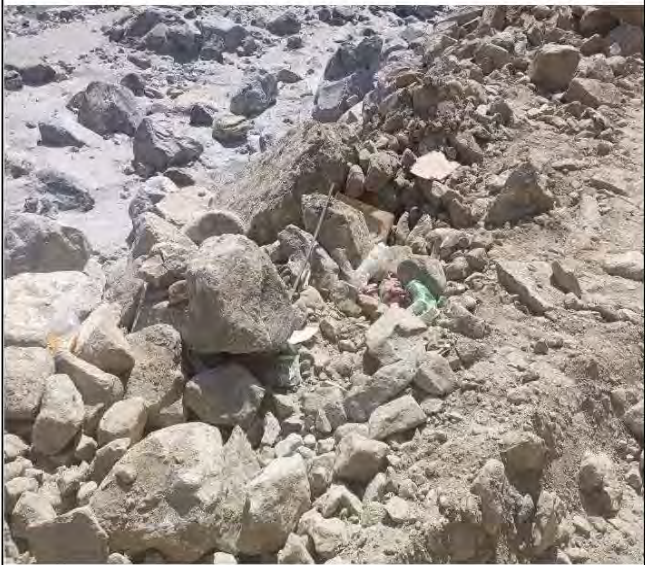
Sr. No	Date and Location of Inspection	EHS observations	Picture	Instructions to the Contractor	Timeline	Action Taken by the Contractor
8.1	23-09-2022 kandia bypass and Gayal road	littering

The contractor is instructed to place waste bins at the site and educate the workers to use the bins and follow 3R principal	immediate

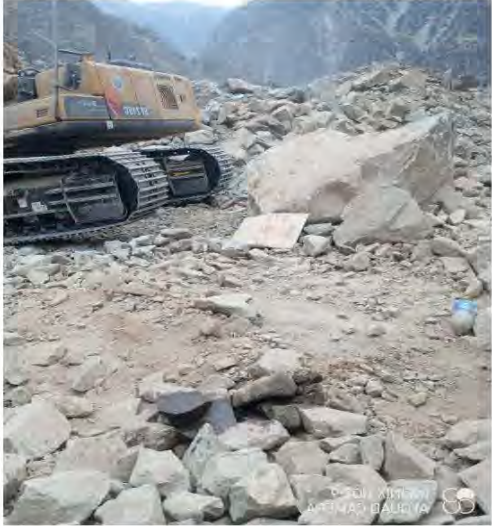
Sr. No	Date and Location of Inspection	EHS observations	Picture	Instructions to the Contractor	Timeline	Action Taken by the Contractor	Completion Date
3.1	16-07-2022 KKH-02	Oil Spillage

Contractor is instructed to replace the contaminated soil with fresh soil and dispose of the contaminated soil as per SOPs.	Immediate

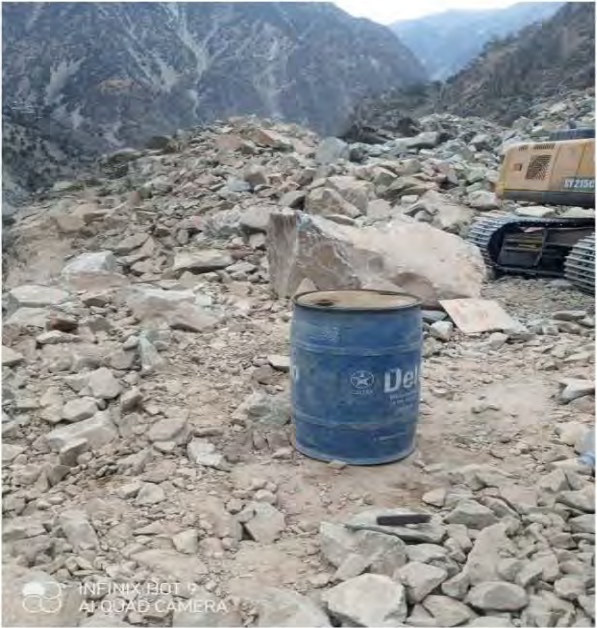
<p>3.2</p>	<p>16-7-22 KKH-02</p>	<p>Poor Housekeeping</p>

<p>The contractor is instructed to maintain good housekeeping practices at all the construction sites as per SOPs.</p>	<p>Immediate</p>		
------------	---------------------------	------------------------------	--	--	-------------------------	--	--

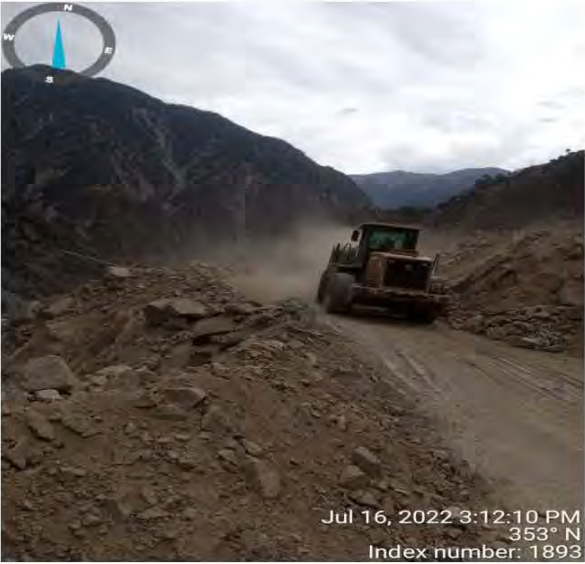
<p>3.3</p>	<p>16-07-2022 KKH-02</p>	<p>Heavy dust</p>

<p>The contractor is instructed to undertake water sprinkling activity with immediate effect. At Panibah KKH-02 site. The water sprinkling activity should be done at least four time a day. As instructed during Monthly meetings as well.</p>			
------------	------------------------------	-------------------	--	---	--	--	--

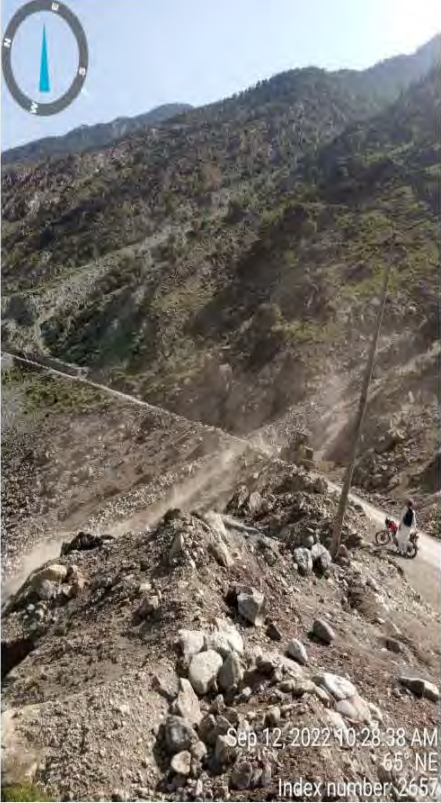
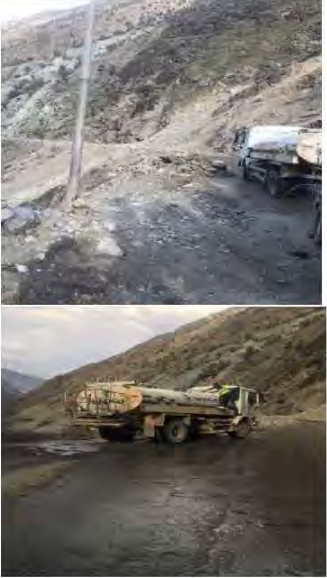
Sr. No	Date and Location of Inspection	EHS observations	Picture	Instructions to the Contractor	Timeline	Action Taken by the Contractor	Completion Date
	12-09-2022 KKH-02	Dust

Contractor is instructed to Sprinkling on the site should done daily to overcome air pollution . Increase the frequency of the sprinkling

<p data-bbox="1395 994 1720 1294">During the visit of the inspector, water was not available at our camp due to the damage to pipelines by the flash flood. Despite the above problem, we brought the water from far away and sprinkled the water over the site thrice a day to overcome the air pollution on site.</p>		15-09-2022

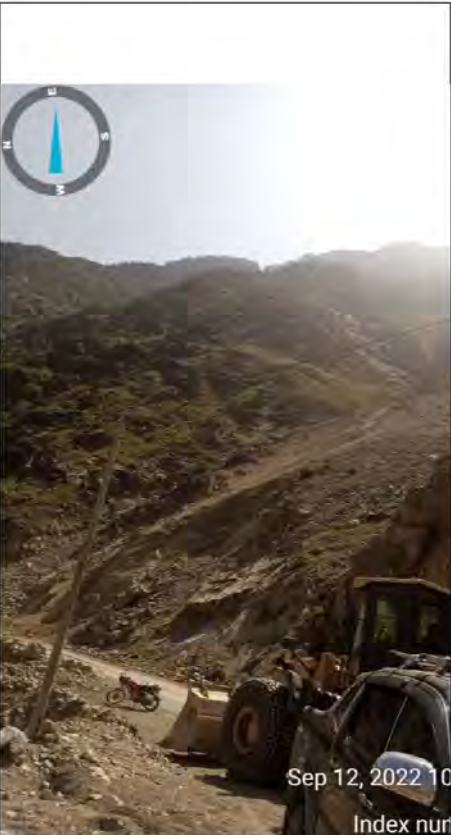
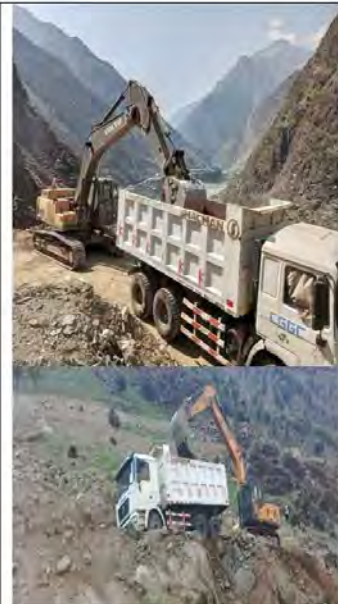
<p>12-09-2022 KKH-02</p>	<p>Excavated spoil is rolled downwards into Indus river</p>

<p>Contactor is instructed to Stop excavated material being rolling down the slope and make sure haulage of spoil which is thrown down the slope</p>

<p>During the excavation, some of the excavated materials roll down the slope unintentionally. Actually the excavated materials loaded on the dumpers and dumping in designated area. The rolled down materials could not enter in to the river as there more distance between the river edge and deposited area.</p>		
--	------------------------------	---	---	--	---	--	--

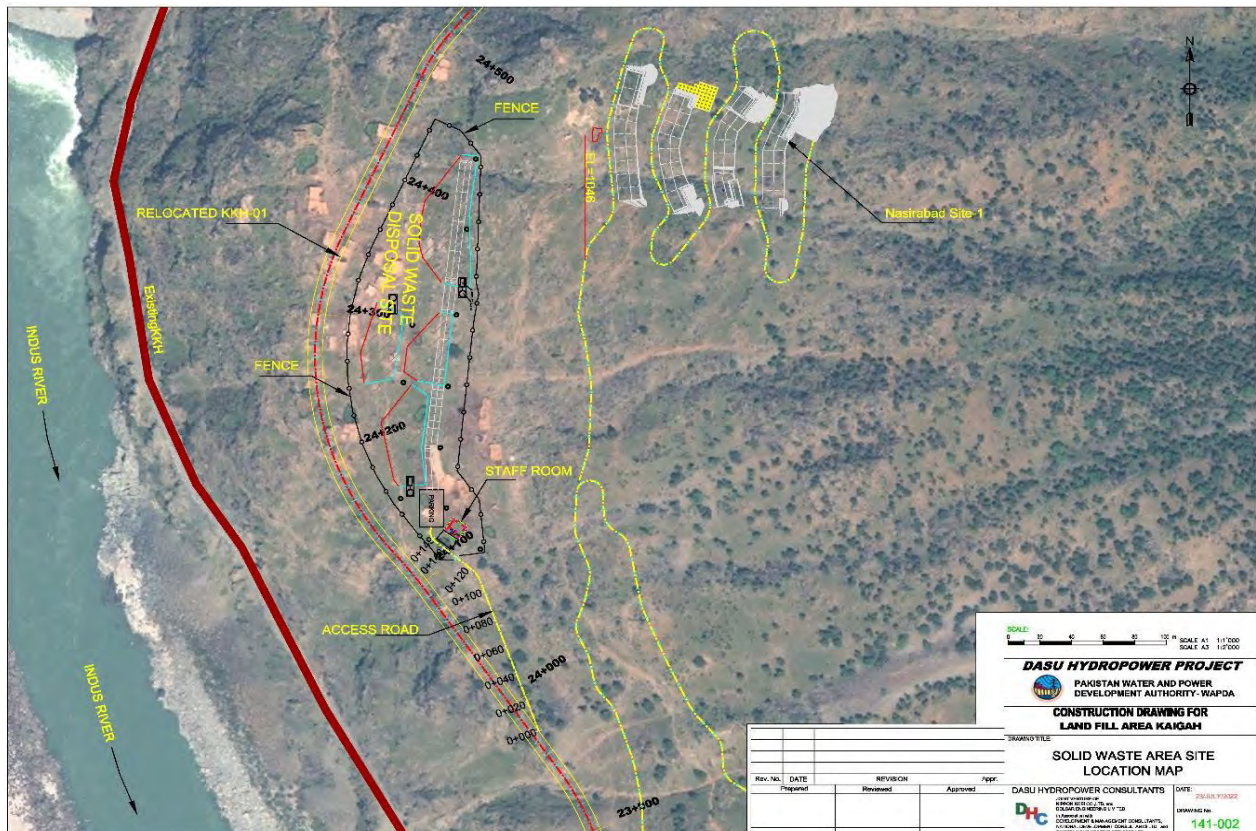
Figure 10.1: Proposed Solid Waste Disposal Site near Valley Kaigah

DHC Surveyed a potential solid waste disposal site at Kaigah along the realigned KKH. The landfill site criteria as per the IFC guidelines was checked and the site was promising as it was fulfilling most of the criteria. DHC Survey section was engaged to conduct its topographic survey which after completion was later handed over to DHC geology section to carry out its geological investigation. The potential site has an area of 34 Kanals approx. and can accommodate solid waste up to 7 years. The detailed environmental assessment was submitted to GM/PD Office of WAPDA on 5th of Aug 2022.

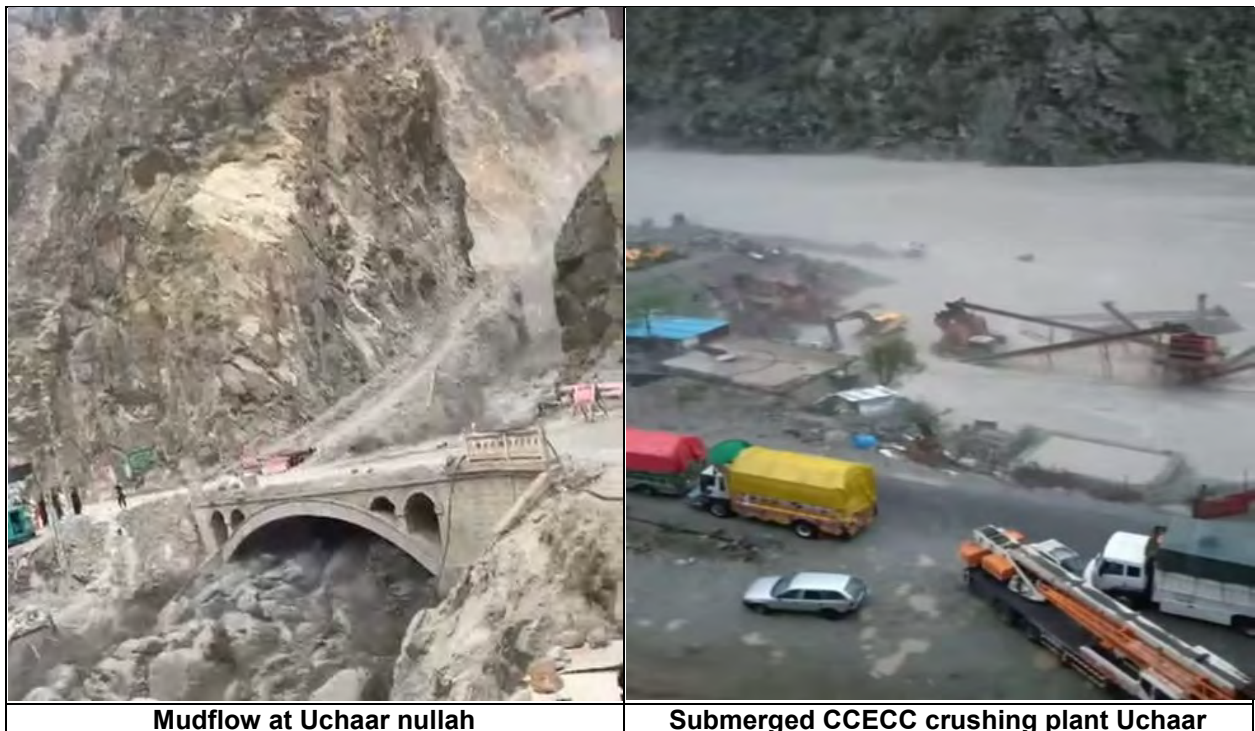
This continuous & severe rainfall which brought havoc to the Districts of Upper and Lower Kohistan led to number of landslides on the existing KKH as well as hundreds of animals been drowned and some human casualties (4 persons drowned at Dubair Nullah, Lower Kohistan) have also been seen in Lower Kohistan. No causality were reported in Upper Kohistan but loss of precious property, timber, Machinery and vehicles of DHPP were reported.

The pictorial view of the flood incidence is presented in figure 11.2

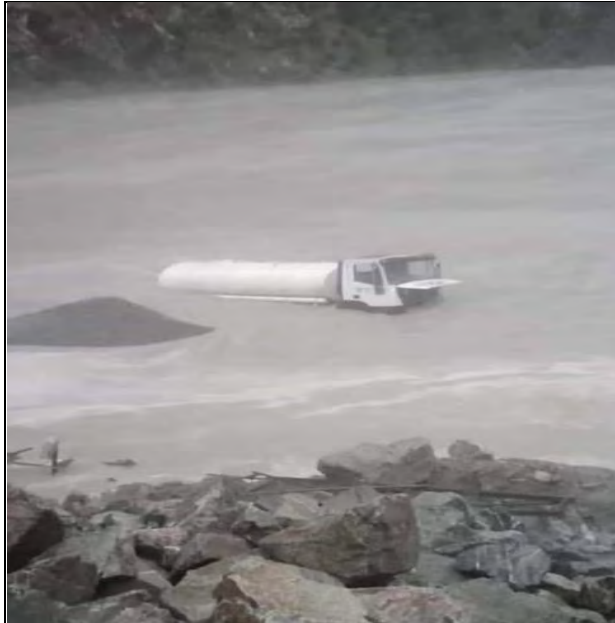
Submerged CCECC Water sprinkler at Uchaar

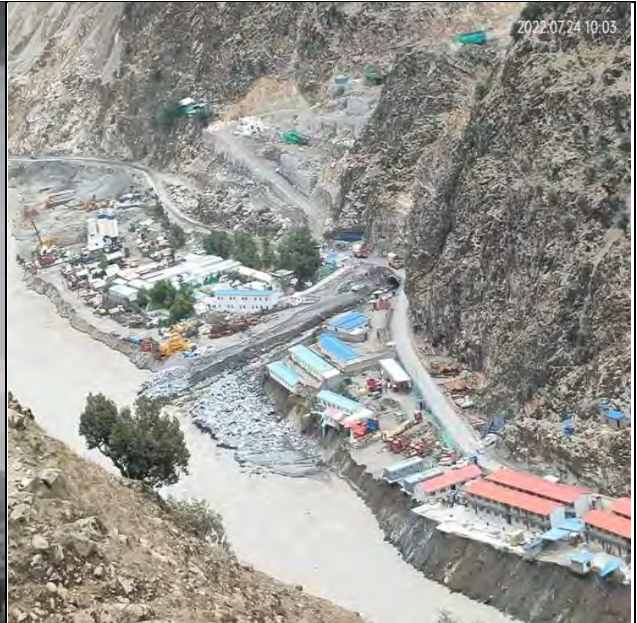
Scouring along the KKH-01, Zhongmei and CGGC camps-Uchaar

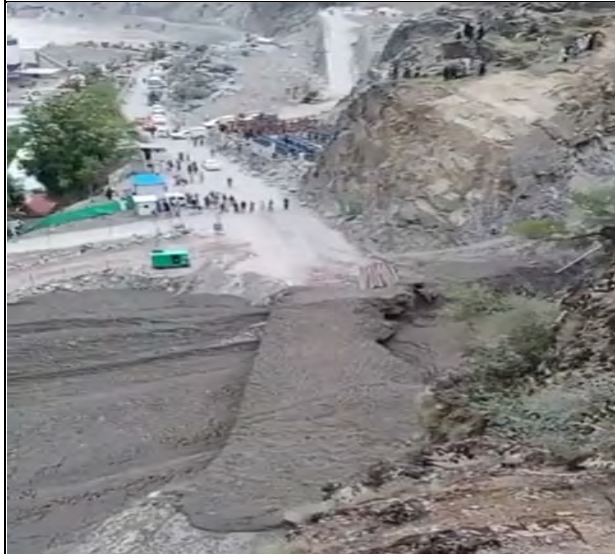
Debris flow at overtopples uchaar nullah bridge

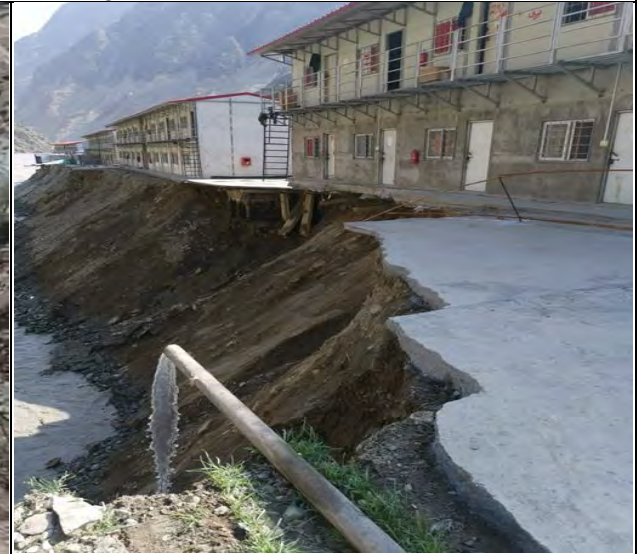
Scoured MW-02 camp at Uchaar

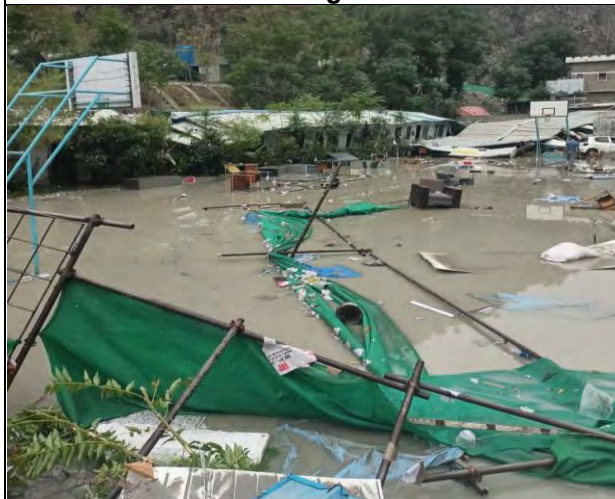
Flooded KKH-01 camp Uchaar

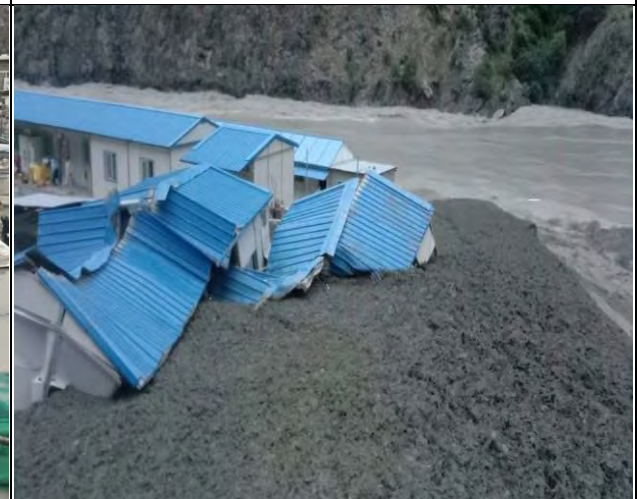
Damaged Zhongmei camp Uchaar

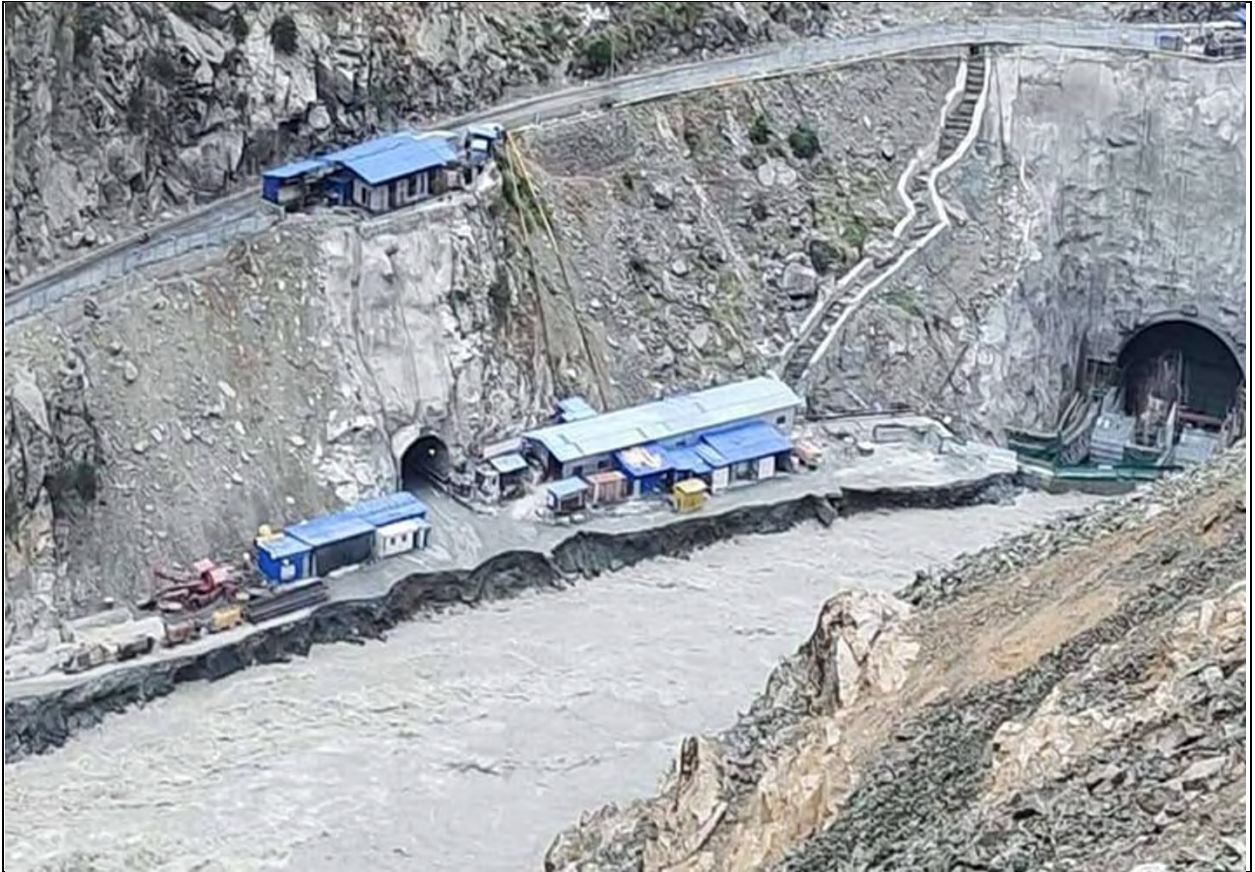
Scoured CR-02 area-Flood of 27th July 2022

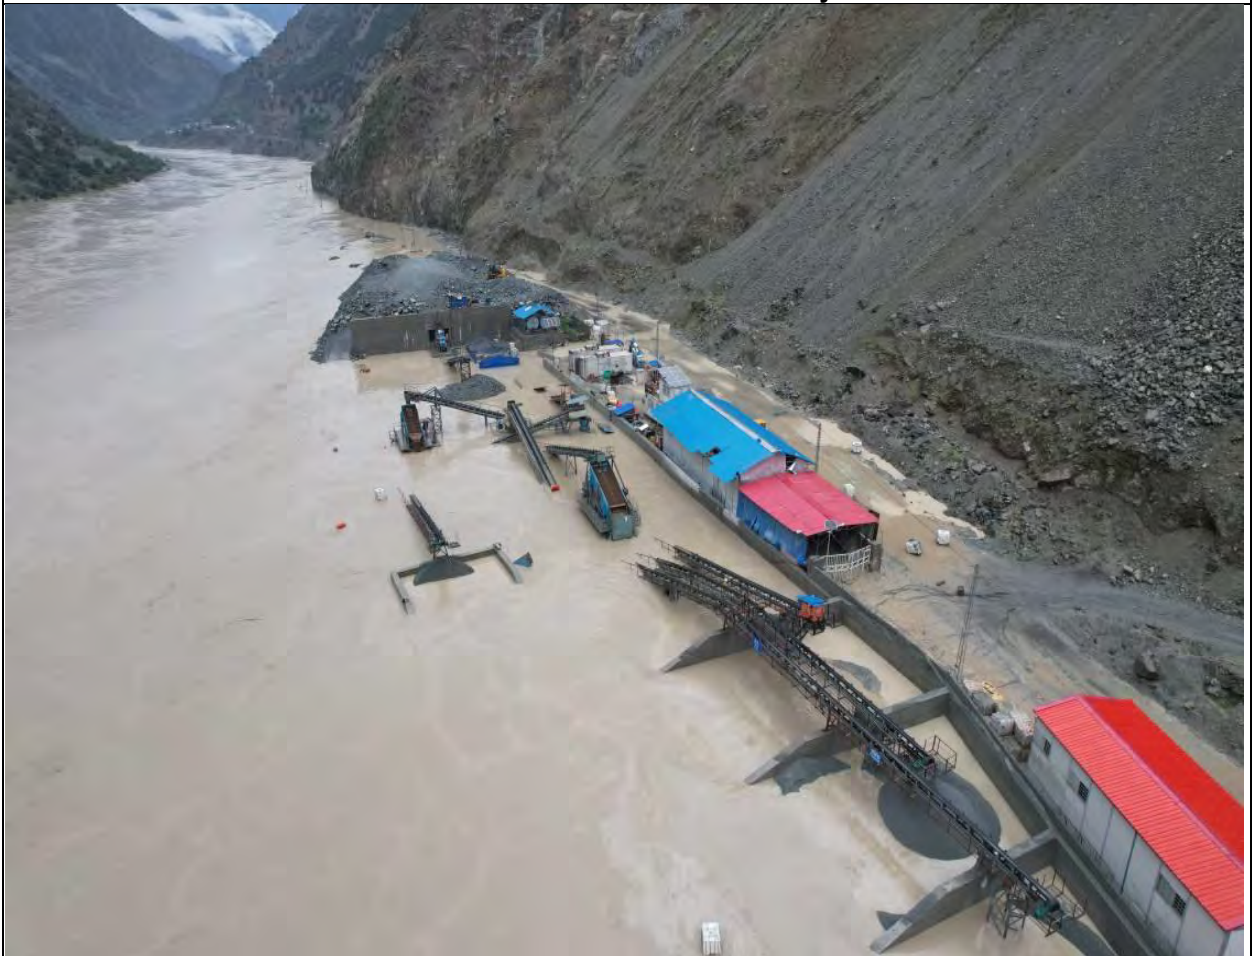
Submerged KKH and Uchaar Crushing plant

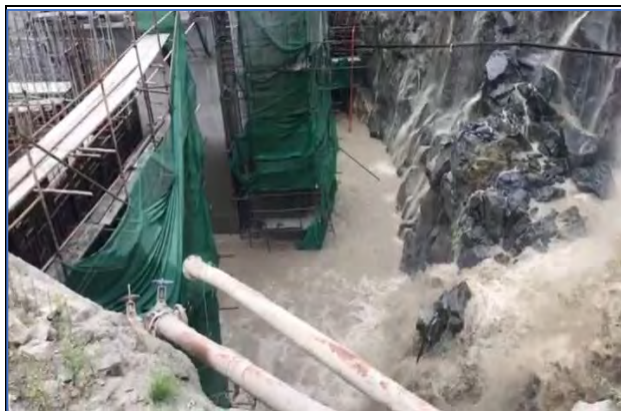
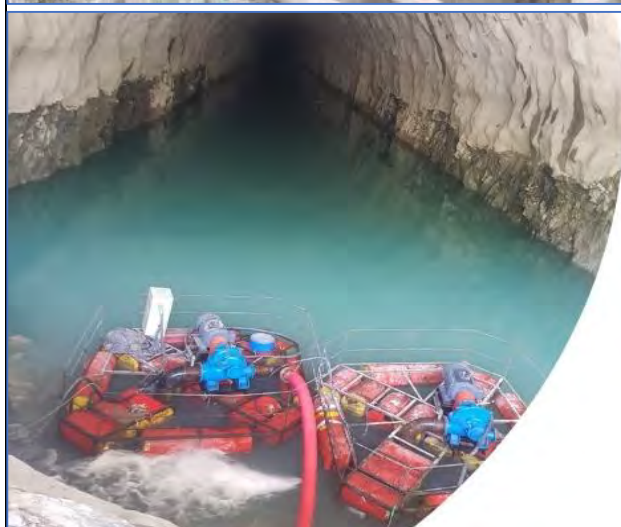
DTA overflow and Standing water in DT-B outlet

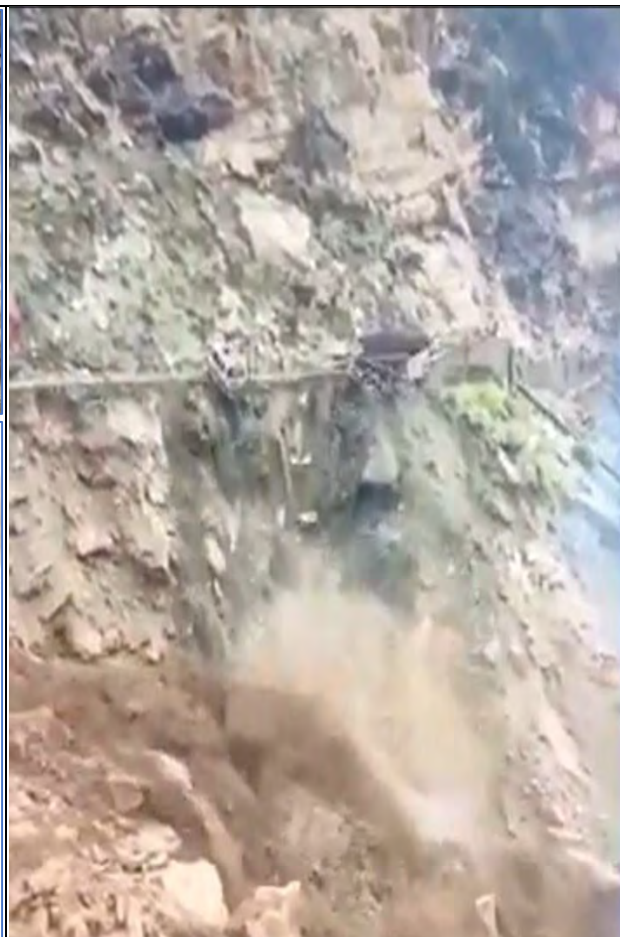
KKH at Zaid Khwar nullah
