## Dasu Hydropower Project

**Subject: Dasu HPP— 32nd ENVIRONMENTAL PROGRESS REPORT FOR THE PERIOD FROM OCT TO DECEMBER 2022**

# **Environmental Quarterly Progress Report**

**Report Number: 32<sup>nd</sup>**

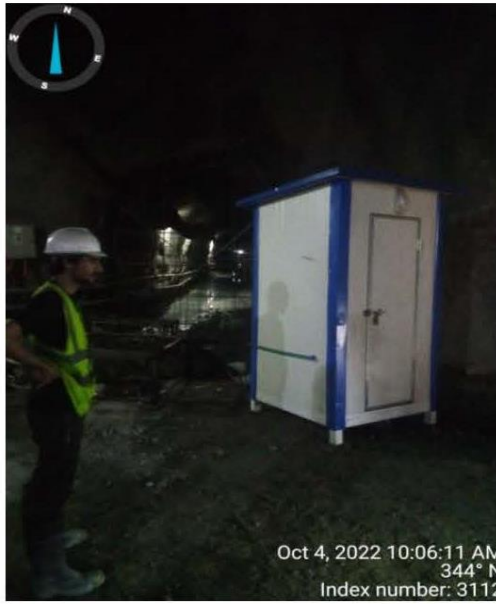
60.3	03-10-2022 MW-02 STA Panastic junction	Inadequate Toilet Facilities

The contractor is instructed to provide toilet facility and also install the sewage within the underground system. Increase the numbers of toilets at different locations as per ration 1 toilet for 10 people.	Immediate

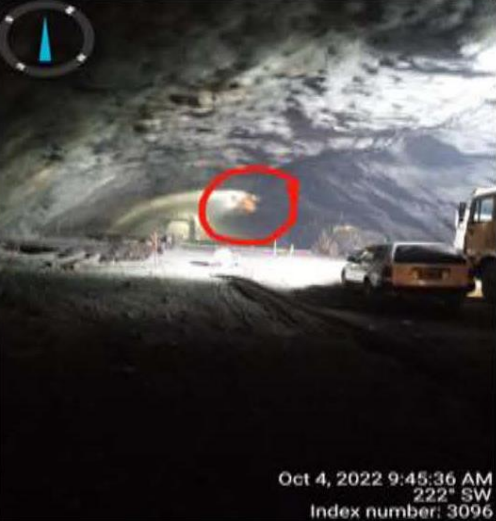
All raised facility issues provided. 04-11-2022
60.4	04-10-2022 MW-02; TC Tunnel	Dust and suffocation

Contractor is instructed to the extend the ventilation duct to the actual working face in order to Overcome dust and suffocation.	Immediate	In going it will take a week to install exhaust fans inside tunnels.	04-11-2022

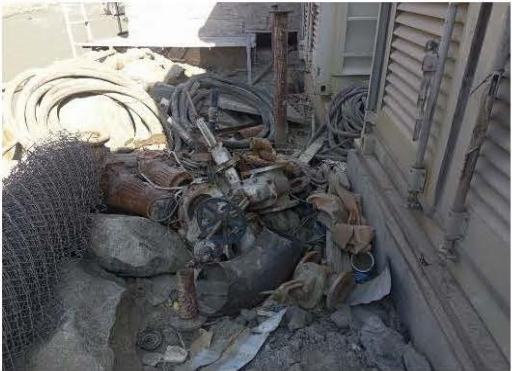
Sr. No	Date and Location of Inspection	EHS observations	Picture	Instructions to the Contractor	Timeline	Action Taken by the Contractor	Completion Date
61.1	18-10-2022 CR9 generator room	Inadequate housekeeping

The contractor is instructed maintain good housekeeping on site and manage construction material properly according to ECPs.	immediate

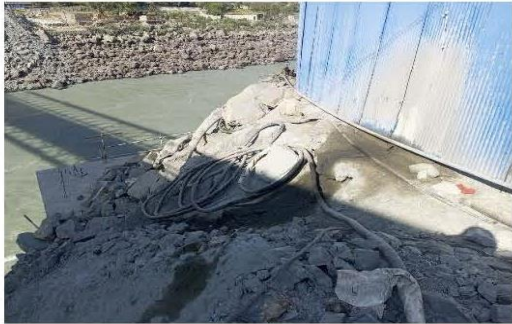
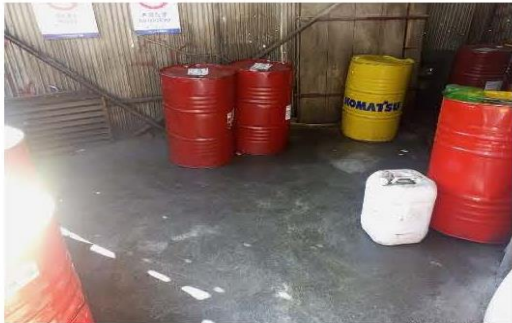
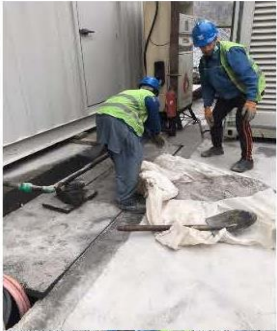
61.2	18-10-2022 CR9 generator room+works hop	Oil spill

<p>The contractor is instructed to remove the oil spill from the site by replacing contaminated soil with fresh soil and follow the ECP's provided in the contract agreement and train the workers to avoid sprinkling water on oil spill when sprinkling water it flows and contaminate more soil.</p>	<b>Immedi ately</b>

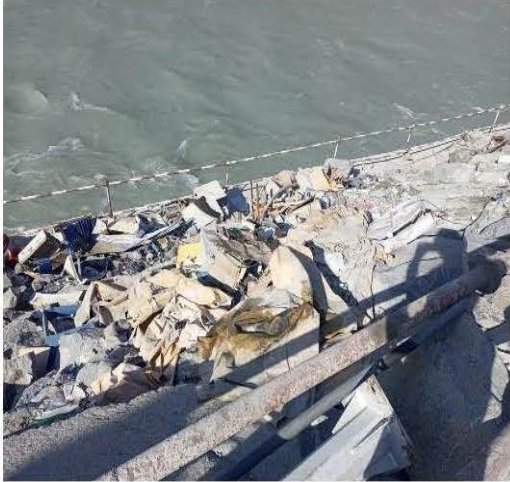
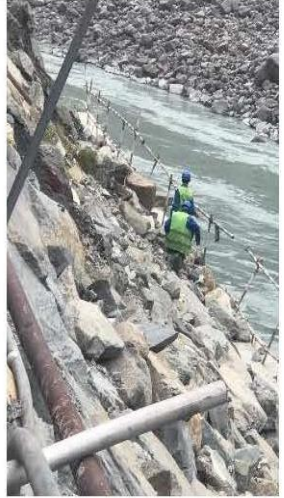
61.3	18-10-2022 CR9 generator room's slop	Solid waste

<p>The contractor is instructed to place the waste bin at the site.</p> <p>And aware the workers and staff to put the solid waste in the waste bin rather than thrown everywhere.</p> <p>After that dispose the waste at the final disposal site approved by the engineers.</p>	<b>immediate</b>

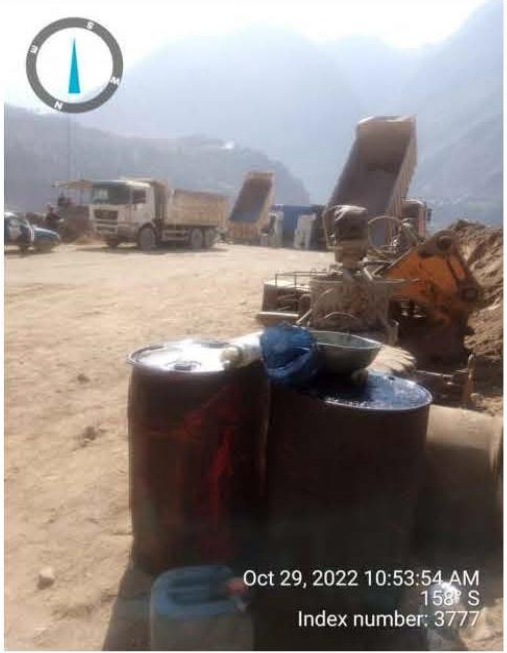
Sr. No	Date and Location of Inspection	EHS observations	Picture	Instructions to the Contractor	Timeline	Action Taken by the Contractor	Completion Date
62.1	29-10-2022 switch yard	Inadequate housekeeping

The contractor is instructed to maintain good housekeeping on site and place the oil drums at their designated place which should be in Accordance to procedures given in ECPs.	immediate

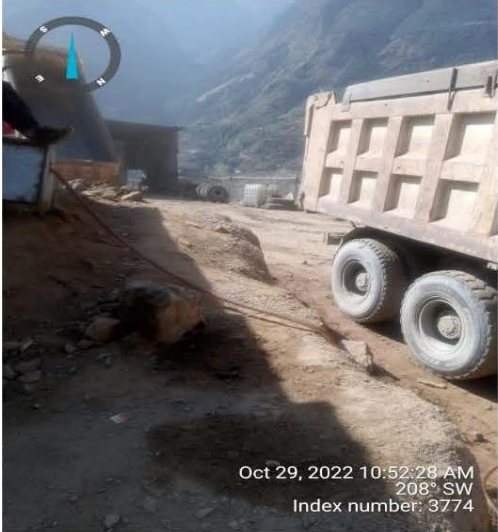
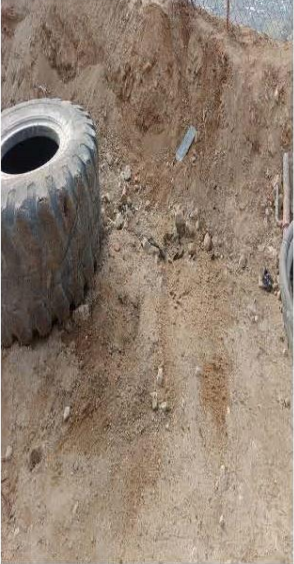
62.2	29-10-2022 switch yard	Oil spill

The contractor is instructed to remove the contaminated soil having oil spill by replacing it with clean and fresh soil.	<b>immediate</b>

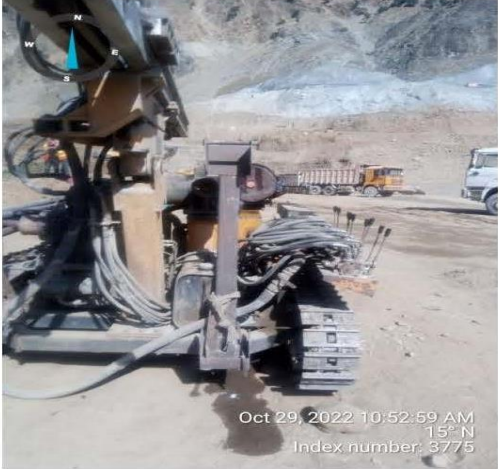
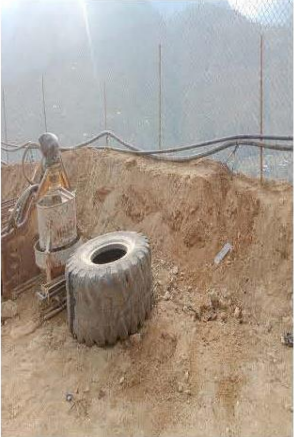
04-11-2022
	29-10-2022 switch yard	Oil spill

<b>immediate</b>

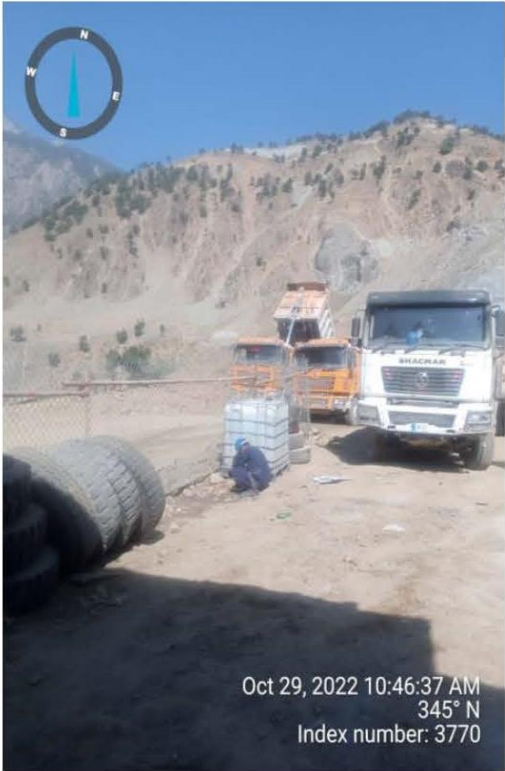
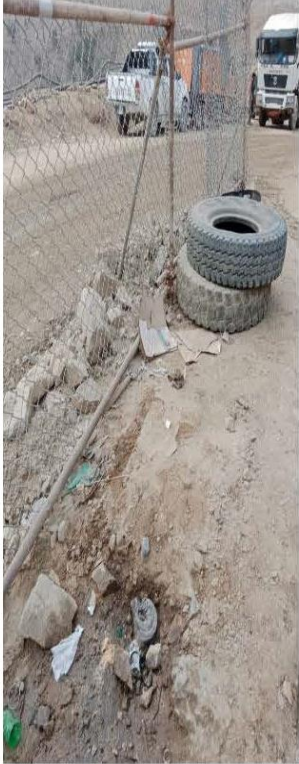
62.3	29-10-2022 switch yard	Used Chemical Tank being used for humans water usage

<p>The contractor is instructed that it is strictly prohibited to use of chemical tank for hand washing or any other human usage like ablution and washroom purposes. Install a domestic type of water tank for staff and workers.</p>	<p style="text-align: center;"><b>Immediate</b></p>

<p>Officially informed to site management to provide water tanks as required.</p> <p>04-11-2022</p>
------	---------------------------	--	--	--	---	---	---

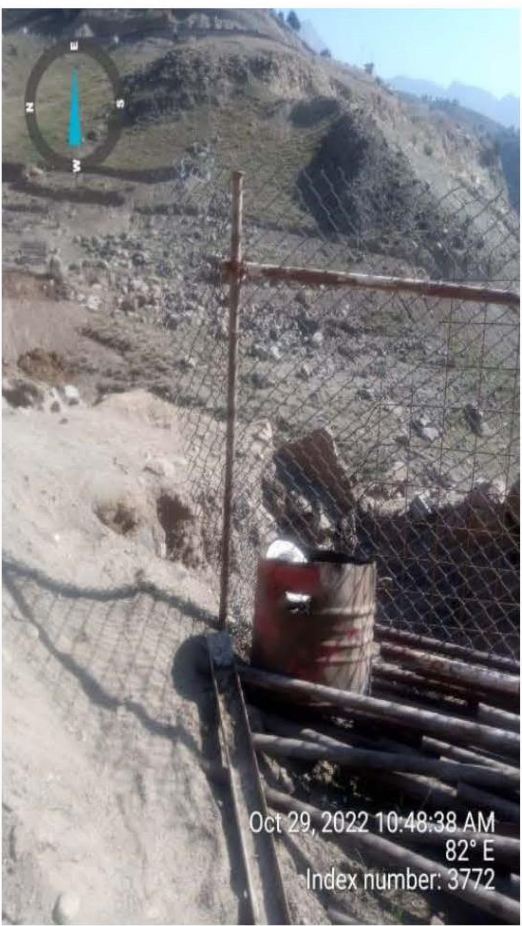
<p>62.4</p>	<p>29-10-2022                  switch yard</p>	<p>Improper                  dustbin                  (Only one)</p>

<p>The contractor is instructed to provide the proper dustbins at the site. Increase the numbers of dustbins at the site. Follow SOPs and ECPs.</p>	<p><b>Immediate</b></p>

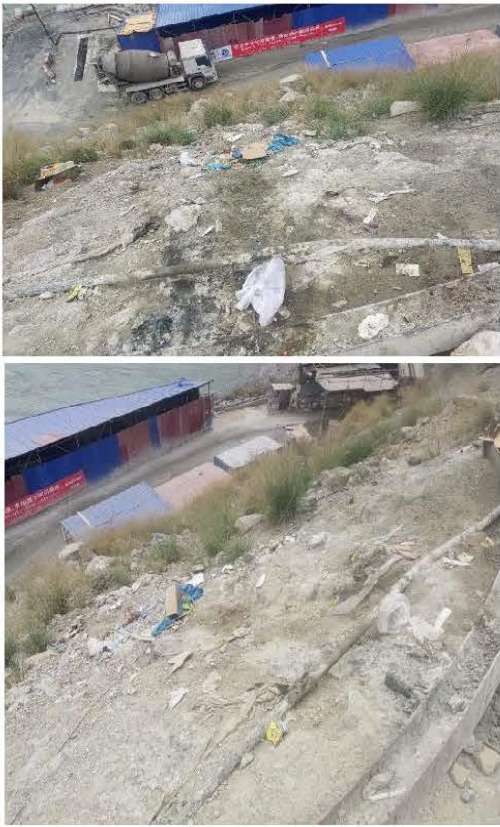
Sr. No	Date and Location of Inspection	EHS observations	Picture	Instructions to the Contractor	Timeline	Action Taken by the Contractor	Completion Date
63.1	2-11-2022 CR-09 MAT slope	Littering

<p>This observation was highlighted in walk through report NO#E73 at 31-10-2022 but until not rectified. Again it send for you as a reminder.</p> <p>the Contactor is instructed to place waste bins at the site. collect the solid waste from different place and put them into the bins at the site</p> <p>After that dump the litter at designated site.</p>	immediate

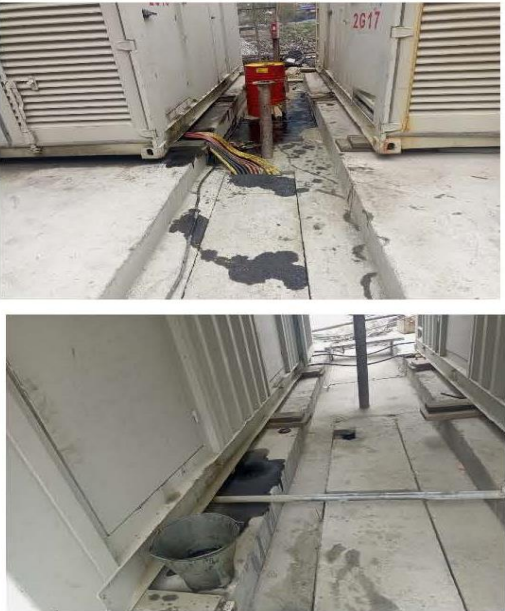
63.2	31-10-2022 CR-9 generator Room	Oil spill

The contractor is instructed to remove the oil spill from the site by replacing fresh soil and store toxicity soil in a drum temporary then transport to the designated site.	immediate		
63.3	31-10-2022 CR-09 A-3 portal	Inadequate Housekeeping

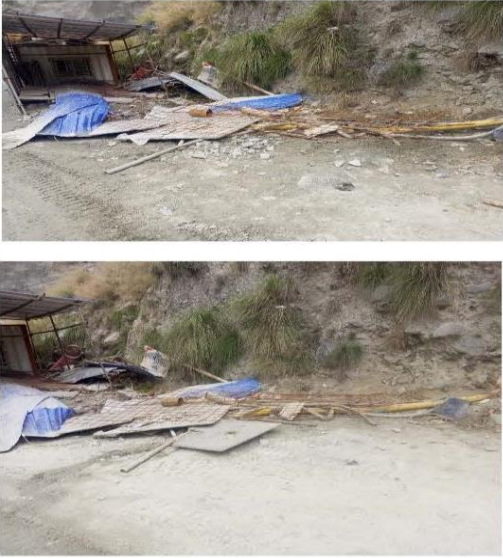
This observation was highlighted in previous walk through report but until now it is still not rectified. Again it is being send for you as a reminder. The contractor is instructed to maintain good housekeeping at site. Manage construction material as per ECPs	immediate

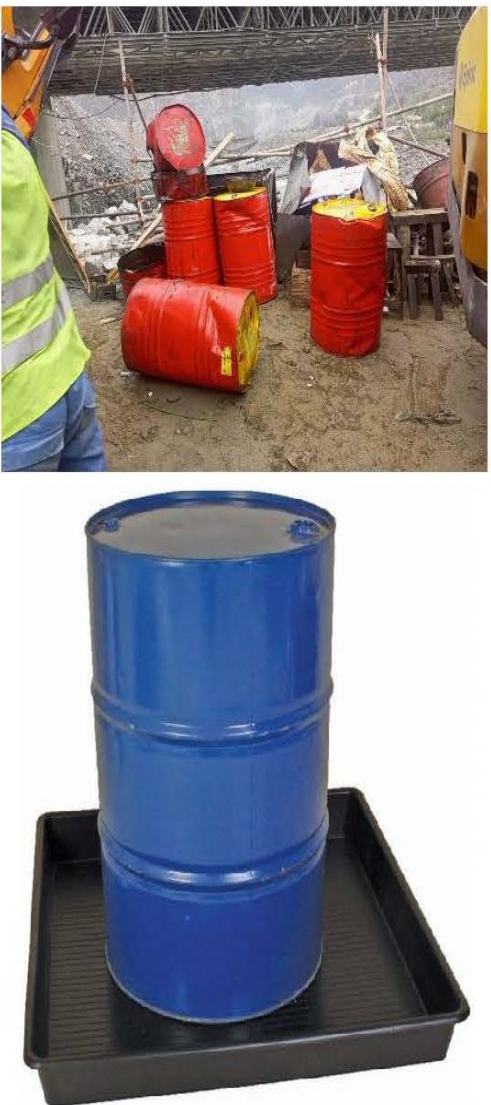
63.4	2-11-2022 CR9 main workshop	Improper placement of oil drums

The contractor is instructed to put individual oil drum on drip tray as shown in the picture.			
------	-----------------------------------	---------------------------------------	---	---	--	--	--

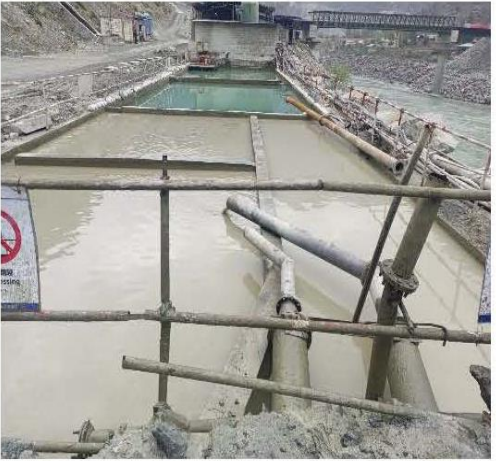
63.5	2-11-2022 MAT sedimentati on pound	Untreated water

<p>At MAT Pond it is observed that water is directly discharged from first basin into river. In the last AFI it was observed that the pH value of first basin was very high so it needed to connect with second basin the contractor is instructed to open way for water from first basin to second basin and after proper treatment then discharge in local water body.</p>			
------	---	--------------------	--	--	--	--	--

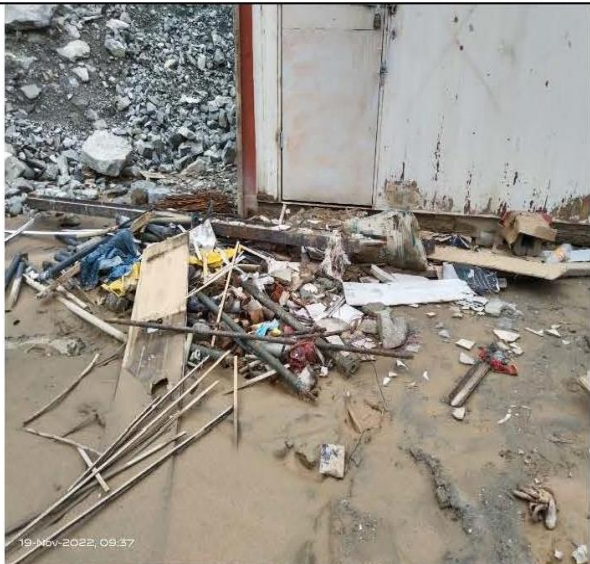
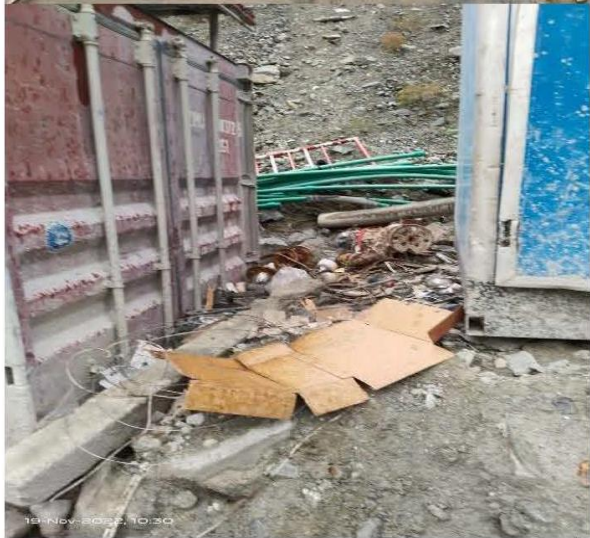
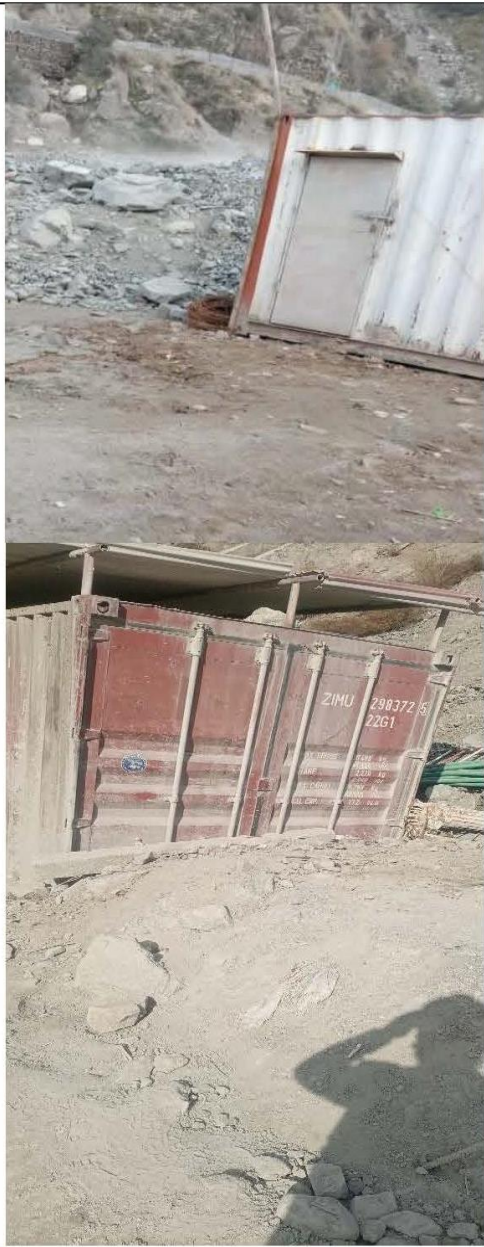
<p>64.2</p>	<p>19-11-2022 CT-2 Tunnel and CR-9</p>	<p>Inadequate housekeeping</p>	 	<p>It is instructed the contractor keep maintain good housekeeping at all sites. Clean and clear all the sites ASAP.</p>	<p><b>Immediate</b></p>

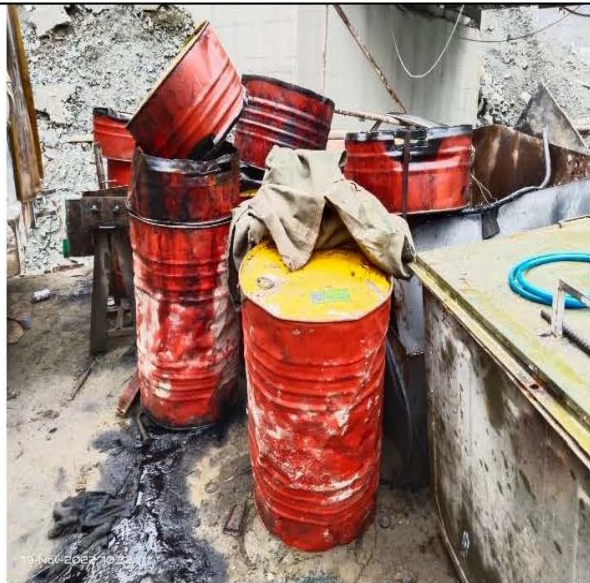
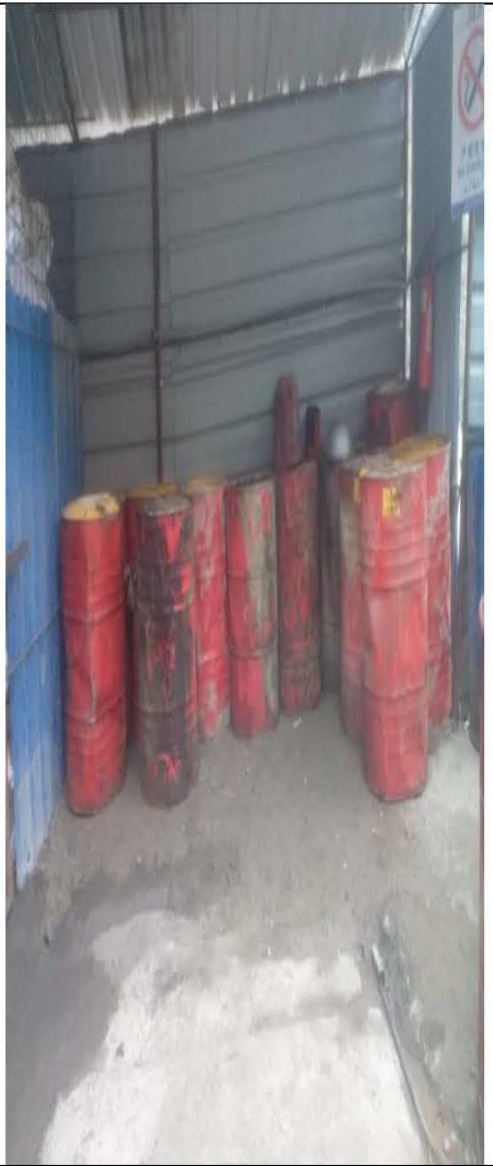
<p>64.3</p>	<p>19-11-2022 CT-2 Tunnel And CR-9 Workshop</p>	<p>Oil spill</p>	 	<p>The Contractor is instructed to constructed concrete floored and bunded fuel storage site.</p> <p>The Contractor is also Instructed to Clean and Clear the Contaminated soil with fresh and clean Soil as per SOPs provided in ECP.</p>	<p>Within 3 days</p> <p>immediate</p>	 
-------------	---	------------------	---	--	---------------------------------------	--

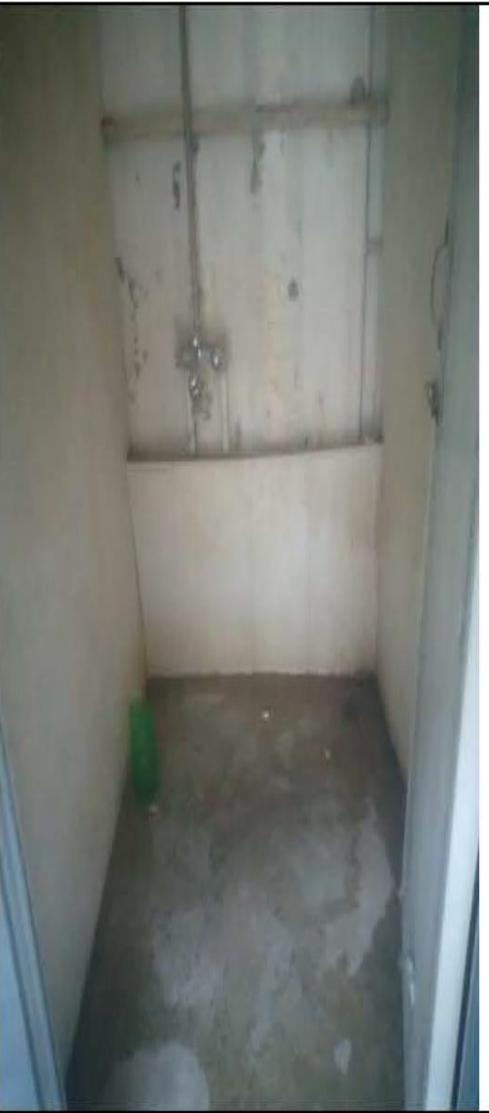
64.5	19-11-2022 CT-2 Tunnel	Bad conditi on of Washr ooms

<p>19-Nov-2022, 09:25</p>	Instructed the Contractor to keep clean the washrooms and provide hot water facility for work force.	Within 3 days

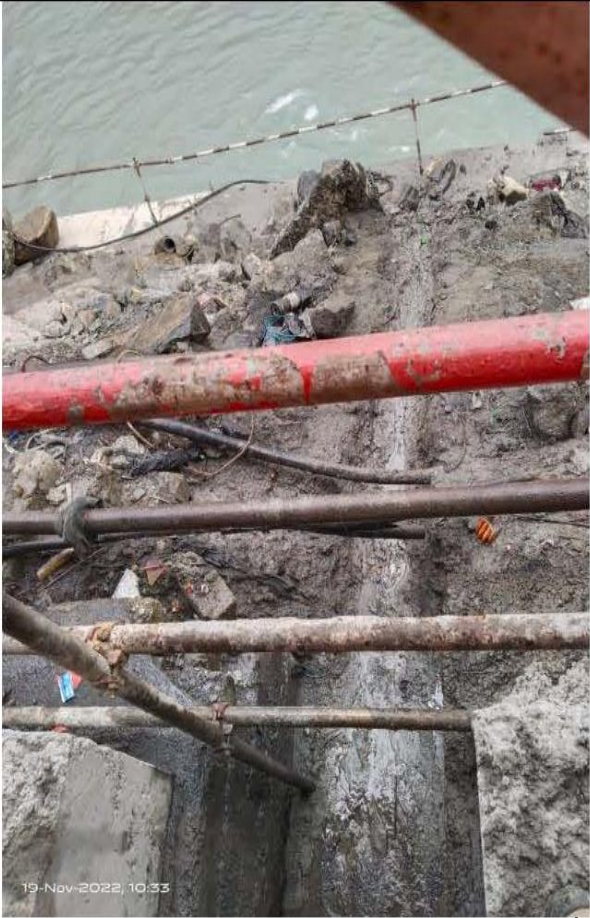
<p>64.6</p>	<p>19-11-2022 CR-9</p>	<p>Works hop Waste/ Oil</p>

<p>It has been observed that Workshop Waste/Oil directly going to Indus River. It is Strictly Instructed the contractor stop this practice immediately and rectify ASAP and report within 2 days.</p>	<p>Within 2 days</p>	 	
-------------	----------------------------	---	---	---	----------------------	--	--

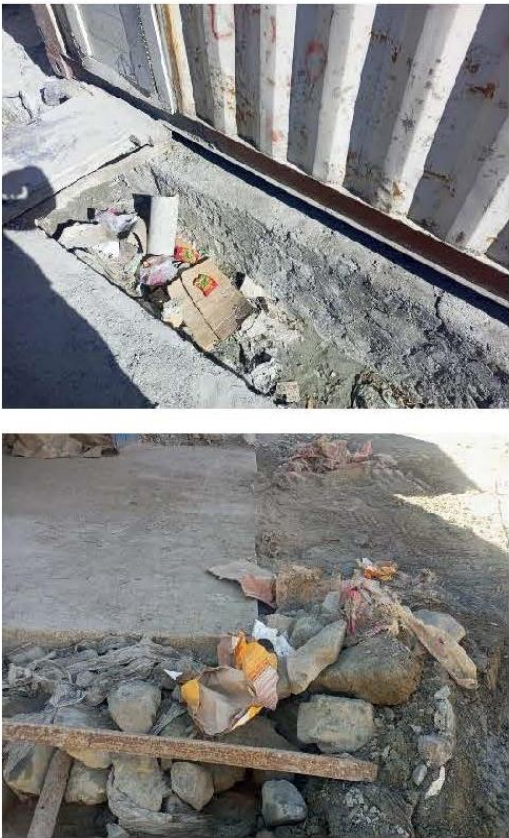
Sr. No	Date and Location of Inspection	EHS observations	Picture	Instructions to the Contractor	Timeline	Action Taken by the Contractor	Completion Date
65.1	25-11-2022 MAT MT Rest Room + Batching Plant back side	Littering

The Contactor is instructed to place waste bins at the site. collect the solid waste from different place and put them into the bins at the site After that dump the litter at designated site.	Immediate

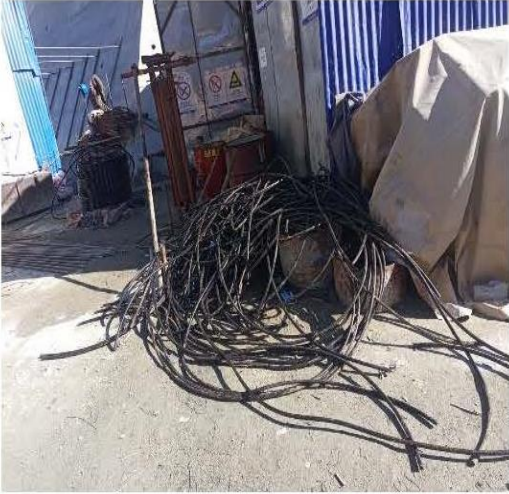
65.2	25-11-2022 front of MAT ET Store	Inadequate Housekeepin g

The contractor is instructed to maintain good housekeeping at site. Manage construction material as per ECPs. and shift raw material to designated site	immediate		
------	---	--------------------------------	--	---	-----------	--	--

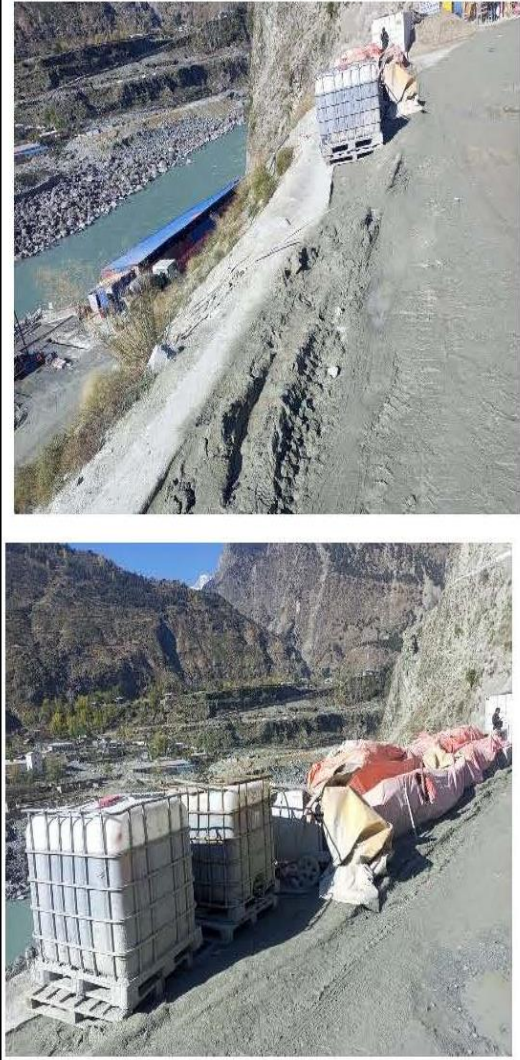
65.3	25-11-2022 MAT portal	Improper Drainage

The contractor is instructed to remove sludge from the drainage line and keep stock pile away from drainage channels as far as possible	Immediate		
------	--------------------------	----------------------	---	---	-----------	--	--

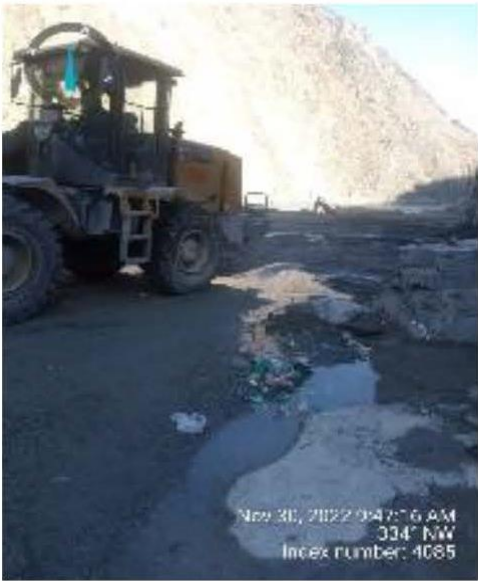
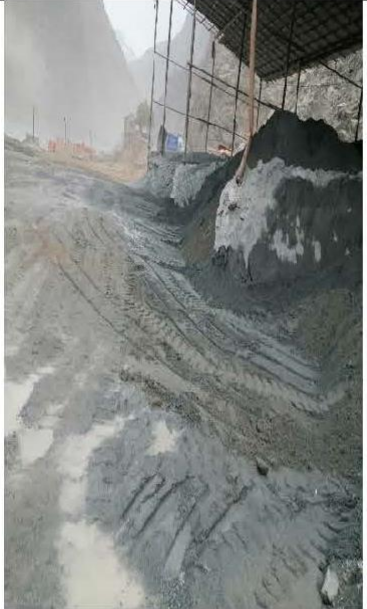
Sr. No	Date and Location of Inspection	EHS observations	Picture	Instructions to the Contractor	Timeline	Action Taken by the Contractor	Completion Date
66.1	30-11-2022 CR-02	Littering, solid waste.

<p style="text-align: right; font-size: small;">New 30, 2022 04:57:06 AM 034° NW Index number: 4685</p>	The Contactor is instructed to place waste bins at the site for Collection of solid waste from different place. Follow Waste Management ECP's.	Immediate

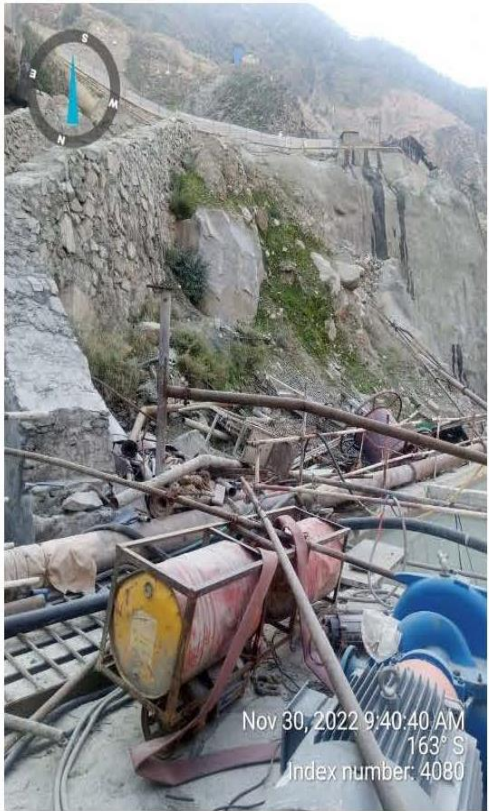
<p>66.2</p>	<p>30-11-2022 CR-02 Near sedimentation pond (A1)</p>	<p>Inadequate Housekeeping</p>

<p>The contractor is instructed to maintain good housekeeping at site. Manage construction material as per ECPs and shift raw material to designated site.</p>	<p>Immediate</p>

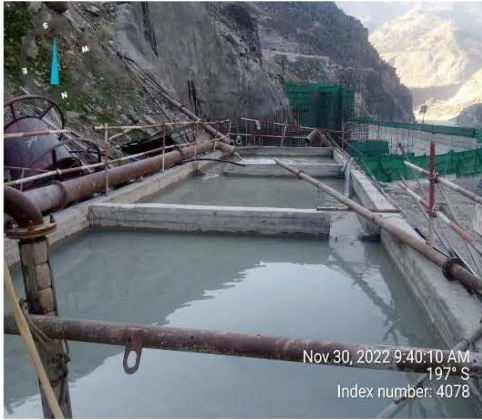
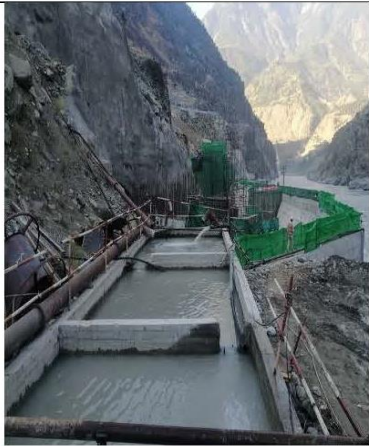
66.3	30-11-2022 CR-02 Sedimentation pond (A1).	Untreated water

During routine supervision it was observed that fresh water is stopped in pond. The contractor is instructed to keep always open fresh water in pond.	Reminder

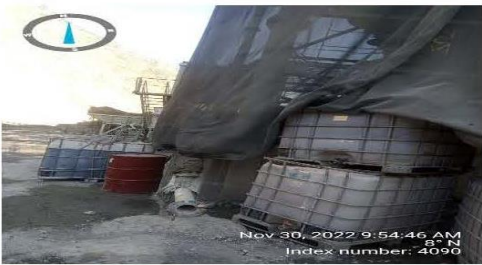
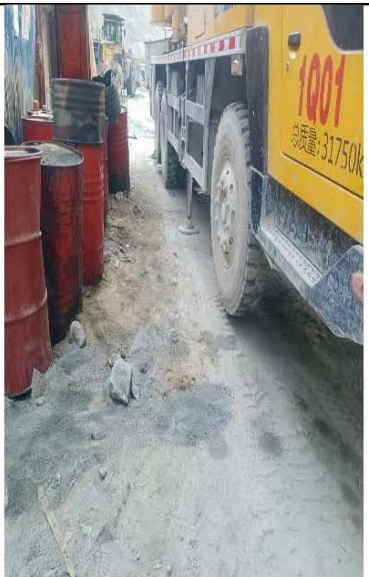
66.4	30-11-2022 CR-02 Batching plant.  30-11-2022	Inadequate handling and storage of chemical and oil drums

The contractor is instructed to make a proper concrete pavement with boundary for oil and chemicals drums. Place dip tray for each drums to avoid oil spilling and leaking.	Immediate

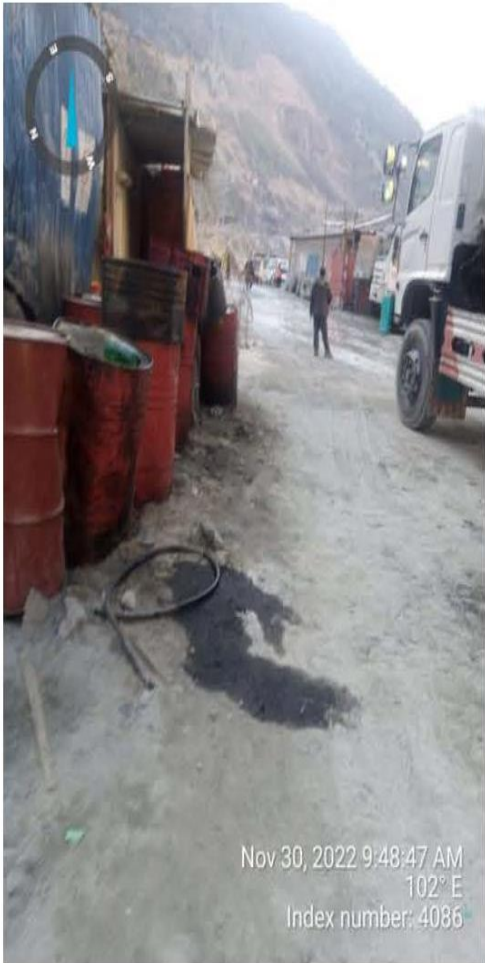
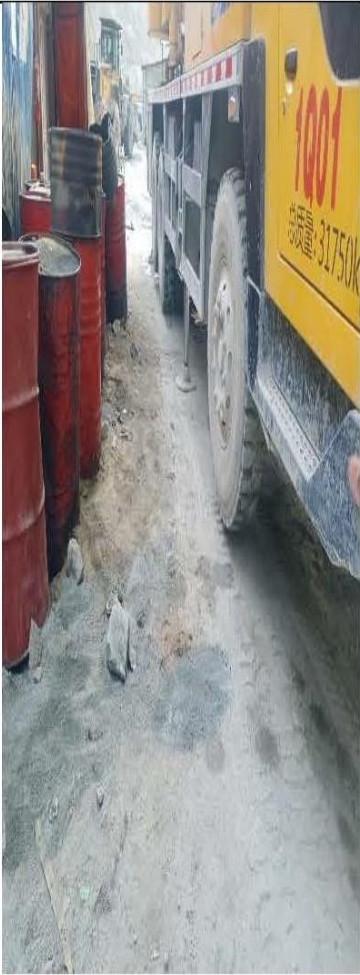
66.5	CR-02	Oil spill

<p>Nov 30, 2022 9:48:47 AM 102° E Index number: 4036</p>	The contractor is instructed to remove the contaminated soil from the site by replacing fresh soil and deal with the toxic soil as per SOP's provided in ECP's.	Immediate

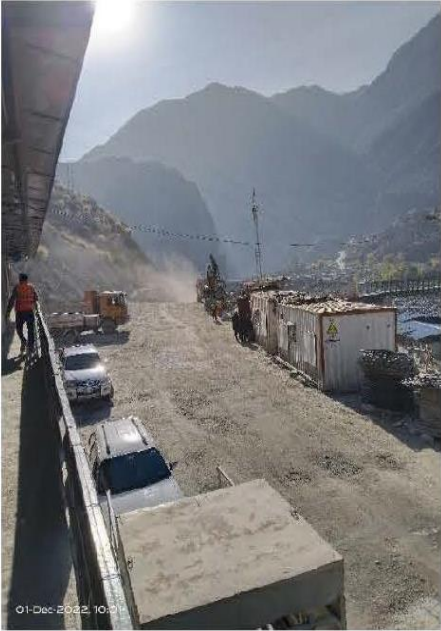
Sr. No	Date and Location of Inspection	EHS observations	Picture	Instructions to the Contractor	Timeline	Action Taken by the Contractor	Completion Date
67.1	01-12-2022 CR-9	Fugitive Dust

Contractor is instructed to ensure water sprinkling daily with at least frequency of 3, 4 times a days	Immediate

Regular water sprinkling ensured at site as per the weather condition

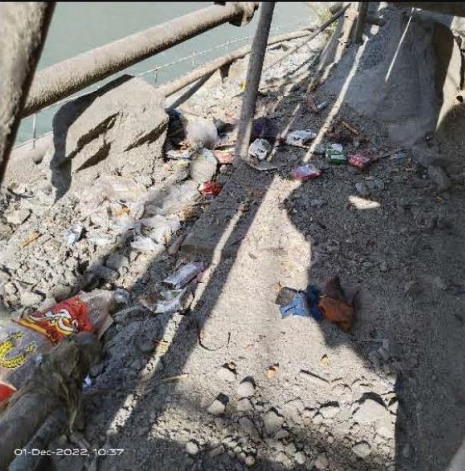
67.2	01-12-2022 CR-9 Workshop	Inadequate housekeeping

Contractor is instructed to maintain good housekeeping at all sites. Clean and clear all the sites ASAP.	<b>Immediate</b>

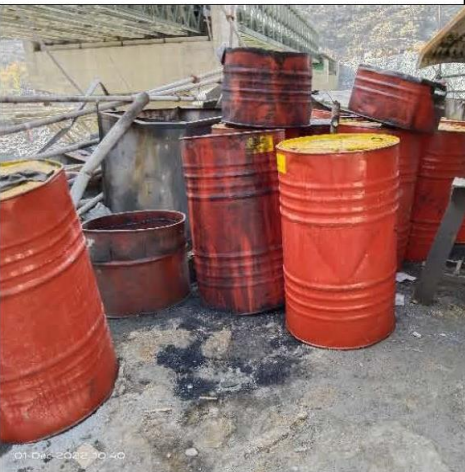
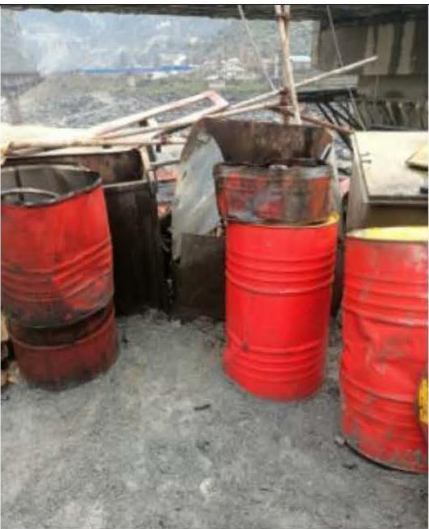
Cleaning done at site and reinforce with the team to comply
67.3	01-12-2022 CR-9 Workshop	Oil spill

Instructed the Contractor construct the Paved Concrete Floor for fuel storage ASAP.	<b>7 Days</b>

Cleaning done at site and reinforce with the team to comply

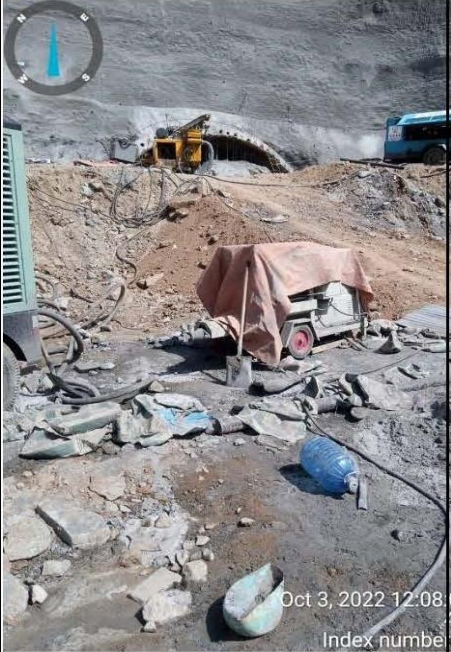
Sr. No	Date and Location of Inspection	EHS observations	Picture	Instructions to the Contractor	Timeline	Action Taken by the Contractor	Completion Date
34.1	03-10-2022 K9 tunnel	Inadequate housekeeping

The contractor is instructed maintain good housekeeping on site and manage construction as per EMAP and ECP's.	Immediate

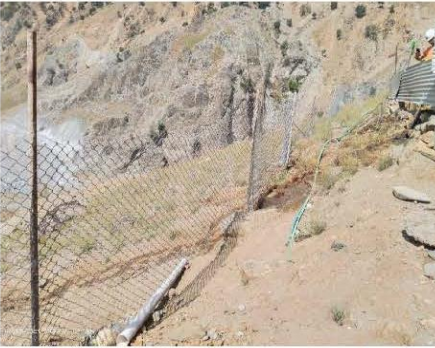
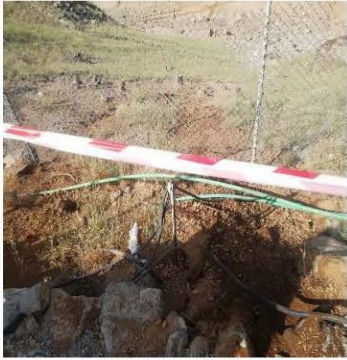
34.3	03-10-2022 K9 tunnel	Oil spill

<p>The contractor is instructed to remove the contaminated soil and replace it with clean and fresh soil. Follow Spill procedures as provided in EMAP and ECPs.</p>	Immediate

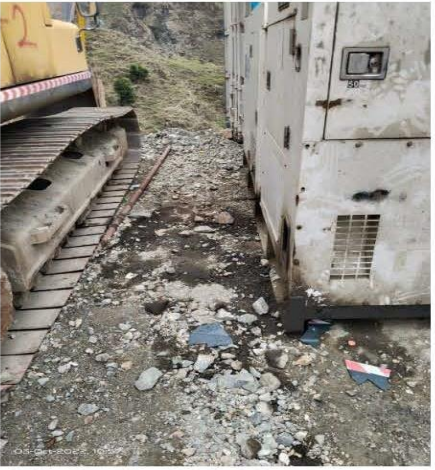
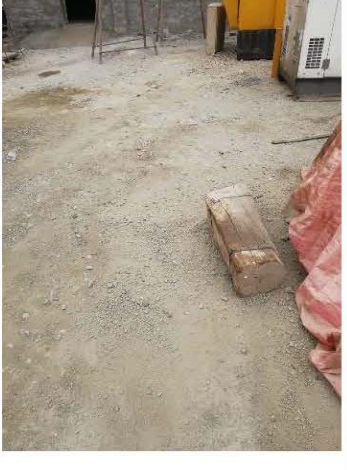
15-10-2022
	K4 Tunnel	Oil spill

<p>The contractor is instructed to remove the contaminated soil and replace it with clean and fresh soil. Follow Spill procedures as provided in EMAP and ECPs.</p>	Immediate

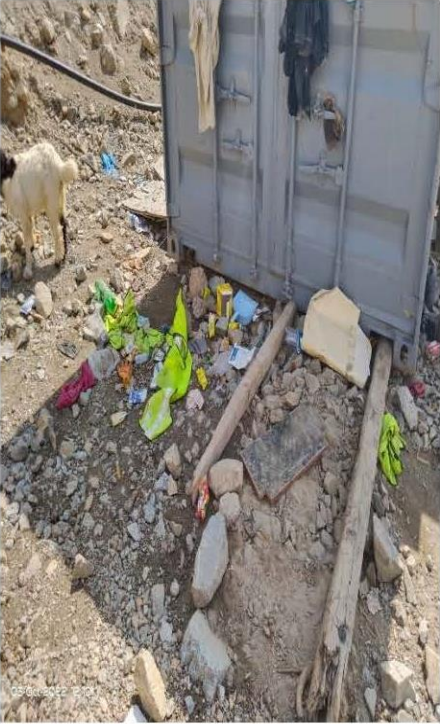
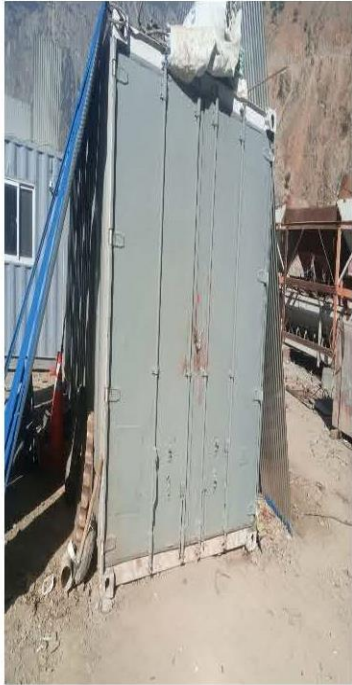
34.4	03-10-2022 In front of K9 tunnel	Solid waste

<p>The contractor is instructed to place the waste bin at the site.</p> <p>And aware the workers and staff to put the solid waste in the waste bin rather than littering.</p> <p>Furthermore ECP for Waste management should be followed in true letter and spirit</p>	Immediate

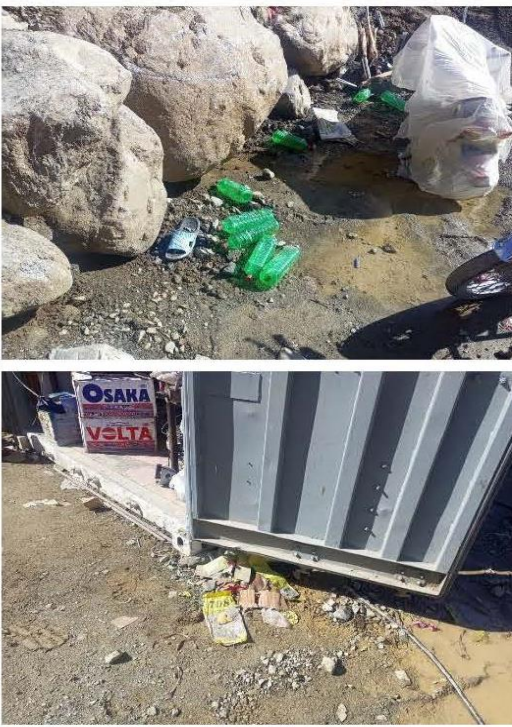
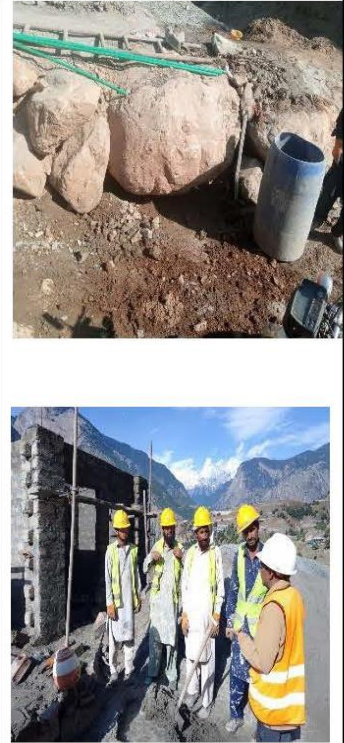
Sr. No	Date and Location of Inspection	EHS observations	Picture	Instructions to the Contractor	Timeline	Action Taken by the Contractor	Completion Date
35.1	21-10-2022 k-09 store camp toilets	Littering

<p>Contractor is instructed to place waste bins at the site. collect the solid waste from all the littered places and put them to the waste bins at the site Ensure training of the contractor staff on waste management ECP's.</p>	immediate

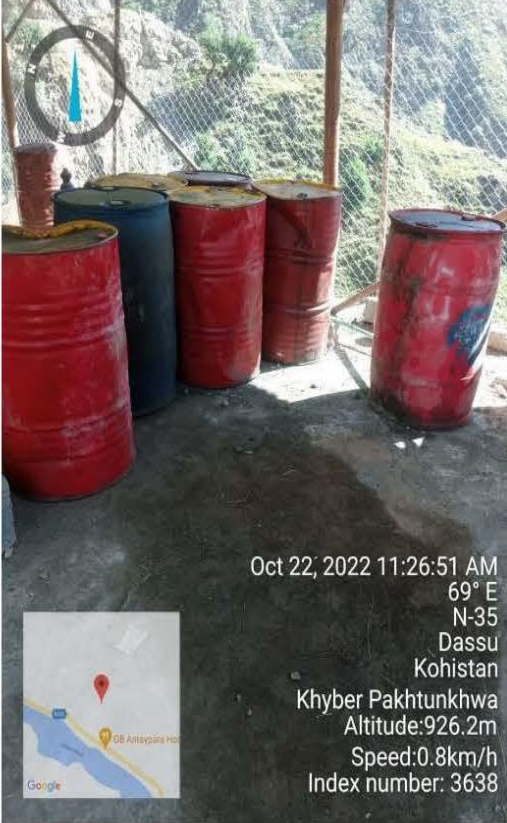
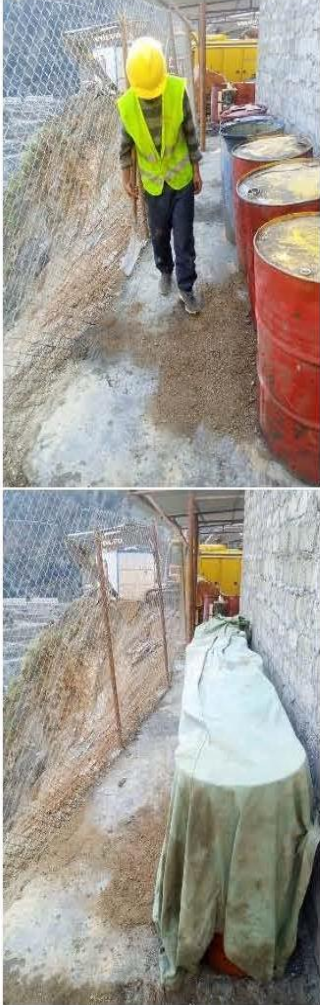
35.2	22-10-2022 k-04 workshop	Oil spill

<p>Oct 22, 2022 11:26:51 AM 69° E N-35 Dasu Kohistan Khyber Pakhtunkhwa Altitude:926.2m Speed:0.8km/h Index number: 3638</p>	<p>The contractor is instructed to remove the oil spill from the site by replacing fresh soil and store toxicity soil in a drum or tank temporary then deal with the contaminated soil as per ECP's of Oil Spill.</p>	<p><b>immediate</b></p>

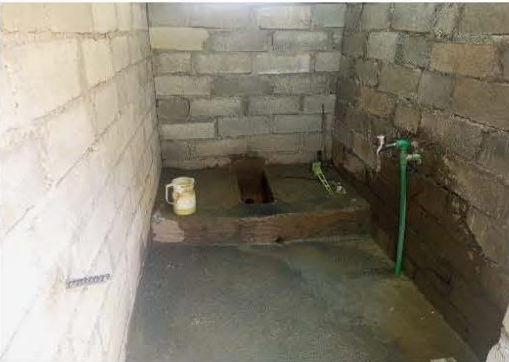
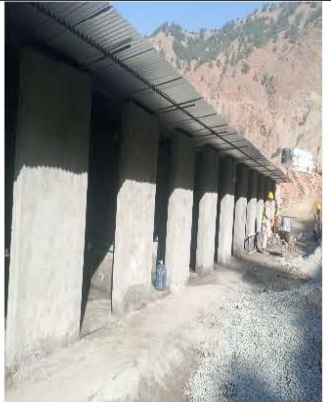
35.3	21-10-2022 k-09 Pakistani camp	Poor welfare facility

The contractor is instructed to ensure the provision of proper toilet facility i.e., Commode with Flushing system for workers. Workers are using pit toilets in camp which is noncompliance to ECP's	<b>immediate</b>

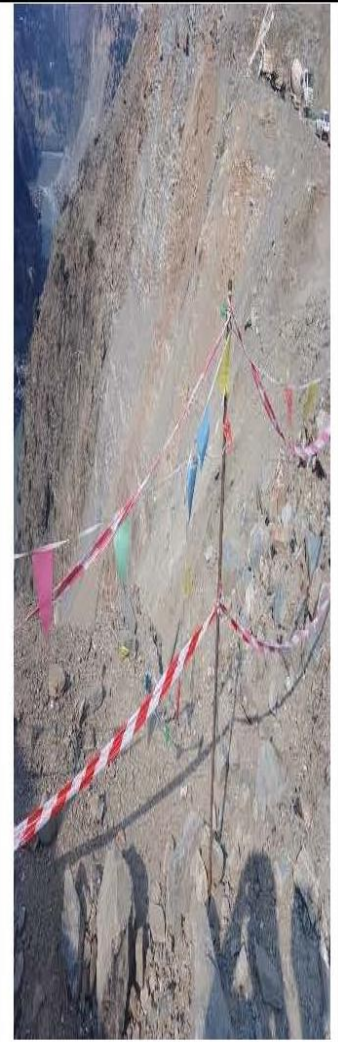
35.5	22-10-2022 k-04 slope	Excavated spoil thrown downwards

<p>Contractor is instructed to dump the excavated spoil at the proper designated spoil disposal site approved by the engineers rather than thrown abruptly downwards to existing KKH road. Follow SOPS given in ECPs.</p>	<p><b>immediate</b></p>

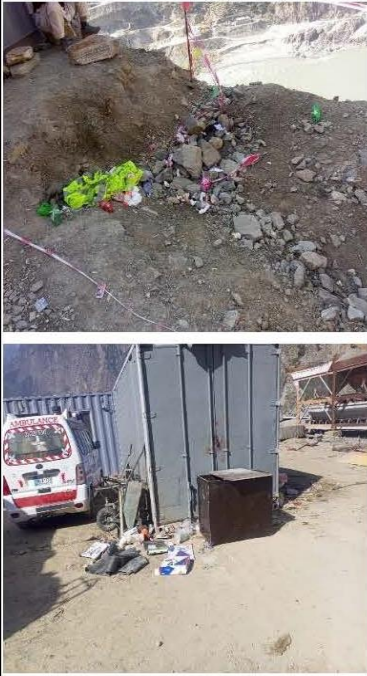
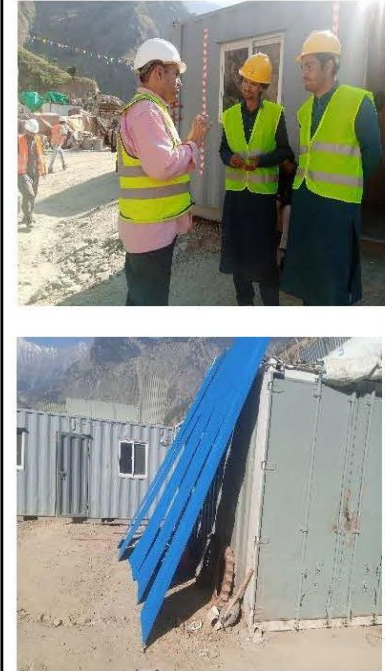
Sr. No	Date and Location of Inspection	EHS observations	Picture	Instructions to the Contractor	Timeline	Action Taken by the Contractor	Completion Date
36.1	27-10-2022 k-09 store+K-04	Littering of Solid Waste

<p>Contractor is instructed to place waste bins at the site. collect the solid waste from all the littered places and put them into the waste bins at the site Provide Awareness/ Training to your staff/ Labor not to through away solid waste here and there but put it in waste bins.</p>	Immediate

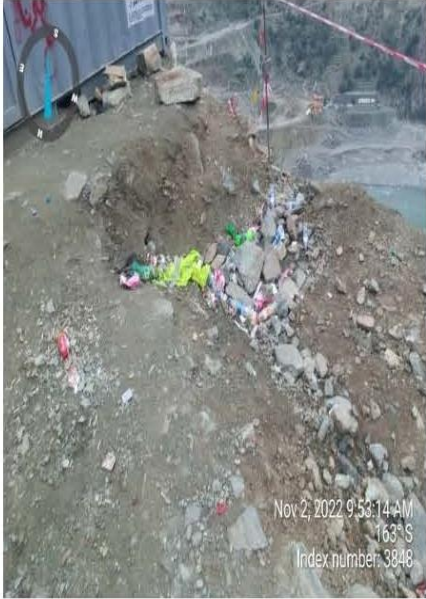
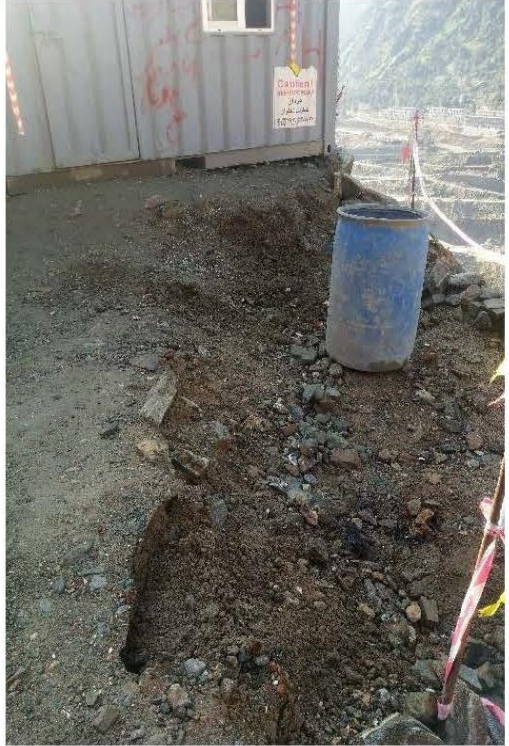
Sr. No	Date and Location of Inspection	EHS observations	Picture	Instructions to the Contractor	Timeline	Action Taken by the Contractor
37.1	2-11-2022 K-04	Littering

<p>the Contactor is instructed to place waste bins at the site.</p> <p>collect the solid waste from different place and put them into the bins at the site</p> <p>After that dump the litter at designated site.</p>	immediate

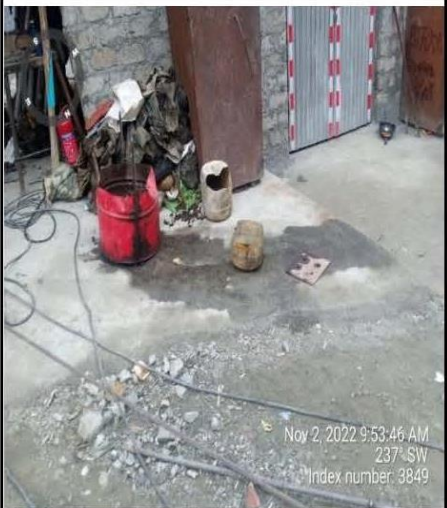
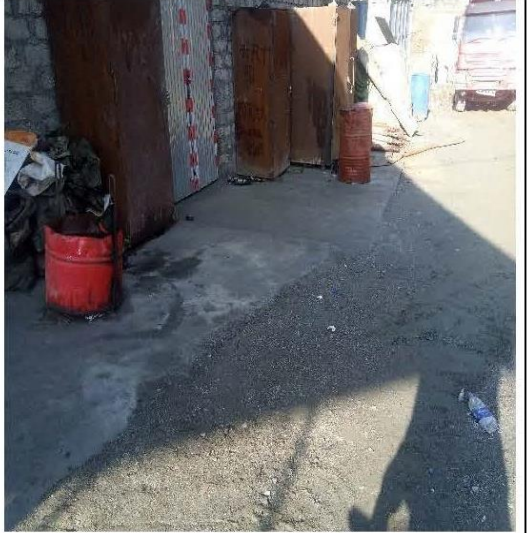
37.2	02-11-2022 K-04 ET store	Oil spill

<p style="text-align: right; font-size: small;">Nov 2, 2022 9:53:46 AM 237 SW Index number: 3849</p>	<p>The contractor is instructed to remove oil spill from site by replacing fresh soil and store toxicity soil in a drum temporary then transport to the designated site.</p>	immediate

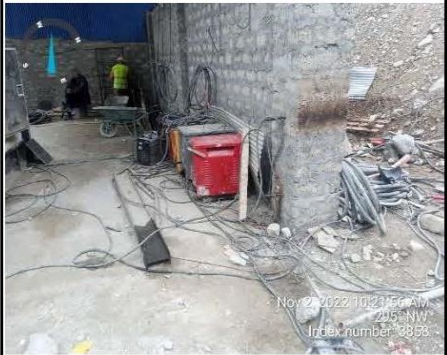
37.3	02-11-2022 K-09	Inadequate Housekeeping

<p style="text-align: right; font-size: small;">Nov 2, 2022 10:21:56 AM 245 NW Index number: 3853</p>	<p>The contractor is instructed to maintain good housekeeping at site. Manage construction material as per ECPs</p>	immediate
