## Dasu Hydropower Project

**Subject: Dasu HPP— 32nd ENVIRONMENTAL PROGRESS REPORT FOR THE PERIOD FROM OCT TO DECEMBER 2022**

# **Environmental Quarterly Progress Report**

**Report Number: 32<sup>nd</sup>**

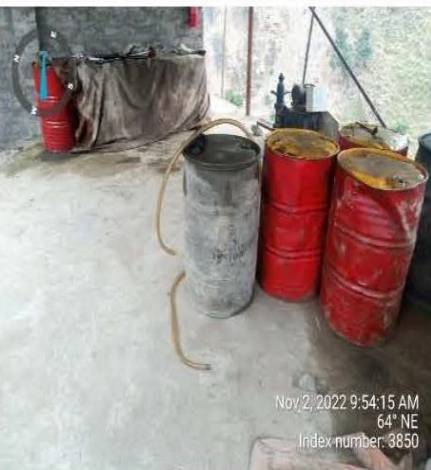
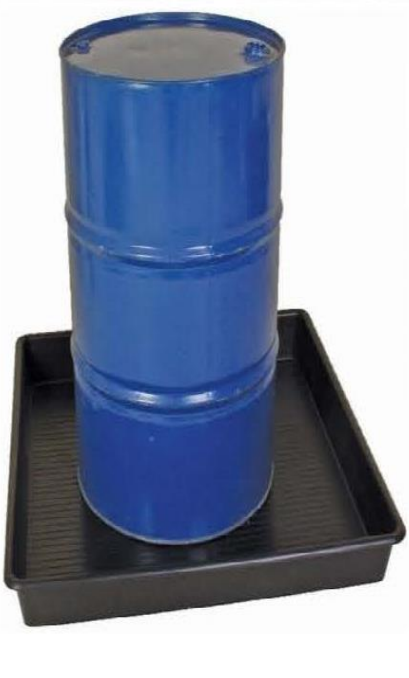
37.4	2-11-2022 k-04	Improper placement of oil drums

The contractor is instructed to put individual oil drum on drip tray as shown in the picture.	Immediate

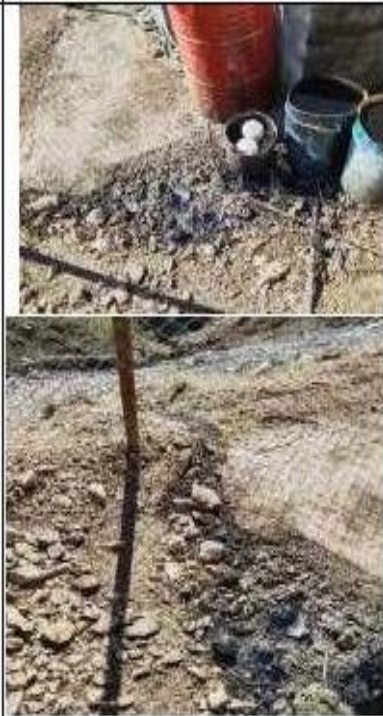
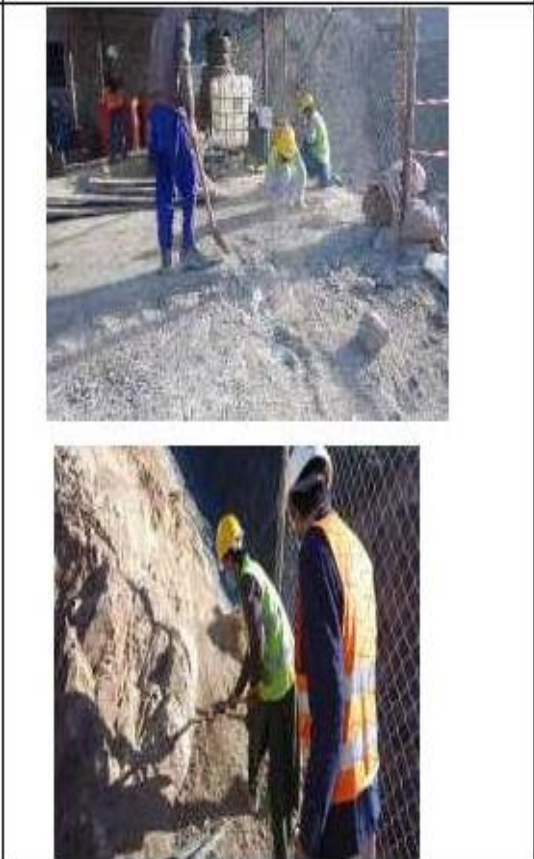
Sr. No	Date and Location of Inspection	EHS observations	Picture	Instructions to the Contractor	Timeline	Action Taken by the Contractor	Completion Date
38.1	20-11-2022 K4 Tunnel Portal	Fuel/ Oil Spills Spillage at slope

<p>The Contractor is instructed to place drip trays while refueling or changing Mobil oil. The Contaminated soil should be removed and replace with fresh soil.</p> <p>Ensure spill kits availability at the site.</p> <p>Dispose of the toxicities Soil in a drum.</p> <p>Dispose of the contaminated soil as per SOPs provided in ECP</p>	Immediate

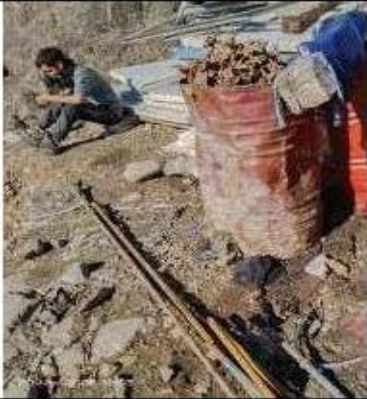
Sr. No	Date and Location of Inspection	EHS observations	Picture	Instructions to the Contractor	Timeline	Action Taken by the Contractor	Completion Date
38.2	20-11-2022 K9 Tunnel Portal	Improper placement of fuel drums

The Contractor is instructed to construct bunded concrete flooring for fuels drums.	24 <sup>th</sup> Nov 2022

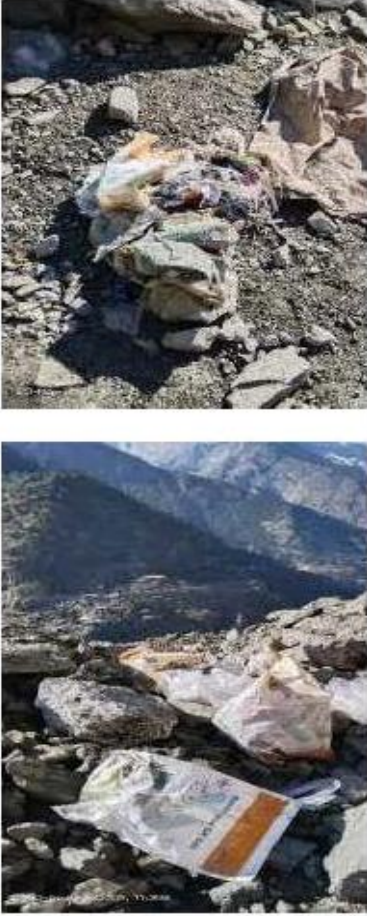
Sr. No	Date and Location of Inspection	EHS observations	Picture	Instructions to the Contractor	Timeline	Action Taken by the Contractor	Completion Date
38.4	20-11-2022 K4 Tunnel Portal	Inadequate housekeeping

Contractor is instructed to keep construction material properly and maintain good housekeeping on site. Install large bins at site as well. Conduct a session with worker for adequate housekeeping of camp and site.

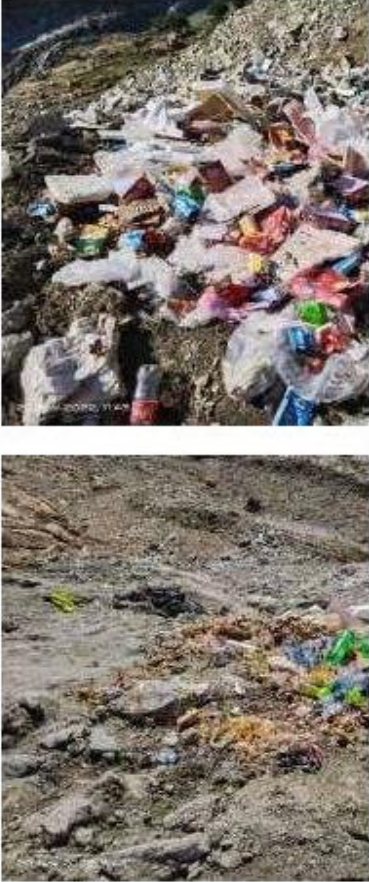
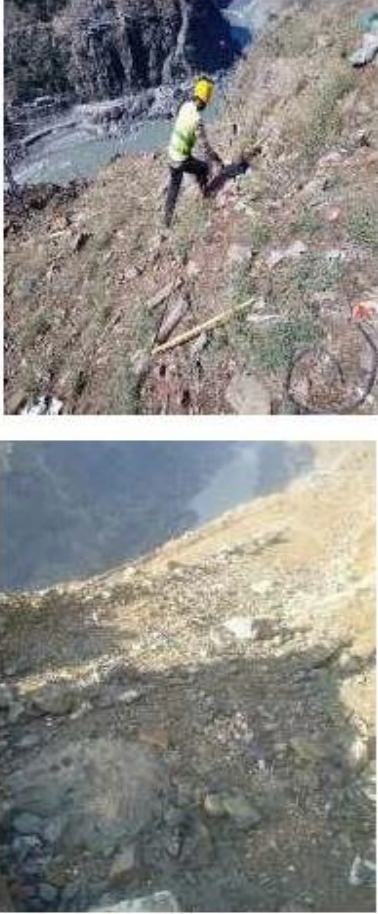
Sr. No	Date and Location of Inspection	EHS observations	Picture	Instructions to the Contractor	Timeline	Action Taken by the Contractor	Completion Date
38.5	20-11-2022 K4 Tunnel Camp	Littering along the slope

<p>It is very unfortunate that after spending more than 6 years at site, the Contractor is not aware of proper waste mgt protocols. The Contractor is Instructed to remove the waste from slopes and ensure placement of bins at site. Arrange an awareness session with the labours regarding solid waste management. And prepare a temporary solid waste disposal site near by the camp.</p>	Immediate

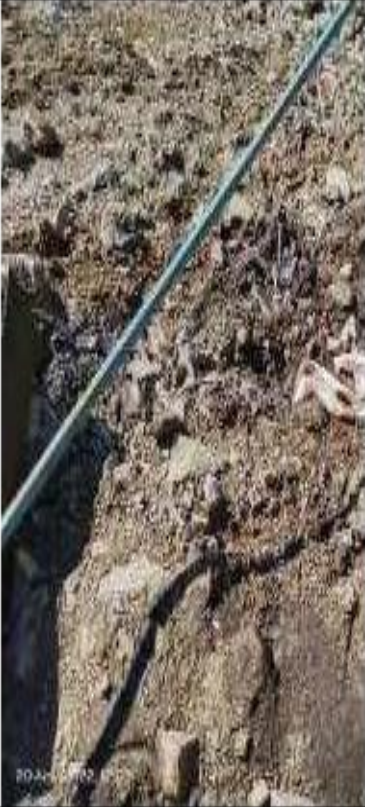
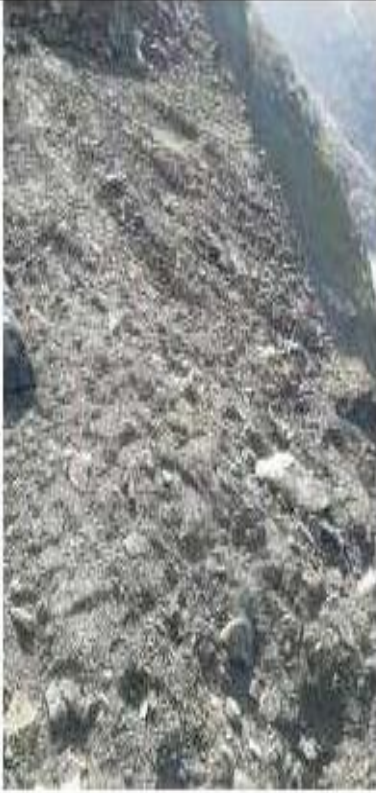
Sr. No	Date and Location of Inspection	EHS observations	Picture	Instructions to the Contractor	Timeline	Action Taken by the Contractor	Completion Date
38.6	20-11-2022 K9	Oil spill

<p>Contractor is instructed to replace the soil with clean and fresh soil immediate basis. And use spill kits for oil spill on the site. Dispose of the toxicities Soil in a drum.</p>

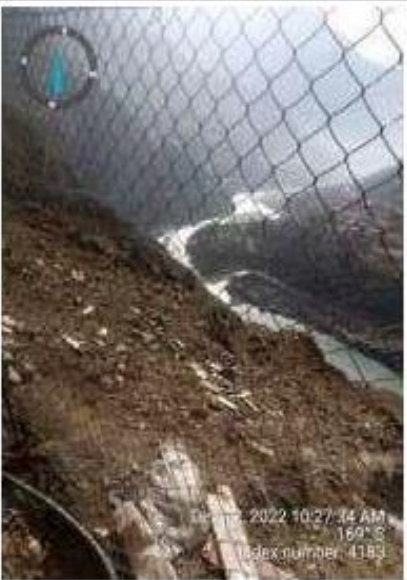
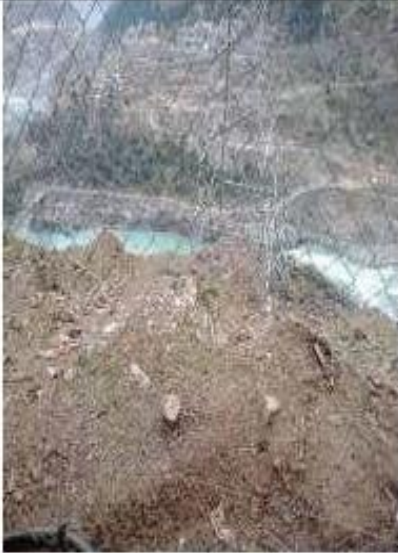
Sr. No	Date and Location of Inspection	EHS observations	Picture	Instructions to the Contractor	Timeline	Action Taken by the Contractor	Completion Date
39.1	12-12-2022 K-04 tunnel portal slope	Littering

The Contactor is instructed to place waste bins at all sites of KKH-01 contract. Collection, segregation must be done as per SOP's provided in ECP's.	<b>Immediate</b>

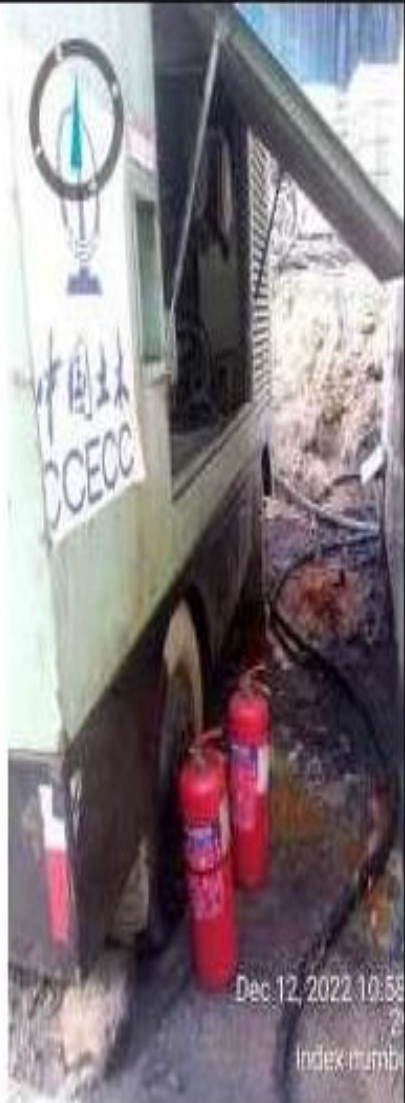
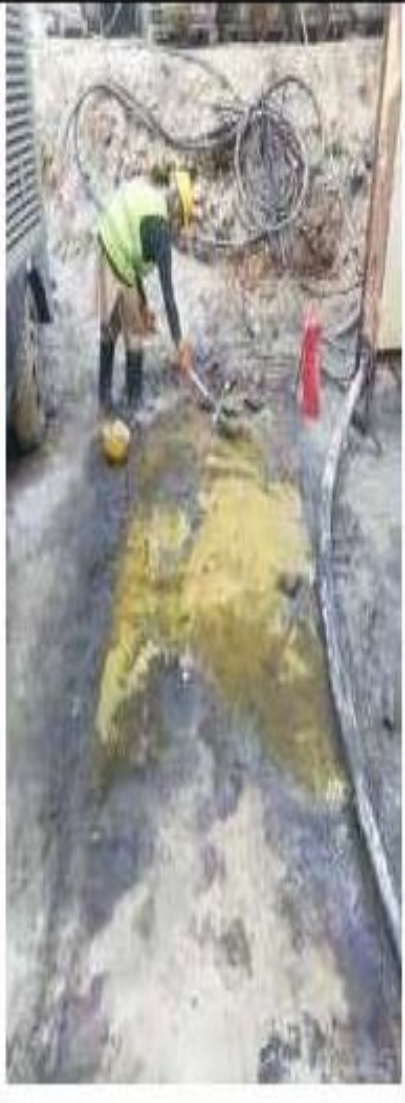
39.2	12-112-2022 k-09 tunnel portal	Oil spill

<p>Dec 12, 2022 10:58 Index numb</p>	<p>The contractor is instructed to remove oil spill from site by replacing fresh soil and store toxicity soil in a drum temporary then transport to the designated site.</p>	immediate

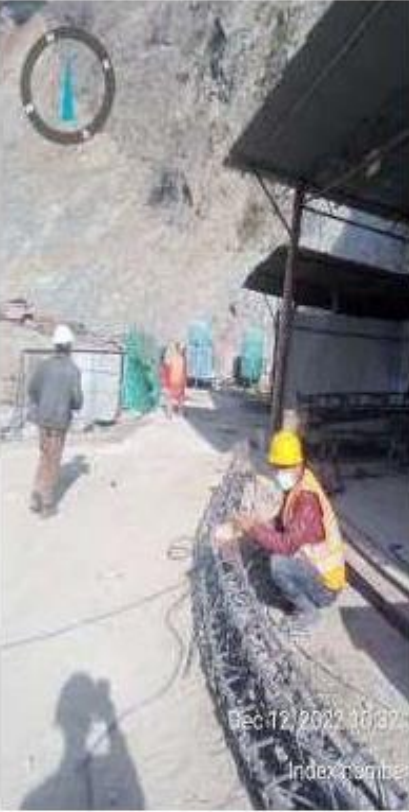
<p>39.3</p>	<p>02-11-2022 K-09</p>	<p>Inadequate PPEs (Protective Shield)</p>

<p>As worker working with welding work having no protective glasses. The contractor is instructed to provide proper PPEs to the workers as per SOPs.</p>	<p><b>Immediate</b></p>

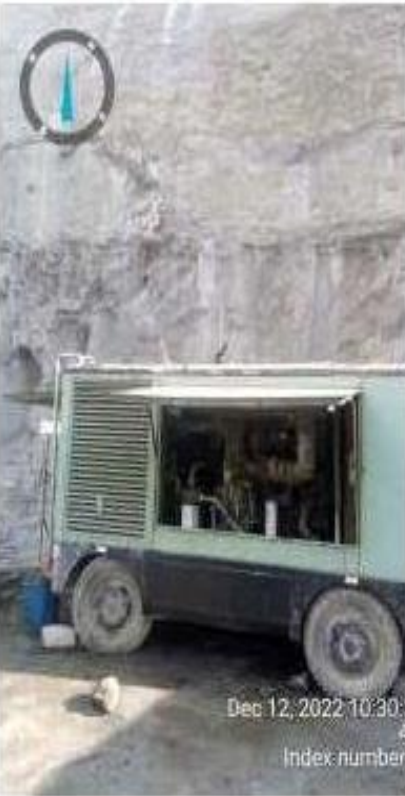
39.5	12-112-2022 k-0 tunnel portal	No signage & No Barricading.

The contractor is instructed to install proper signage and Barricading Tape around this Machine as per SOPs given in ECP's.		Compressor machine is removed from the location	22-12-2022
------	-------------------------------	------------------------------	---	---	--	---	------------

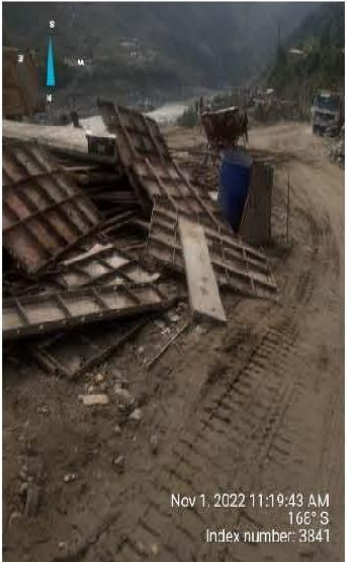
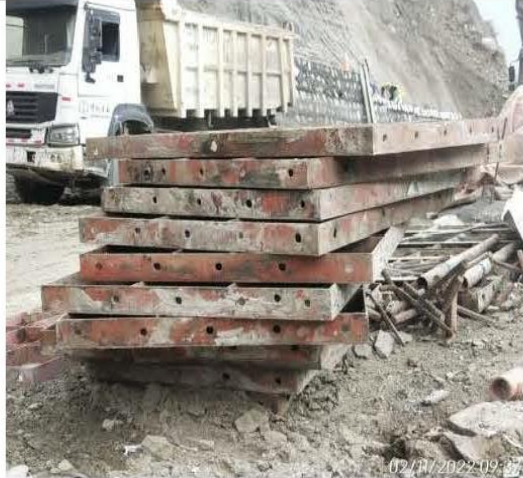
Sr. No	Date and Location of Inspection	EHS observations	Picture	Instructions to the Contractor	Timeline	Action Taken by the Contractor	Completion Date
15.1	01-11-22 RAR-01 Kamila bypass	Inadequate housekeeping

The contractor is instructed to manage construction material properly according to ECPs. The site may result in accidents.	immediate

02-11-2022 Material stacking ensured. Housekeeping carried out

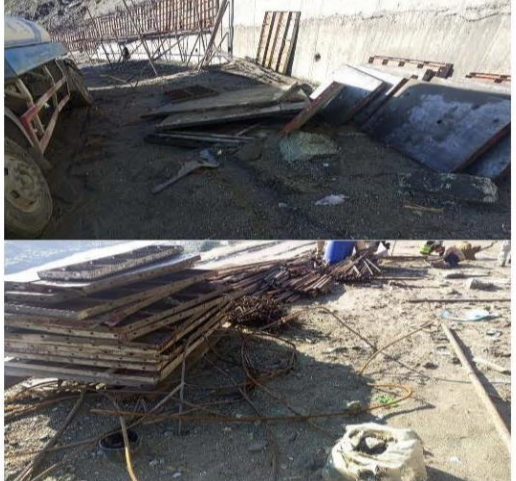
Sr. No	Date and Location of Inspection	EHS observations	Picture	Instructions to the Contractor	Timeline	Action Taken by the Contractor
16.1	10-11-22 RAR-01 Kamila bypass	Inadequate housekeeping

The contractor is instructed to ensure housekeeping	immediate

Housekeeping Done 12-11-2022
16.2	10-11-22 RAR-01 Kamila bypass	Littering of waste

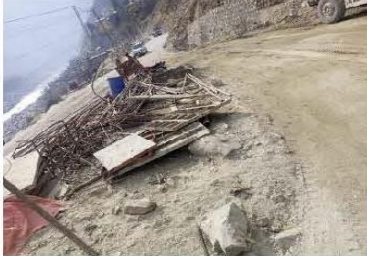
Sr. No	Date and Location of Inspection	EHS observations	Picture	Instructions to the Contractor	Timeline	Action Taken by the Contractor	Completion Date
17.1	08-12-2022 RAR-01 Kamila bypass	Inadequate housekeeping

The contractor is instructed to manage construction material properly according to ECPs and ensure good housekeeping at site.	immediate

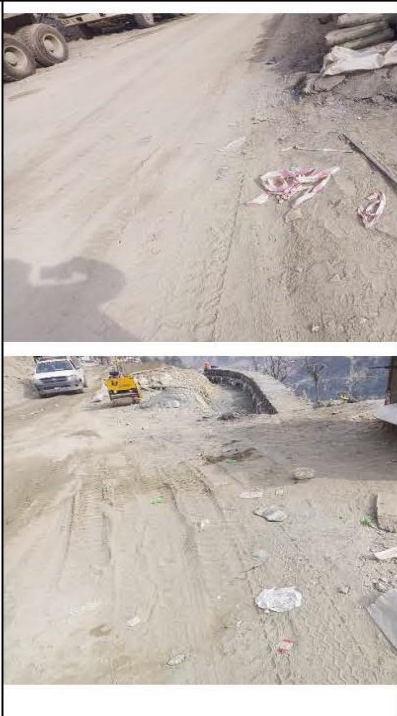
17.2	08-12-2022 RAR-01 Kamila bypass	Littering

<p>The Contactor is instructed to place waste bins at the site. collect the solid waste from different place and put them into the bins at the site After that dump the litter at designated site.</p>	Immediate

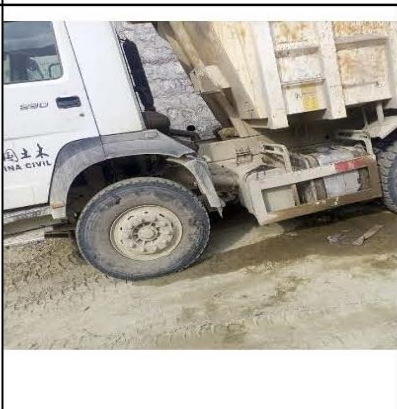
<p>Waste collected and disposed off. 09-12-2022</p>
17.3	08-12-2022 RAR-01 Kamila bypass	Oil spill

<p>The contractor is instructed to remove the oil spill from the site by replacing contaminate soil with fresh soil and follow SOP's given in ECP..</p>	immediate

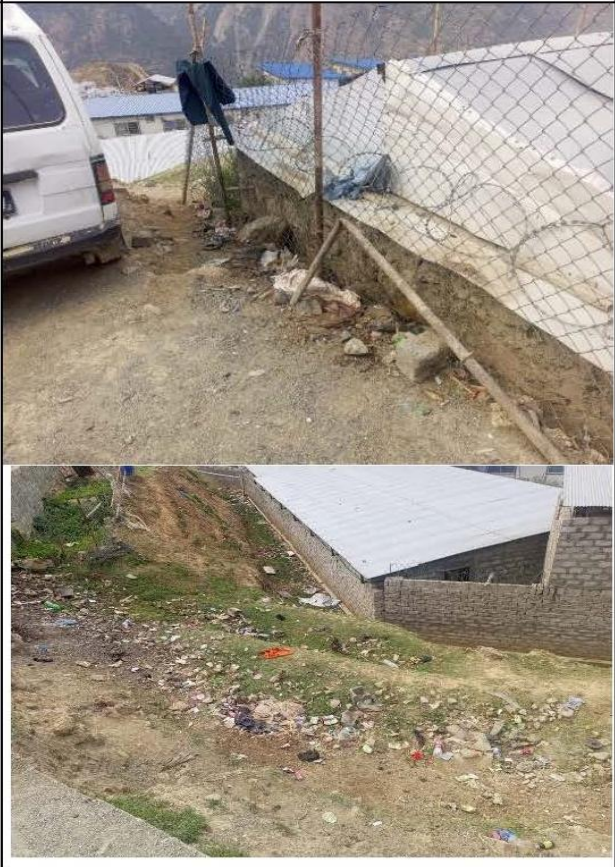
Sr. No	Date and Location of Inspection	EHS observations	Before Rectification Picture	Action Taken by the Contractor	After Rectification picture
37.1	19-10-2022 Labour +FC camp	Littering

<p>Removed the scattered waste from site and dispose off at designated site .also place sufficient numbers of waste bins at different location to avoid littering.</p>

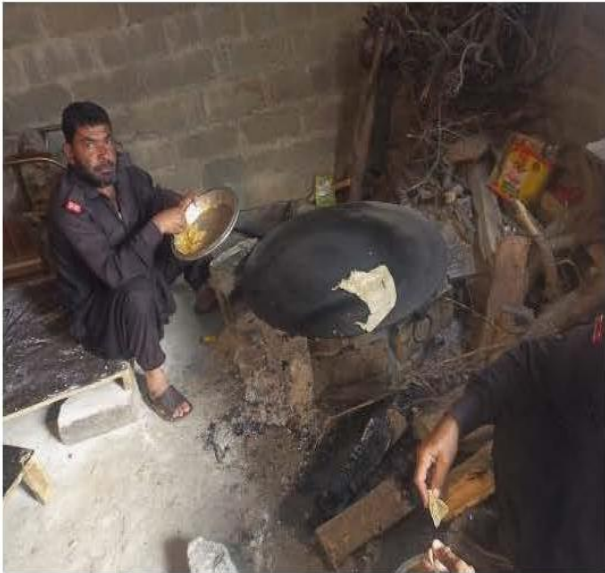
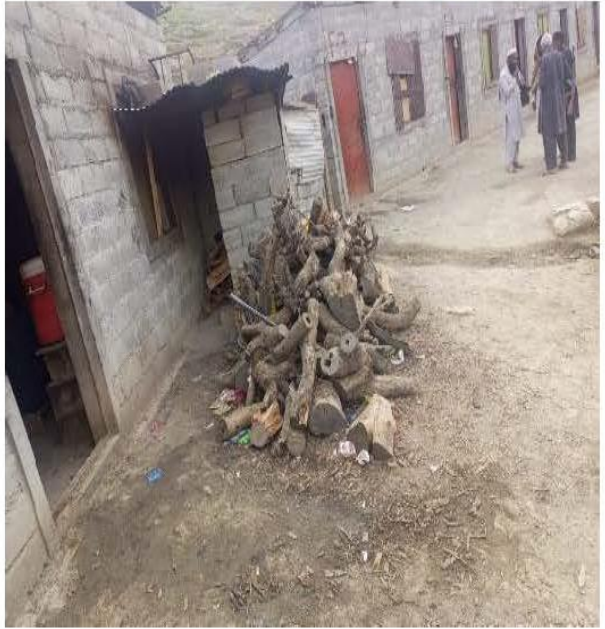
37.4 19-10-2022  
Labor camp +FC camp

Fuel wood

The contractor has strictly instructed to incharge of F.C to use LPG as fuel for cooking and heating purpose .wood as fuel is strictly prohibited at project site.

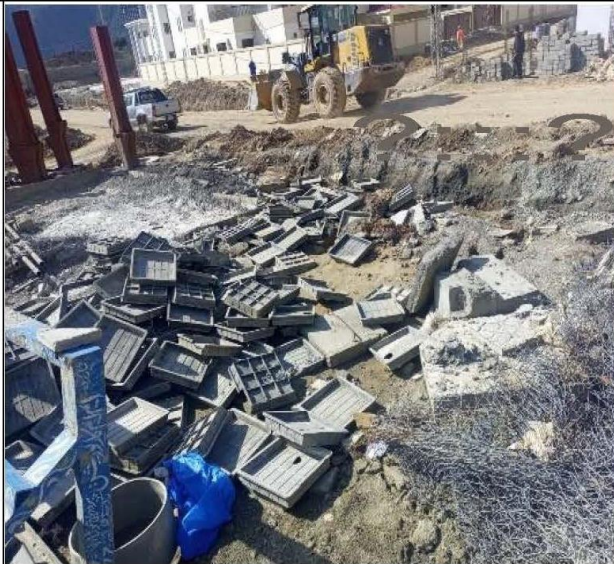
28-10-2022  
Crusher  
plant

housekeeping

Construction material are stacked properly and maintained housekeeping at site.

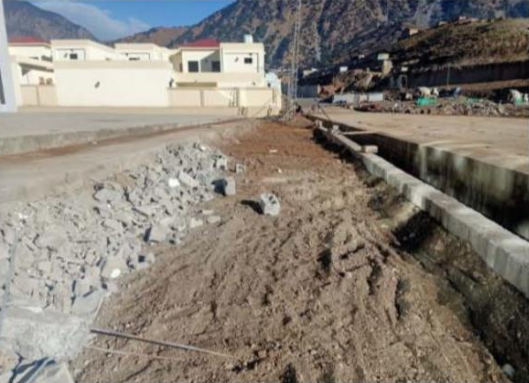
Sr. No	Date and Location of Inspection	EHS Observations	Before Picture	Action Taken by the Contractor	After rectification picture
39.1	28-11-2022 WAPDA colony Chuchang	Littering, solid waste	 	Removed the solid waste from site and disposed off at designated waste disposal site

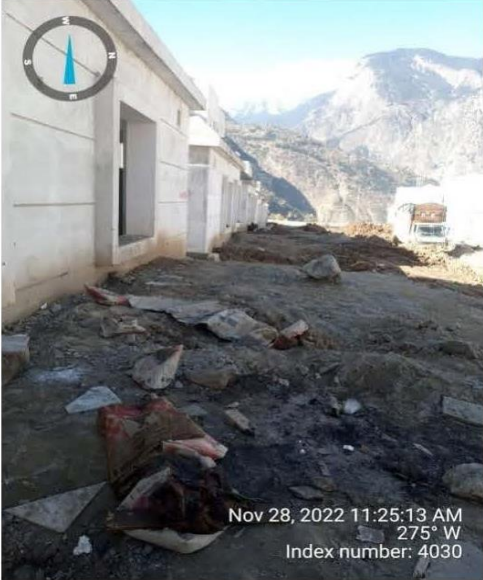
39.4	28-11-2022 WAPDA colony chuchang	Open burning of wooden, cement bags, and packaging

<p>Nov 28, 2022 11:25:13 AM 275° W Index number: 4030</p>	Collect the cement bags from site and stored at cement store also instruct the worker in morning TBT to avoid open burning at site

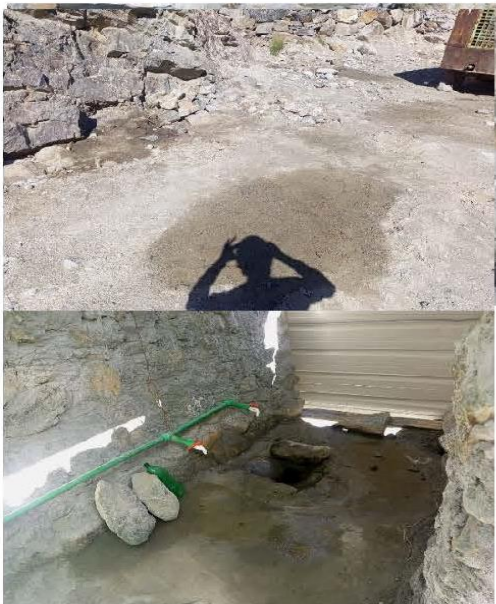
<p>10.3</p>	<p>24-10-2022 Kandia bypass Labor Camp</p>	<p>Poor Toilet facility</p>

<p>During routine supervision it was observed that there is no septic tank and workers are using pit toilet. The contractor is instructed to provide Proper toilet facility for workers with Proper Commode and flushing system and construct a septic tank for this toilet as well. .</p>

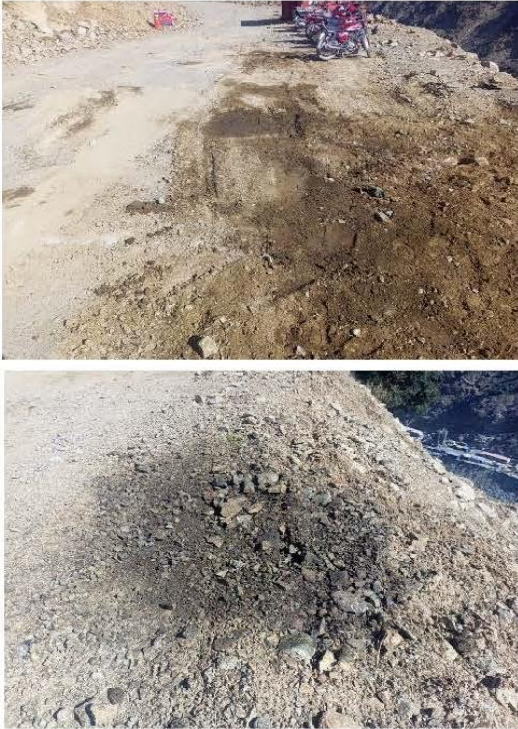
Sr. No	Date and Location of Inspection	EHS observations	Picture	Instructions to the Contractor	Timeline	Action Taken by the Contractor	Completion Date
11.1	26-10-2022 RAR-02 k-13	Oil spill

The contractor is instructed to remove oil spill from site by replacing contaminated soil with clean and fresh soil. EHS Manager for RAR-02 from CGGC has to Provide training to all Staff regarding Use of Spill Kits in case of Oil spill and use of drip trays/ buckets etc and spill sheets underneath to avoid oil/chemical penetration in to the soil.	Immediate

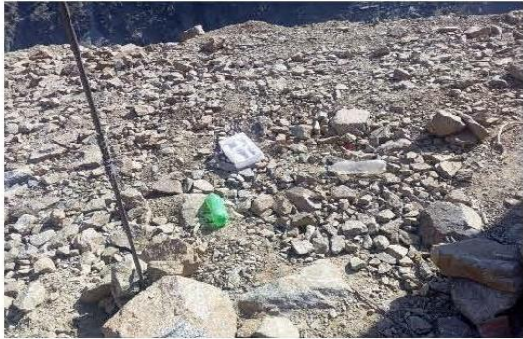
11.2	26-10-2022 RAR-02 k-13	Littering

The contractor is instructed to avoid littering dispose off properly and put more waste bins on site and give a refresher training for all work force and discuss matters pertaining to Solid Waste Management, Oil Spill, and Wood Burning.	Immediate

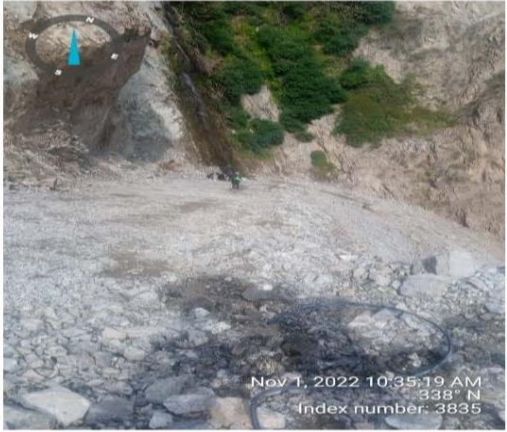
Sr. No	Date and Location of Inspection	EHS observations	Picture	Instructions to the Contractor	Timeline	Action Taken by the Contractor	Completion Date
12.1	01-11-22 RAR-02 k-12	Oil spill

The contractor is instructed remove the contaminated soil by replacing clean and fresh soil and follow ECP's in true letter and spirit	<b>immediate</b>

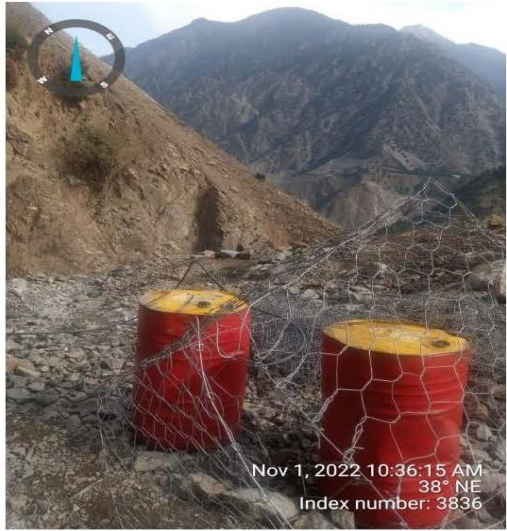
12.2	01-11-22 RAR-02 k-12	Inadequate housekeeping

The contractor is instructed maintain good housekeeping on site and manage construction material in an orderly manner follow SOPs provided in ECP.	<b>immediate</b>

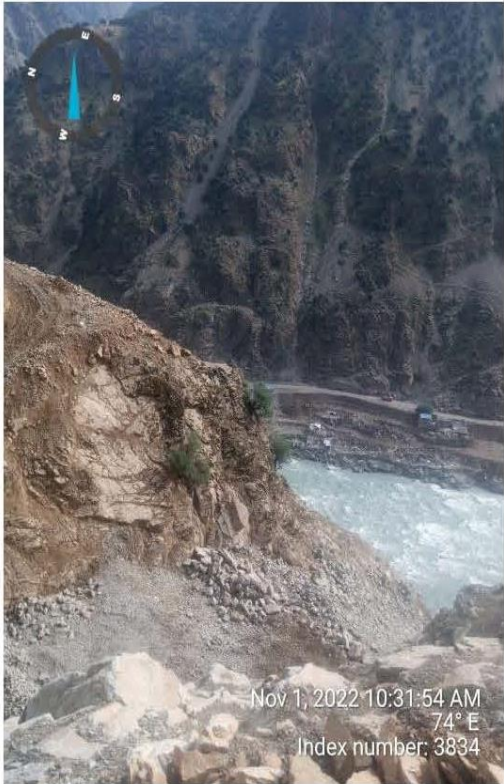
<p>12.3</p>	<p>01-11-22 RAR-02 k-12</p>	<p>Excavation of spoil downwards to river</p>

<p>The contractor is instructed stop the Spoil rolling down the slope and rather comply with haulage of spoil to Spoil disposal designated sites.</p>	<p><b>immediate</b></p>	<p>Contractor will submit the plan about it</p>	
-------------	---------------------------------	---	--	---	-------------------------	---	--

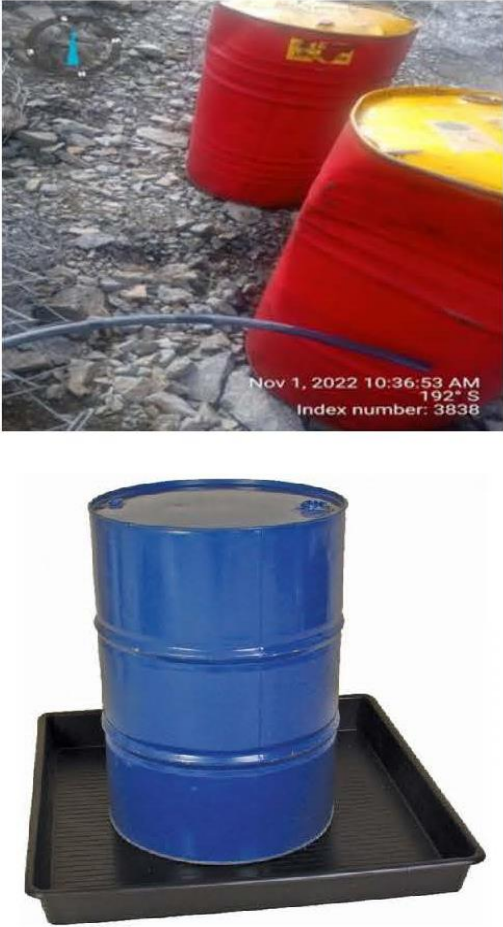
<p>12.4</p>	<p>01-11-22 RAR-02 k-12</p>

<p>The top photograph shows two red drums on a rocky surface. A blue drum is partially visible in the background. A timestamp at the bottom of the image reads: "Nov 1, 2022 10:36:53 AM 192° S Index number: 3838".</p> <p>The bottom photograph shows a blue drum placed on a black plastic drip tray.</p>	<p>The contractor is instructed to keep individual drums in drip trays/ secondary containment (as shown in picture Blue drum) to contain any leakage/ oil spills. Keep designated place clean as per SOPs provided in ECPs. Follow procedure shown with blue drum to avoid Oil Spill.</p>	<p>immediate</p>	<p>In progress</p>	
-------------	---------------------------------	--	--	---	------------------	--------------------	--

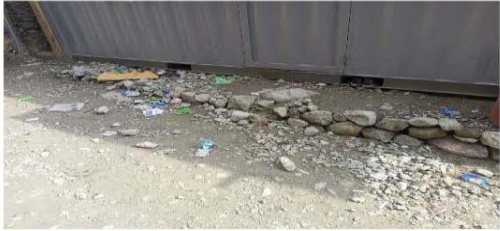
Sr. No	Date and Location of Inspection	EHS observations	Picture	Instructions to the Contractor	Timeline	Action Taken by the Contractor	Completion Date
13.1	16-11-2022 Kandia bypass labor camp	Littering of solid waste

The contractor is instructed to place wastebins and sensitize the labors to use bins for waste	immediate

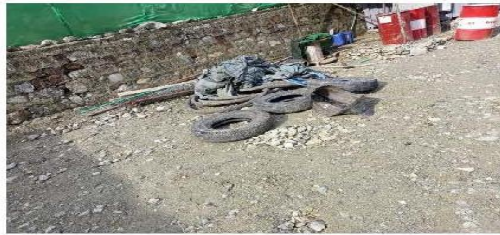
13.2	16-11-2022 Kandia bypass labor camp	Inadequate housekeeping

The contractor is instructed to maintain good housekeeping on site and manage construction material properly also follow SOPs and ECP. Place the oil drums at their designated place.	immediate

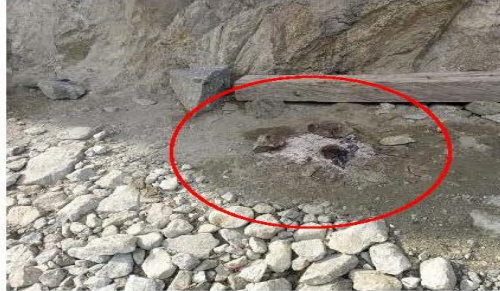
13.3	16-11-2022 Kandia bypass	Open burning

Contractor is instructed to stop the burning of solid waste. Collect the waste into waste bins rather than burnt openly Follow SOPs and ECPs.	immediate

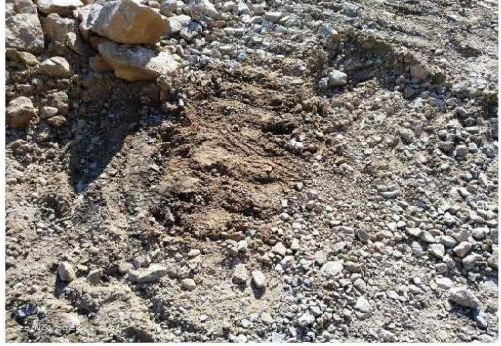
Sr. No	Date and Location of Inspection	EHS observations	Picture	Instructions to the Contractor	Timeline	Action Taken by the Contractor	Completion Date
14.1	28-11-2022 K12	Oil spill

The contractor is instructed remove the oil spill from the site by replacing fresh soil as per SOPs provided in ECP.	<b>Immediate</b>

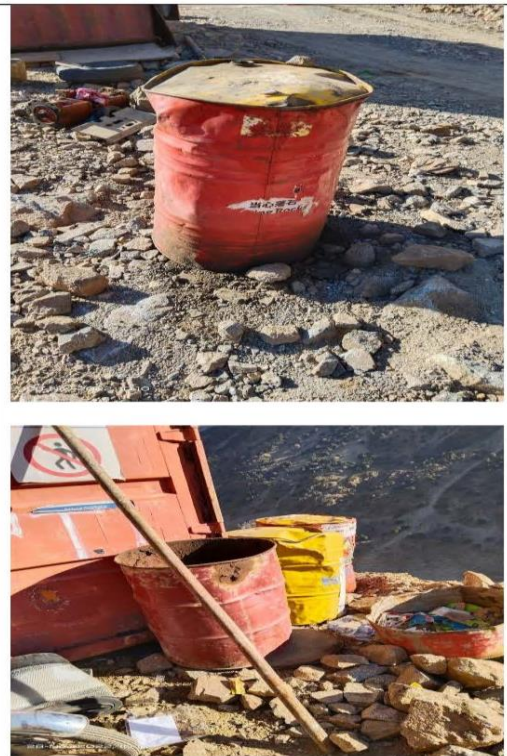
<p>14.4</p>	<p>28-11-2022 K12</p>	<p>Improper placement of drums</p>

<p>The Contractor is instructed to Concrete the bounded area for fuel/Oil Drums within a week.</p>	<p>Within a week</p>

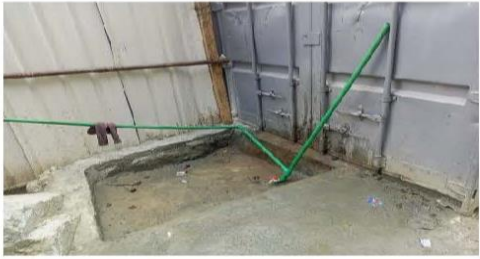
Sr. No	Date and Location of Inspection	EHS observations	Picture	Instructions to the Contractor	Timeline	Action Taken by the Contractor	Completion Date
16.1	12-12-2022 Kandia bypass labor camp	Poor Sanitation Facilities

The contractor is instructed to provide clean and sufficient sanitation facilities for workers as soon as possible.	Immediate

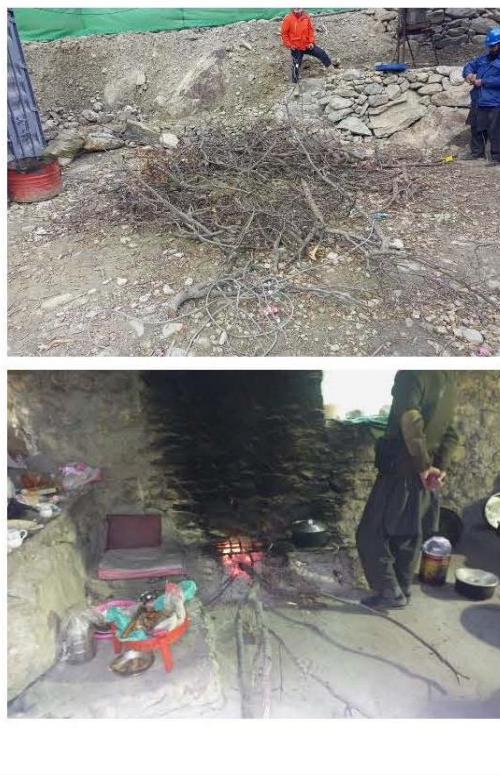
16.2	12-12-2022 kandia bypass labor camp	Fuel wood

<p>The contractor is instructed to provide alternate source of energy for cooking purposes e.g. Bio mass plant or save electric stove or oven. If not possible then provide LPG cylinders with stoves.</p>	<b>Immediate</b>

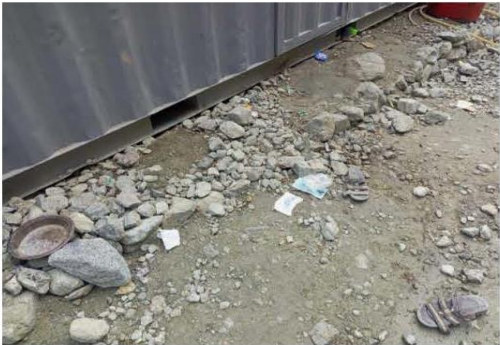
16.4	12-12-2022 Kandia bypass labor camp.	littering

The contractor is instructed to install waste bins at different places in camp. Increase the numbers of waste bins. Educate workforce and staff regarding waste disposal. Follow SOPs given in ECPs.	immediate

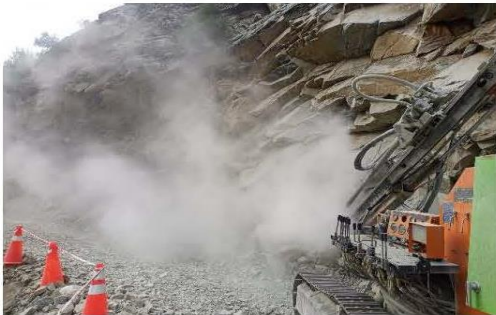
16.5	12-12-2022 Gayal access Road	Heavy dust

The contractor is instructed to repair dust collector of crawling machine and reduce dust emissions and ensure wet drilling at construction site.

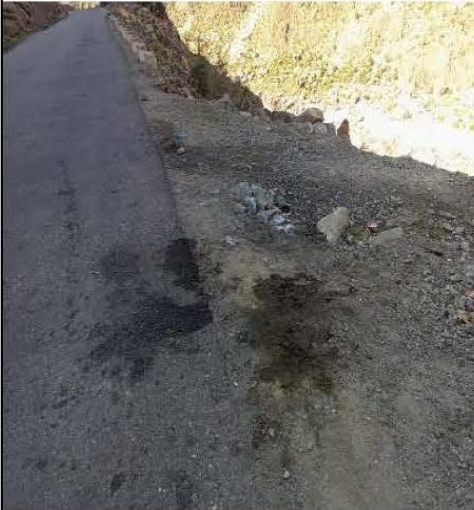
Sr. No	Date and Location of Inspection	EHS observations	Picture	Instructions to the Contractor	Timeline	Action Taken by the Contractor	Completion Date
6.1	24-10-2022 KKH-02 K-34	Oil spill

The contractor is instructed to remove oil spill from site by replacing fresh soil and then store toxicity soil temporary in a pit or drum then transport to final designated dumping site which is approved by the engineers.	immediate

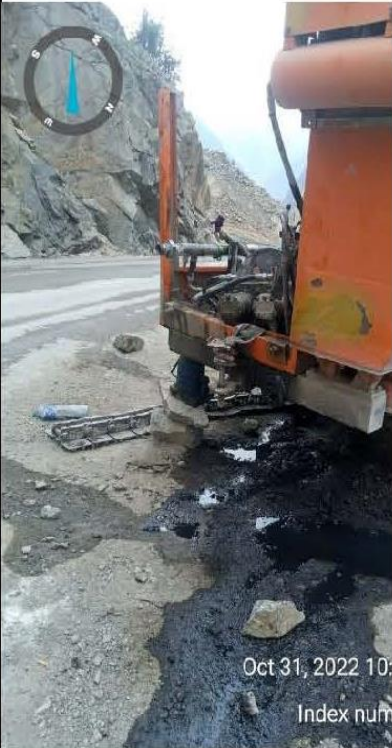
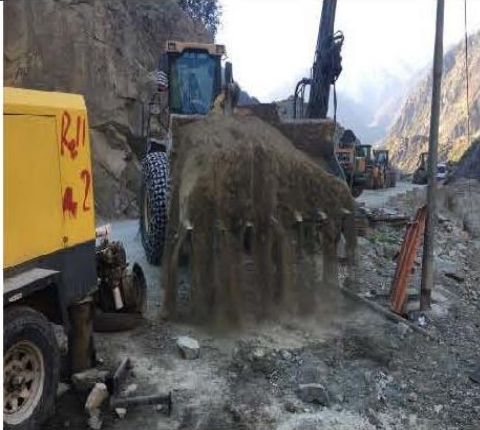
Sr. No	Date and Location of Inspection	EHS observations	Picture	Instructions to the Contractor	Timeline	Action Taken by the Contractor	Completion Date
7.1	31-10-2022 KKH-02 K -34	Oil spill

<p>The contractor is instructed to remove the contaminated soil and replace it with clean and fresh soil. Arrange an awareness session for oil spills on site for all staff of CGGC KKH-02 Component. Follow ECP's regarding Oil Spill.</p>	immediate

<p>The earthen ridges and bunds were immediately made around the oil spill to protect the runoff by raining water for the protection of water resources. In the meantime, fresh soil was added for the replacement of the oil spill, and the contaminated soil was stored for dumping in the designated place.</p>	2-11-2022

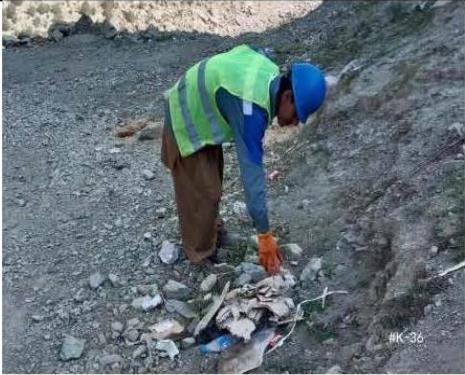
7.3	31-10-2022 KKH-02 K-36 slope	Littering, solid waste	 	<p>Contactor is instructed to place waste bins at the site. Collect the solid waste from different place and put them to the waste bins at the site</p> <p>Train your staff/ labor to throw all discarded materials in the waste bins as per ECP's of Waste Management</p>	Immediate

<p>Waste bin placed at the site and conducted TBTs on waste management and segregation in the same site for the awareness of the employees. The employees trained through a series of trainings about the environment issues.</p>	
-----	---------------------------------------	---------------------------	---	--	-----------	--	--

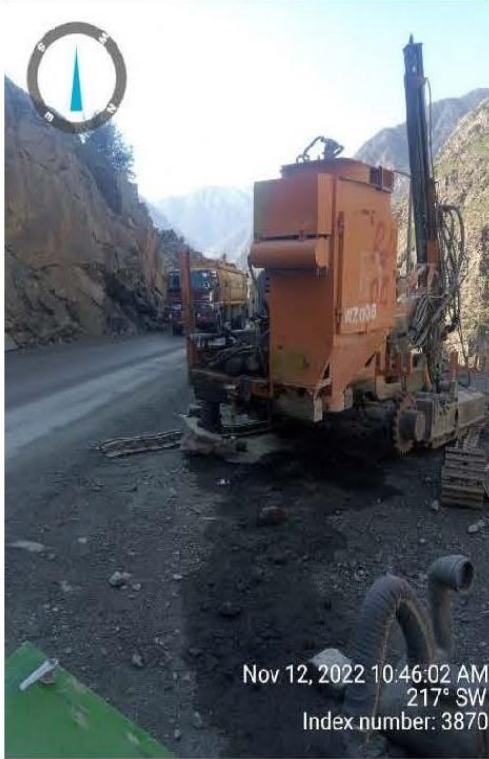
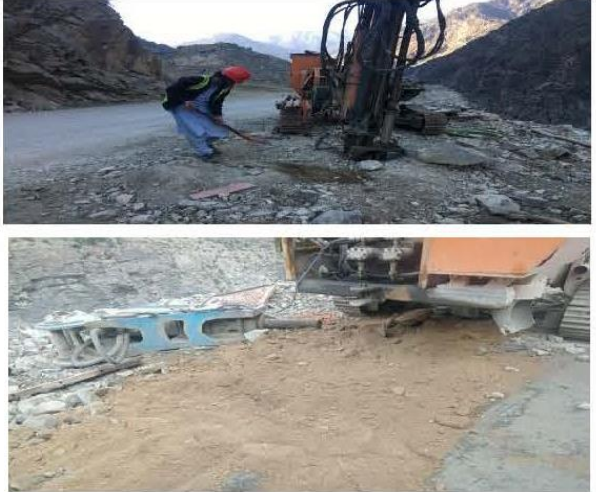
Sr. No	Date and Location of Inspection	EHS observations	Picture	Instructions to the Contractor	Timeline	Action Taken by the Contractor
8.1	12-11-2022 KKH-02 K -34	Oil spill

<p>1.The contractor is instructed to submit Environmental incident report of the Oil spill.</p> <p>2.The contractor is also instructed remove the oil spill from the site by replacing fresh soil and dump properly.</p> <p>3.Drip trays should be used</p>	Reminder

<p>The environmental incident report is submitted with official letter. The spilled oil is removed through fresh soil and stored in proper place for dumping in designated site. Training has been conducted for the mechanics on oil spill and proper use of drum, drip tray and oil spill sheet.</p>

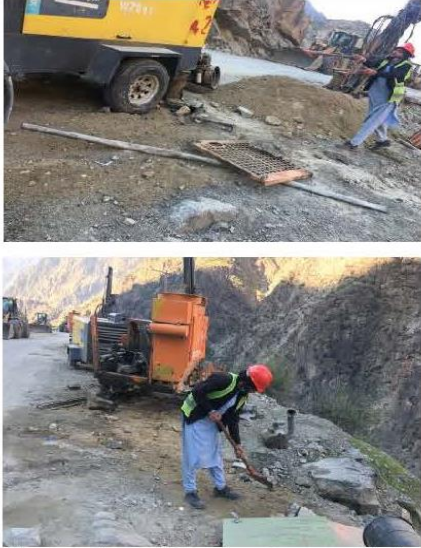
Sr. No	Date and Location of Inspection	EHS observations	Picture	Instructions to the Contractor	Timeliness	Action Taken by the Contractor	Completion Date
09.1	02-12-2022 KKH-02 K-34	Oil spill	 	The contractor is instructed to remove contaminated soil by replacing clean and fresh soil and deal with contaminated soil as per SOP's provided in ECP's.	<b>Immediate</b>

<p>The earthen ridges made around the oil spill to protect the runoff by raining water for the protection of water resources. In the meantime, fresh soil was added for the replacement of the oil spill, and the contaminated soil was stored for dumping in the designated place.</p>	4/12/22

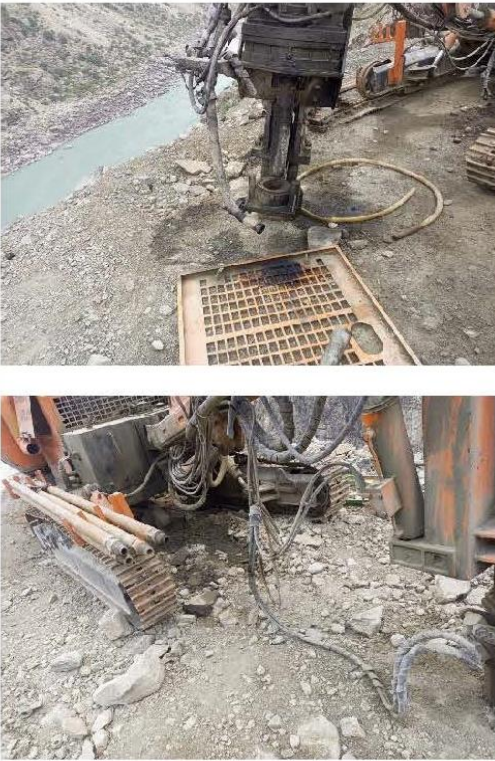
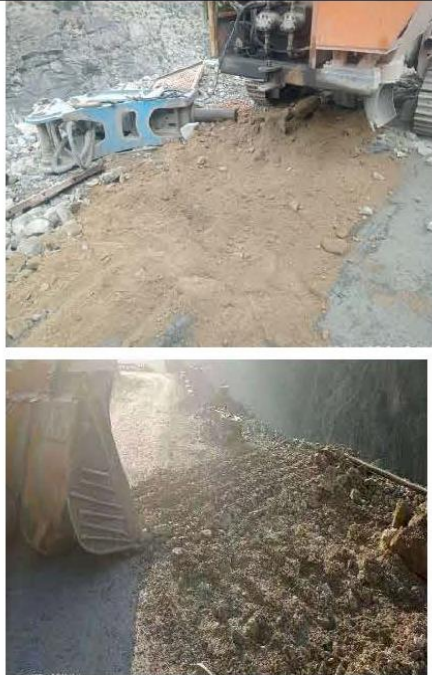
Sr. No	Date and Location of Inspection	EHS observations	Picture	Instructions to the Contractor	Timeline	Action Taken by the Contractor	Completion Date
10.1	12-12-2022 KKH-02 K -34	Oil spill

The contractor is instructed to remove oil spill by replacing fresh soil and store contaminated soil in a drum or pit or tank than transport to designated site which is approved by engineers.	Immediate

<p>The oil spill replaced with fresh soil and contaminated soil transported to designated place</p>	15-12-2022

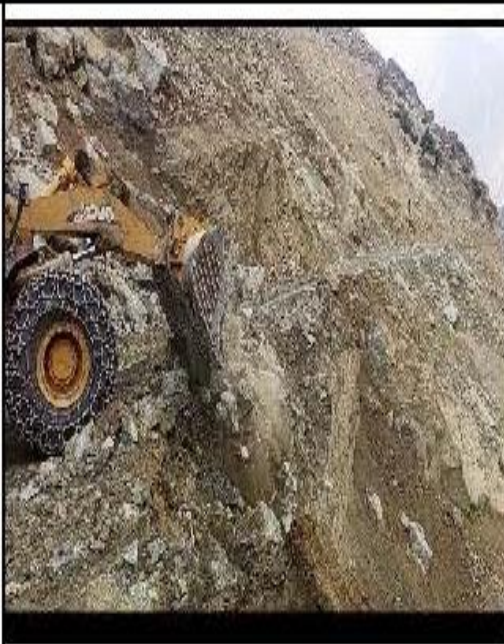
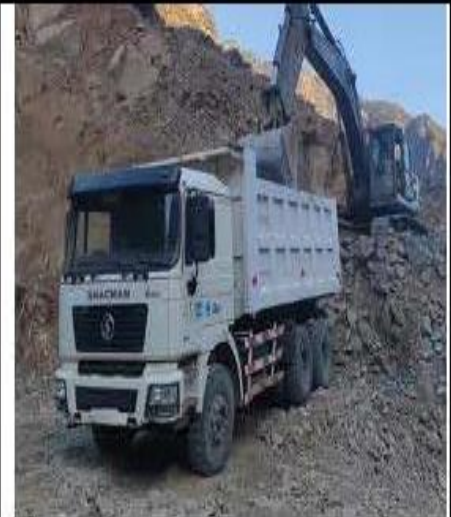
10.2	12-12-2022 KKH-02 K-34	Improper spoil disposal, i.e., Rolling of excavated material down the slope.

<p>The access road was narrow and it was difficult to load the dumper. Later on, the excavated spoil loaded on the dump truck and transported to designated site</p>	
------	------------------------------	--	--	--	-----------------	--	--

The contractor is instructed to ensure proper haulage of excavated material on the 5 designated dumping sites which is approved by engineers and install dumping signboards at dumping site.	<b>Reminder</b>
