Dasu Hydropower Project

Subject: Dasu HPP –33rd ENVIRONMENTAL PROGRESS REPORT FOR THE PERIOD FROM JANUARY TO MARCH 2023

Environmental Quarterly Progress Report

Report Number: 33

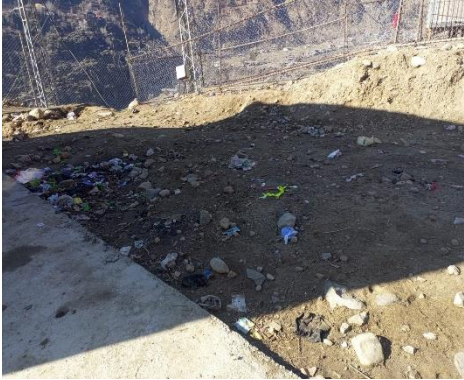
Sr. No	Date and Location of Inspection	EHS observations	Picture	Instructions to the Contractor	Timeline	Action Taken by the Contractor	Completion Date
68.1	03-01-2023 Switch yard labor camp (MWs-02)	Littering

The contractor is instructed to keep waste bins on side and collect solid waste and dispose of properly according to ECPs.	immediate

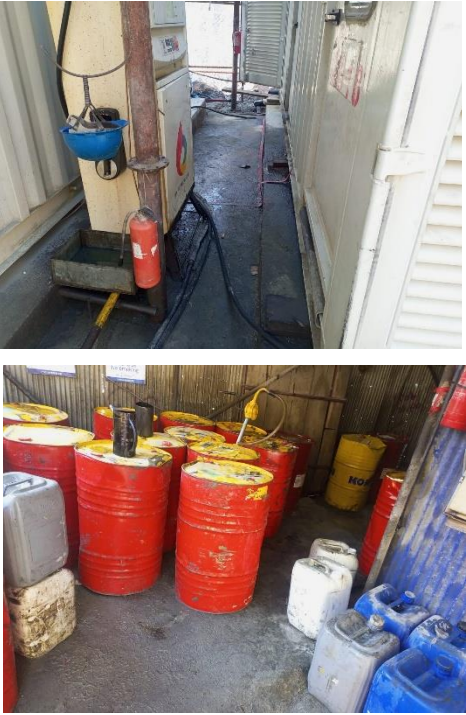
68.2	03-01-2023 CR9 generator room + work shop (MW-02)	Oil spill

<p>Contactors is instructed to remove the spill replace the spill by fresh soil and sand.</p> <p>After that dispose off the toxicity soil as per ECPs and SOPs.</p>	Immediate		
68.3	03-01-2023 CT-2 kitchen. (MW-02)	Fuel wood.

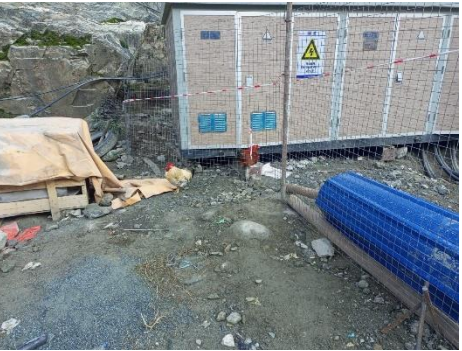
68.4	03-01-2023 MAT sedimentation pond + CT-02 sedimentation pond. (MW-02)	Untreated water.	 	The contractor is instructed to keep always open fresh water in sedimentation pond and stop over flow water from the first chamber.	immediate		
68.5	03-01-2023 CT-02 (MWs-02)	Animals

The contractor is instructed to remove animals from construction site.	immediate

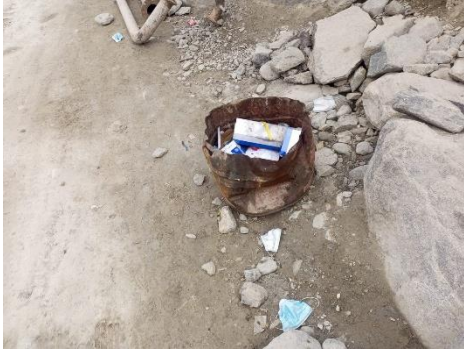
Sr. No	Date and Location of Inspection	EHS observations	Picture	Instructions to the Contractor	Timeline	Action Taken by the Contractor	Completion Date
69.1	06-01-2023 Near A1 tunnel (MW-01)	Littering

The contractor is instructed to keep waste bins on side and collect solid waste and dispose of properly according to ECPs.	immediate

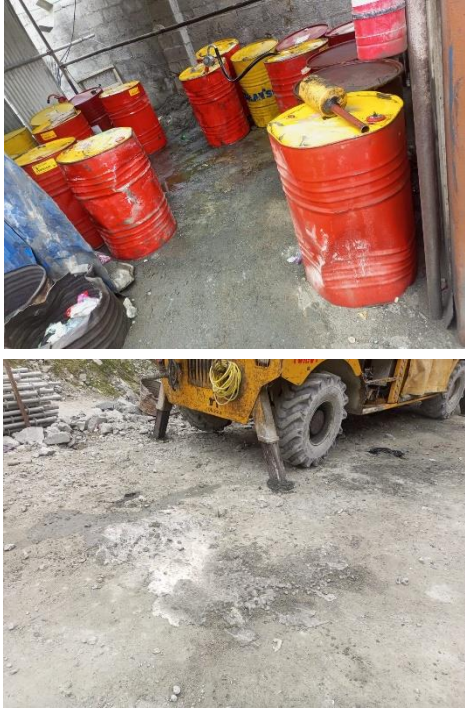
69.2	06-01-2023 Baching plant CR2 + HT office (MW-01)	Oil spill

<p>Contractors is instructed to remove the spill replace the spill by fresh soil and sand.</p> <p>After that dispose off the toxicity soil as per ECPs and SOPs.</p>	Immediate		
69.3	06-01-2023 Old crushing plant uchar (MW-01)	Animals

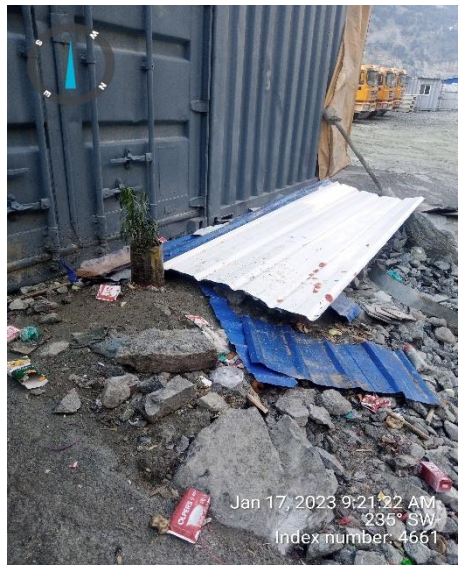
Sr. No	Date and Location of Inspection	EHS observations	Picture	Instructions to the Contractor	Timeline	Action Taken by the Contractor	Completion Date
70.1	17-01-23 CT-02 labor camp.	Solid waste

<p style="font-size: small; text-align: center;">Jan 17, 2023 9:21:22 AM 285° SW Index number: 4661</p>	<p>Contractor is instructed to place the waste bins at the site.</p> <p>collect the solid waste from different place and put them to the bins at the site</p> <p>Dump the waste in to proper dumping site approved by engineers.</p>	immediately

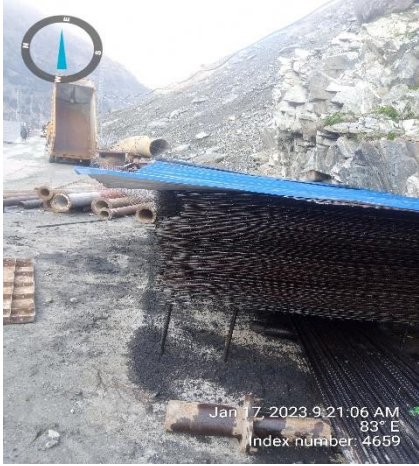
70.2	17-01-23 CT-02 tunnel portal	Oil spillage

<p style="text-align: right; font-size: small;">Jan 17, 2023 9:21:06 AM 83° E Index number: 4659</p>	<p>The contractor is instructed to remove the oil spill from the site by replacing fresh soil.</p> <p>Follow SOPs and ECPs.</p>	immediate		
70.3	17-01-23 CT-02 labor camp	Unhygienic condition

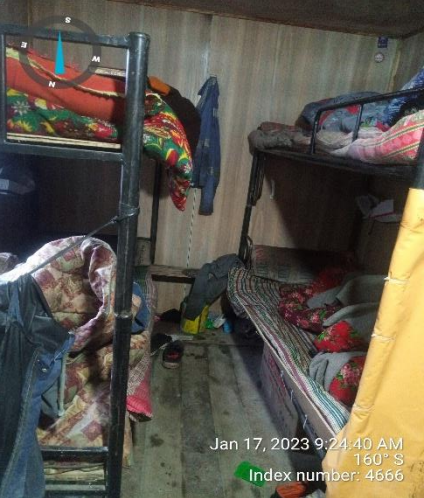
70.4	17-01-23 CT-02 labor camp	Improper workers accommodation

The contractor is instructed to follow the living condition in rooms as per instruction in CEAPS and IFC guidelines.	immediate		
70.5	17-01-23 CT-02 labor camp	poor welfare facilities

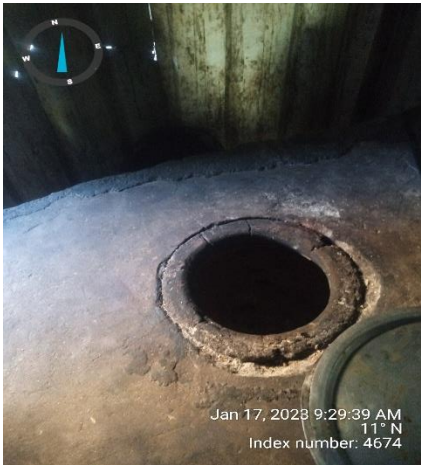
70.6	17-01-23 CT-02 labor camp	Fuel wood.

<p>Contractor is instructed to provide LPG gas for cooking purposes</p> <p>Use of fuel wood is strictly prohibited.</p>	immediate		
70.7	17-01-23 Labor camp barseen.	Poor sanitation

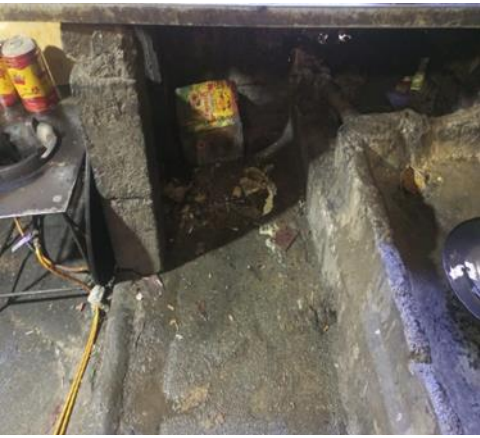
70.8	17-01-23 Management camp barseen.	Unhygienic condition

<p>The contractor is instructed to maintain the hygienic condition in kitchen and also discard the kitchen waste into proper waste bins.</p> <p>Place a waste bins in the kitchen</p>	immediate		
70.9	17-01-23 Management camp barseen	Improper workers accommodation

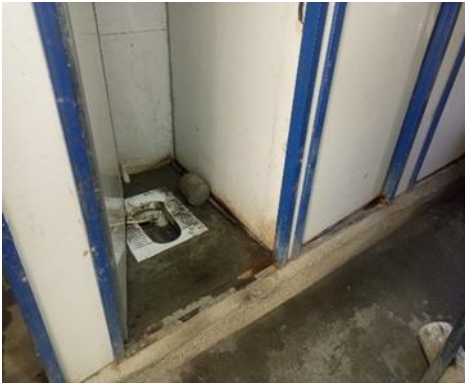
70.1 1	17-01-23 Management camp barseen. And labor camp barseen	poor welfare facilities

Contactor is instructed to provide welfare facilities in toilets and washrooms and also provide hot water facility to the work force. Follow SOPs and ECPs.	immediate		
70.1 2	17-01-23 Management camp barseen. And labor camp barseen	Fuel wood

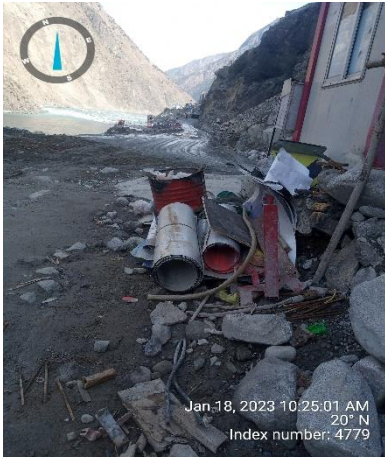
Sr. No	Date and Location of Inspection	EHS observations	Picture	Instructions to the Contractor	Timeline	Action Taken by the Contractor	Completion Date
71.1	18-01-23 CR-02 near Adit -1 tunnel	Inadequate housekeeping

The contractor is instructed to keep and maintain good housekeeping at the site as per ECPs and SOPs.	immediate

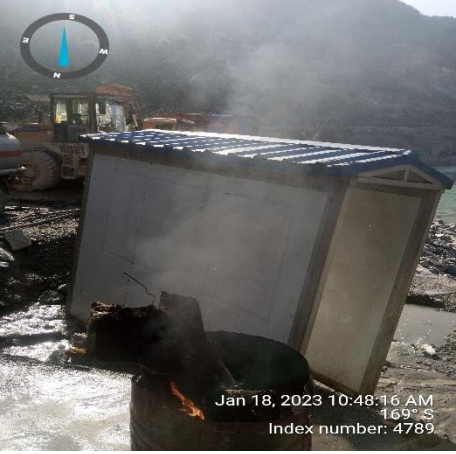
71.2	18-01-23 CR-02 In front of CR-02 mosque.	Open burning

<p>The contractor is instructed to stop This practice immediate.</p> <p>Open burning strictly prohibited.</p> <p>Follow CEAPs and ECPs.</p> <p>Educate and conduct TBT training in every morning to the work force regarding any non-compliances.</p>	immediate		
71.3	18-01-23 CR-02 workshop.	Workshop waste (grease etc.)

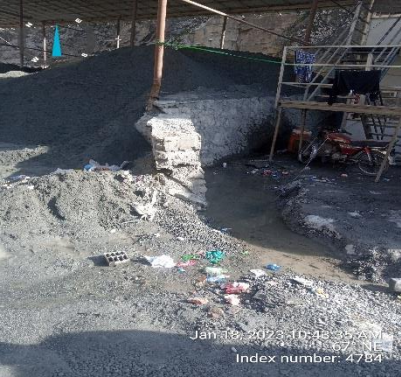
71.4	18-01-23 Near batching plant CR-02	Solid waste

<p>Contactor is instructed to collect the solid waste. litteing from scattered place and also place waste bins there.</p> <p>Follow SOPs and ECPs.</p>			
------	---------------------------------------	-------------	--	--	--	--	--

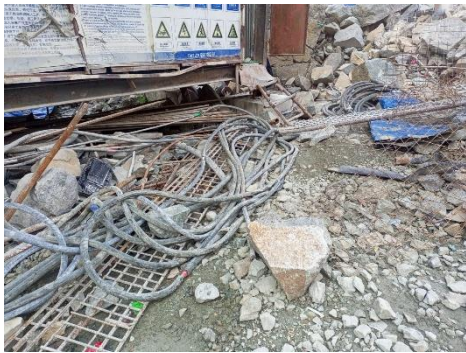
Sr. No	Date and Location of Inspection	EHS observations	Picture	Instructions to the Contractor	Timeline	Action Taken by the Contractor	Completion Date
72.1	20-01-2023 traffic diversion tunnel (MW-01)	Inadequate housekeeping

The contractor is instructed to keep and maintain good housekeeping at the site as per ECPs and SOPs.	immediate		
72.2	20-01-2023 HT office slope CR2 (MW-01)	Improper waste mgt

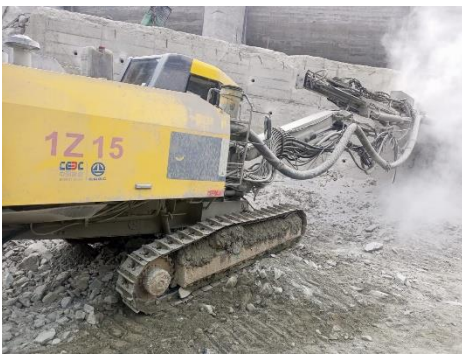
72.3	20-01-2023 coffer dam (MW-01)	Heavy dust during drilling

The contractor is instructed to ensure maintenance of equipment and ensure wet drilling at construction site as soon as possible	Immediate		
72.4	20-01-2023 uchar old crushing plant	Poor maintenance of sedimentation tank

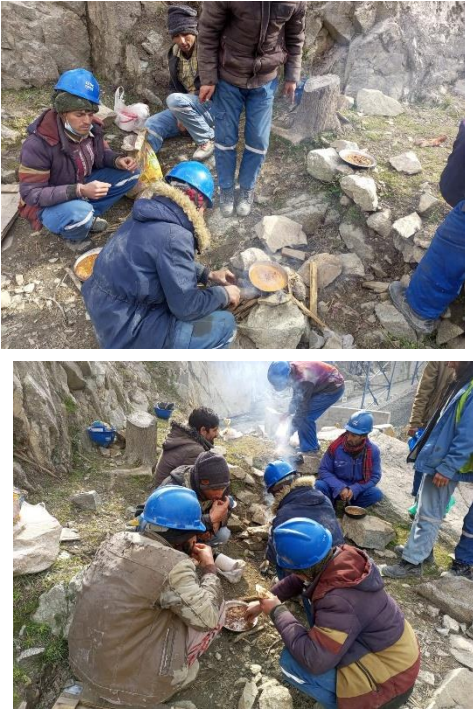
72.5	20-01-2023 thoki crushing plant Uchaar(MW-01)	Labour welfare facility

The contractor is instructed to provide dinning place/container with availability of safe drinking water.	Immediate		
72.6	20-01-2023 Thoki crushing plant Uchaar(MW-01)	Oil spill

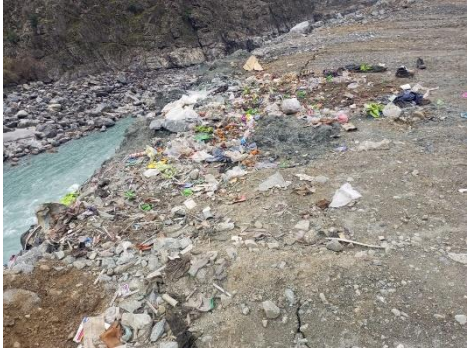
Sr. No	Date and Location of Inspection	Environment Observations	Picture	Instructions to the Contractor	Timeline	Action Taken by the Contractor	Completion Date
73.1	21-01-2023 CT-02 main gate	Littering on the Slope above Indus River.

The contractor is instructed to keep waste bins on site and collect solid waste from the slopes and dispose of properly according to ECPs.	Immediate

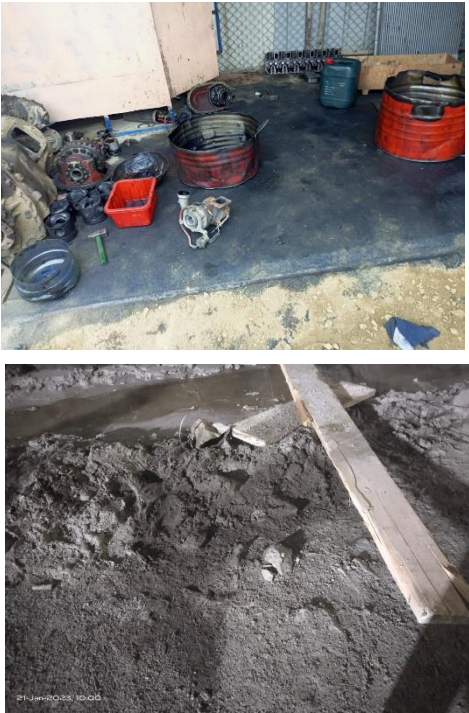
73.2	21-01-2023 power house + switch yard	Oil spill

<p>Contactors is instructed to remove the oil spill and replace the contaminated soil by fresh soil and sand.</p> <p>Dispose off the contaminated soil as per ECPs and SOPs.</p>	Immediate		
------	--	-----------	--	--	------------------	--	--

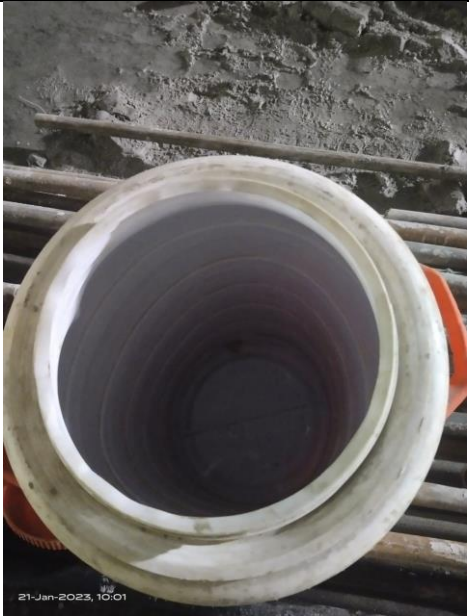
73.3	21-01-2023 Underground power house	No drinking water

The contractor is instructed to provide clean drinking water for underground working Staff	Immediate		
------	--	----------------------	--	--	------------------	--	--

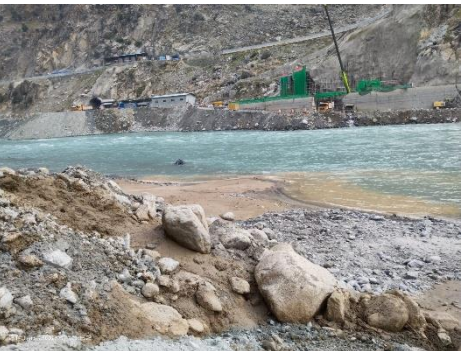
The contractor is instructed to remove empty drums and admixture chemical tanks from the site to avoid any environmental incident at site. Transport the empty drum/chemical tank to designated Storage site having concrete foundation and proper boundary.	Immediate		
73.5	21-01-2023 starter dam	Improper dispose of sludge

The contractor is instructed to dispose off sludge away from river bank ensure disposal at designated dumping site rather than releasing it in the flowing Indus River.	Immediate

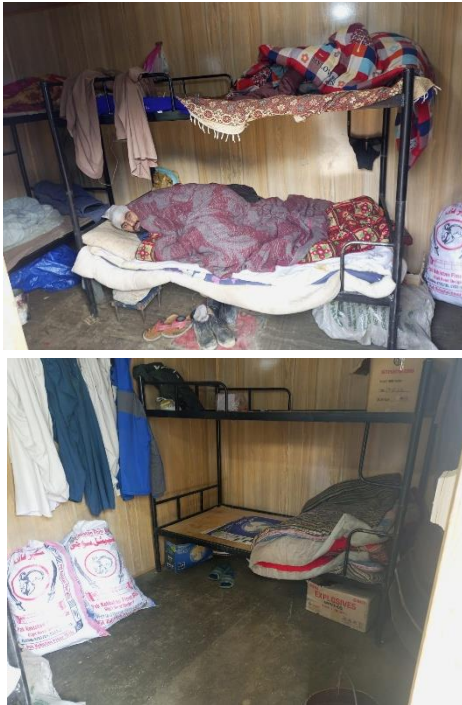
<p>During camp inspection it was observed that there are total of 21 rooms and in one room 6 and 9 workers are living</p> <p>The contractor is instructed to provide ILO standard accommodation for workers:</p> <ul style="list-style-type: none"> a) separate bed for each worker; b) adequate headroom, providing full and free movement, of not less than 203 centimetres; c) the minimum inside dimensions of a sleeping space should be at least 198 centimetres by 80 centimetres; d) beds should not be arranged in tiers of more than two; e) bedding materials should be reasonably comfortable; f) bedding and 	Immediate		
------	---	------------------------------	--	---	------------------	--	--

<p>bedframe materials</p> <p>should be designed to deter vermin;</p> <p>g) separate accommodation of the sexes;</p> <p>h) adequate natural light during the daytime and adequate artificial light;</p> <p>i) a reading lamp for each bed;</p> <p>j) adequate ventilation to ensure sufficient movement of air in all conditions of weather and climate;</p> <p>k) heating where appropriate;</p> <p>l) adequate supply of safe potable water;</p>			
--	--	--	--	---	--	--	--

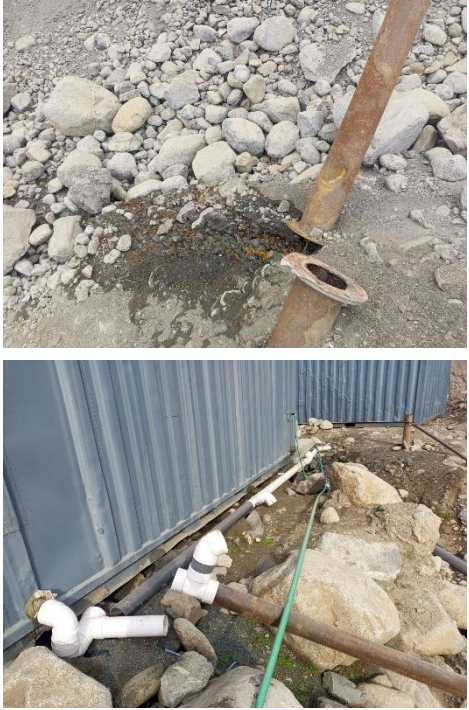
73.8	21-01-2023 switch yard labor camp	Improper sewerage system

The contractor is instructed to connect the sewage water pipe to septic tank with immediate effect.	immediate		
------	---	--------------------------------	--	---	------------------	--	--

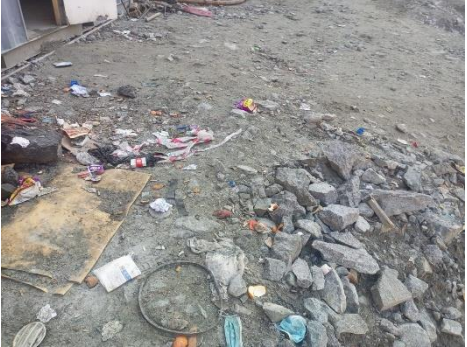
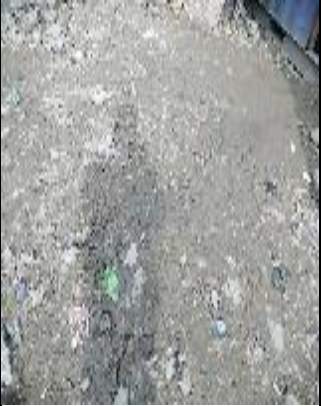
Sr. No	Date and Location of Inspection	EHS observations	Picture	Instructions to the Contractor	Timeline	Action Taken by the Contractor	Completion Date
74.1	27-01-2023 DTA outlet office (MWs-01)	Littering

The contractor is instructed to keep waste bins on side and collect solid waste and dispose of properly according to ECPs.	immediate

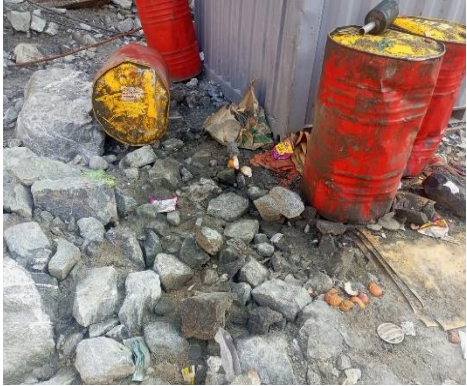
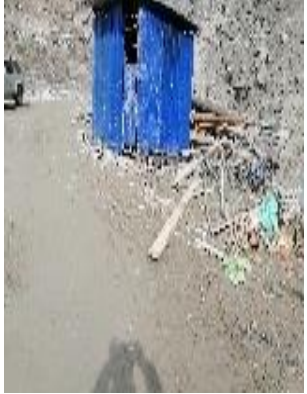
31-01-2023
74.2	27-01-2023 DTA outlet office (MWs-01)	Oil spill

Contractors is instructed to remove the spill replace the spill by fresh soil and sand. After that dispose off the toxicity soil as per ECPs and SOPs.	Immediate

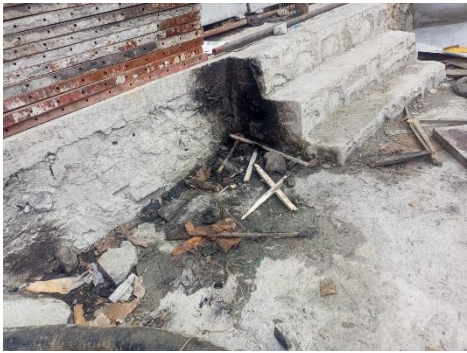
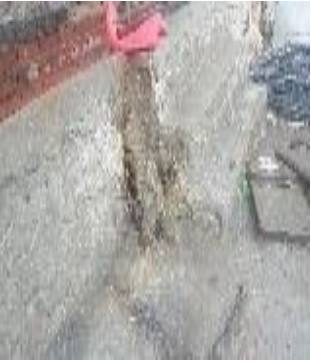
74.5	27-01-2023 near A1 sedimentation pond (MWs- 01)	Open burning

<p>The contractor is instructed to stop This practice immediate.</p> <p>Open burning is strictly prohibited.</p> <p>Follow CEAPs and ECPs.</p> <p>Educate and conduct TBT training in every morning to the work force regarding any environmental non-compliances.</p>	Immediate

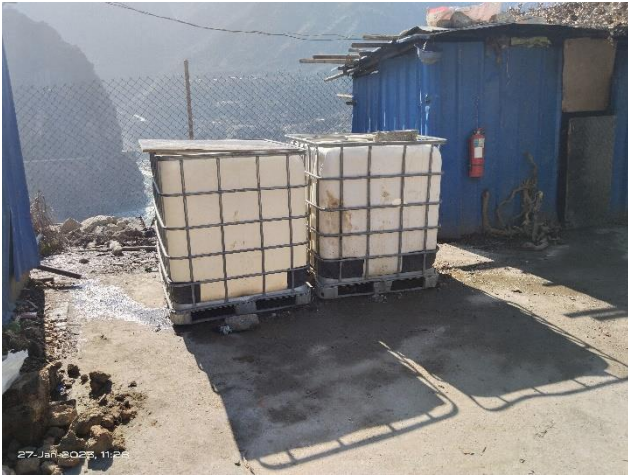
Sr. No	Date and Location of Inspection	EHS observations	Picture	Instructions to the Contractor	Timeline	Action Taken by the Contractor	Completion Date
75.1	28-01-2023 Switchyard Labor camps (CT-3)	Chemical Tanks

Chemical Tanks are in use for Drinking water, Cooking etc. It is strictly instructed the contractor to remove the chemical tanks from camps and provide safe tanks ASAP.	Immediate

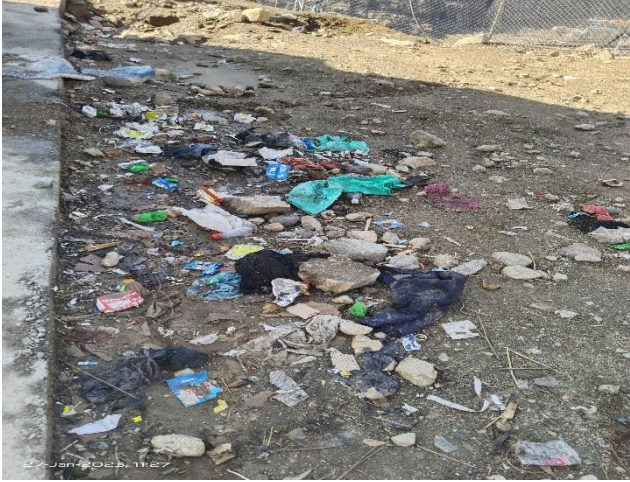
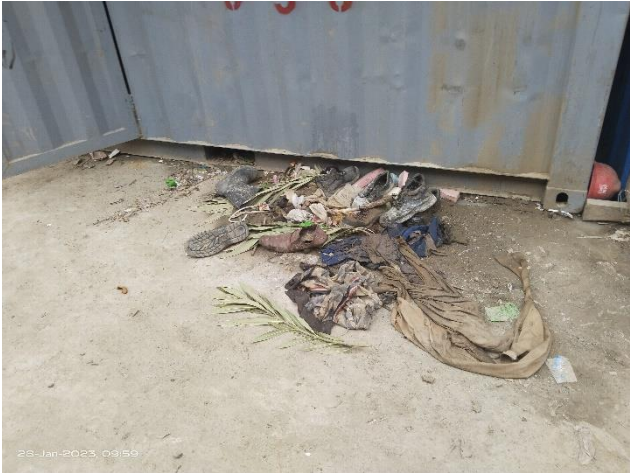
75.2	28-01-2023 Switch yard Labor camps (CT-3)	Inadequate housekeeping	 	It is instructed the contractor keep maintain good housekeeping at all sites. Clean and clear all the sites ASAP.	Immediate

<p>The top photograph shows a cluttered outdoor area with a blue metal container on the left. In front of it is a large, weathered tree stump. To the right, there are several red metal barrels and a large pile of coiled grey hoses and dry sticks. The ground is dirt and covered with some debris. A timestamp '28-Jan-2023, 10:00' is visible in the bottom left corner of the photo.</p> <p>The bottom photograph shows a grey metal container with its doors closed. In front of the container, there is a large amount of trash, including a bright green tarp, a blue plastic bag, and other pieces of waste. The ground is dirt and littered with debris. A timestamp '28-Jan-2023, 10:00' is visible in the bottom left corner of the photo.</p>				
--	--	--	--	--	--	--	--

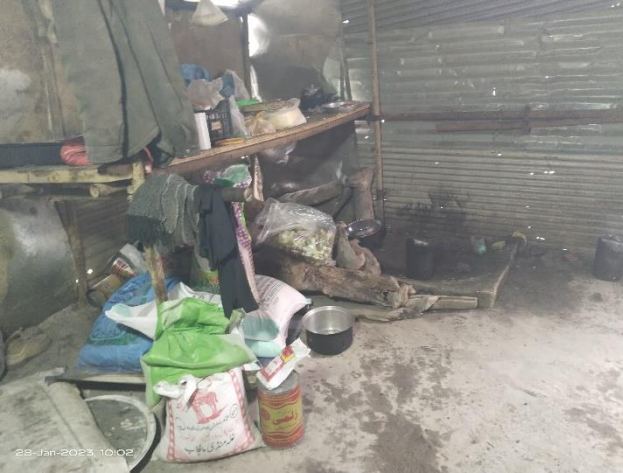
75.4	28-01-2023 Switch yard Labor camps (CT-2)	Inadequate kitchen

Instructed the contractor to maintain good kitchen at all camps.	Immediate		
------	---	-----------------------	--	--	------------------	--	--

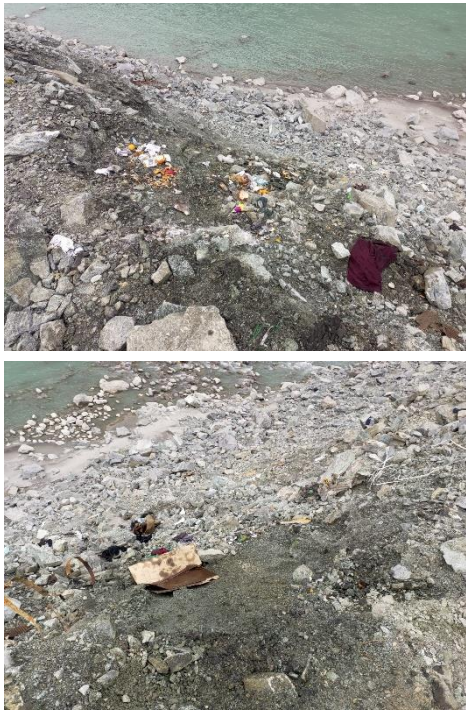
Sr. No	Date and Location of Inspection	EHS observations	Picture	Instructions to the Contractor	Timeline	Action Taken by the Contractor	Completion Date
76.1	28-01-2023 CR-02 HT office (MWs-01)	Littering

The contractor is instructed to keep waste bins on side and collect solid waste and dispose of properly according to ECPs.	immediate

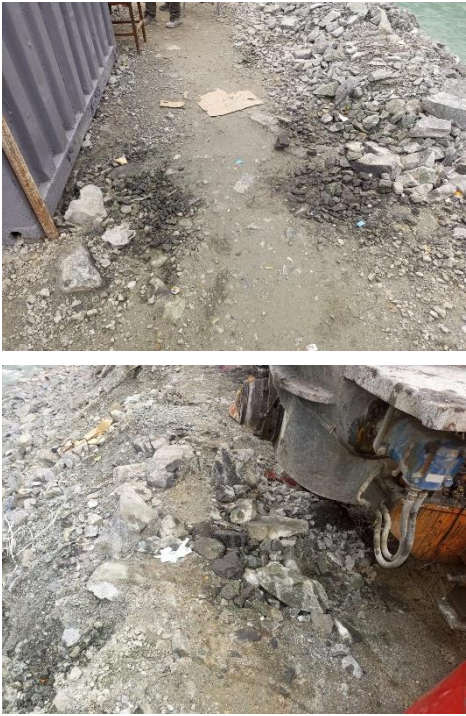
76.2	28-01-2023 CR-02 HT office (MWs-01)	Oil spill

<p>Contractors is instructed to remove the spill replace the spill by fresh soil and sand.</p> <p>After that dispose off the toxicity soil as per ECPs and SOPs.</p>	Immediate		
76.3	28-01-2023 DTB outlet (MWs-01)	Heavy dust

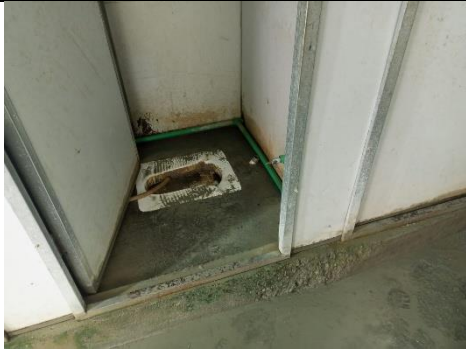
76.4	28-01-2023 CR-02 toilets (MWs-01)	Poor hygienic condition

The contractor is instructed to past a daily cleaning checklist and ensure cleaning on daily basis and disinfect the toilets at least once a week.	Immediate		
76.5	28-01-2023 CR-02 workshop (MWs-01)	Water sprinkling over oil spill

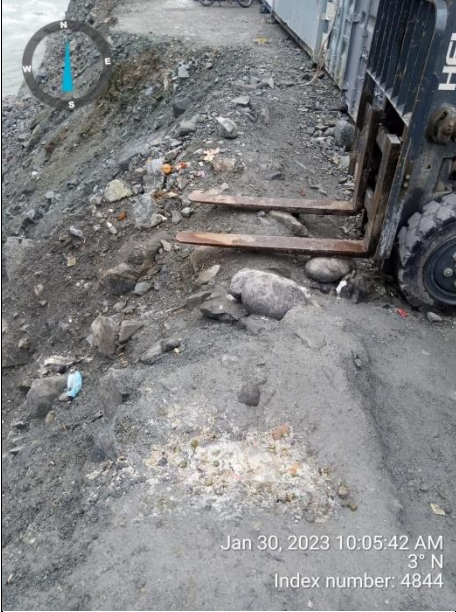
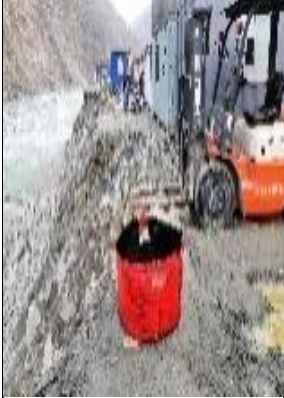
Sr. No	Date and Location of Inspection	EHS observations	Picture	Instructions to the Contractor	Timeline	Action Taken by the Contractor	Completion Date
77.1	30-01-2023 CR-02 workshop slope	Discarded food waste

The contractor is instructed to keep waste bins on side and collect solid waste and dispose of properly according to ECPs.	immediate

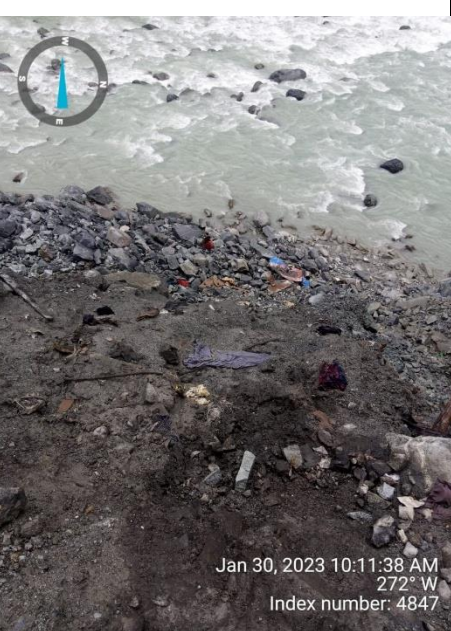
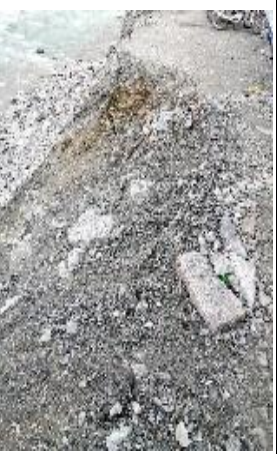
77.2	30-01-2023 CR-02 workshop slope	Oil spill

<p style="text-align: right; font-size: small;">Jan 30, 2023 10:11:38 AM 272° W Index number: 4847</p>	<p>Contactors is instructed to remove the spill replace the spill by fresh soil and sand.</p> <p>After that dispose off the toxicity soil as per ECPs and SOPs.</p>	Immediate

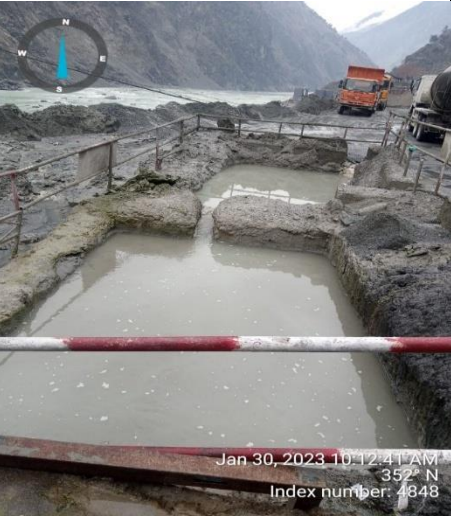
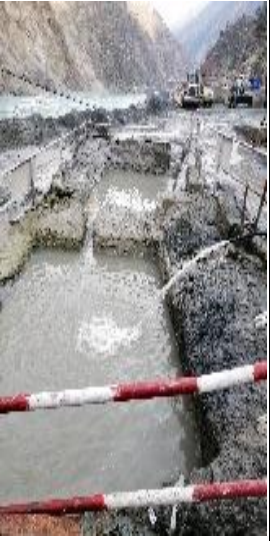
<p>77.4</p>	<p>CR-02 sedimentation pond in front of batching plant.</p>	<p>Untreated water discharge</p>

<p>During routine inspection the addition of fresh water to the sedimentation tank was not witnessed</p> <p>It is instructed to the contactor to make practice of fresh water addition consistence to overcome PH level.</p>	<p>immediate</p>

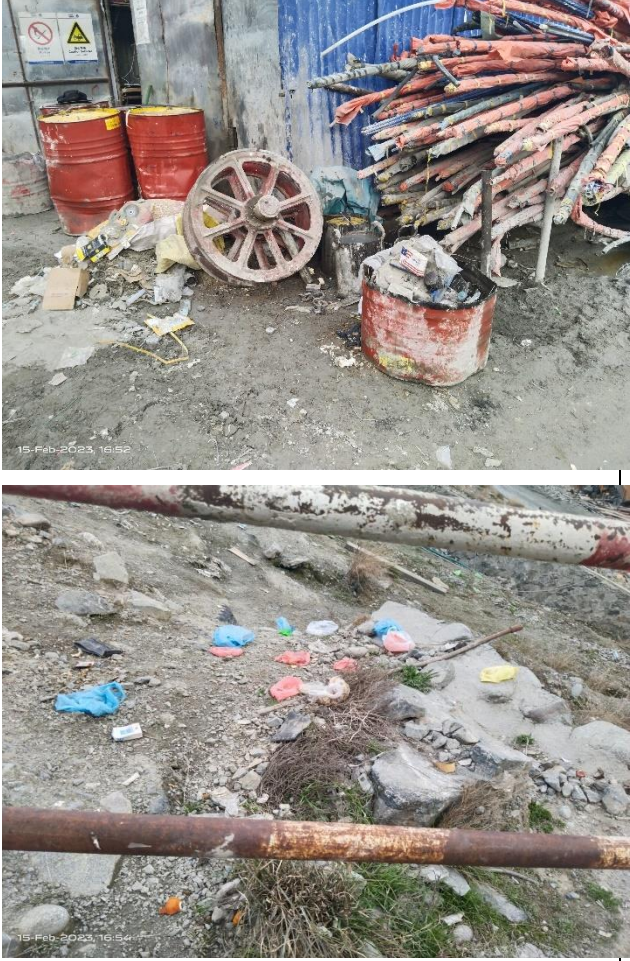
Sr. No	Date and Location of Inspection	EHS observations	Picture	Instructions to the Contractor	Timeline	Action Taken by the Contractor	Completion Date
78.1	15-02-2023 CR-9	Inadequate housekeeping

Contractor is instructed to keep maintain good housekeeping at all sites. Clean and clear all the sites ASAP.	Immediate

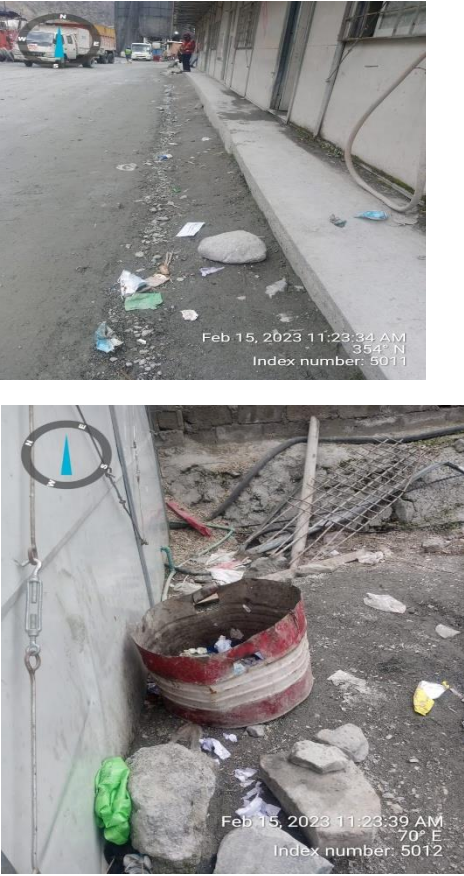
Sr. No	Date and Location of Inspection	EHS observations	Picture	Instructions to the Contractor	Timeline	Action Taken by the Contractor	Completion Date
79.1	15-02-2023 CR-02 office front	Solid waste, littering

<p>The Contactor is instructed to place waste bins at the site.</p> <p>collect the solid waste from different place and put them into the bins at the site</p> <p>After that dump the litter at designated site.</p>	immediate

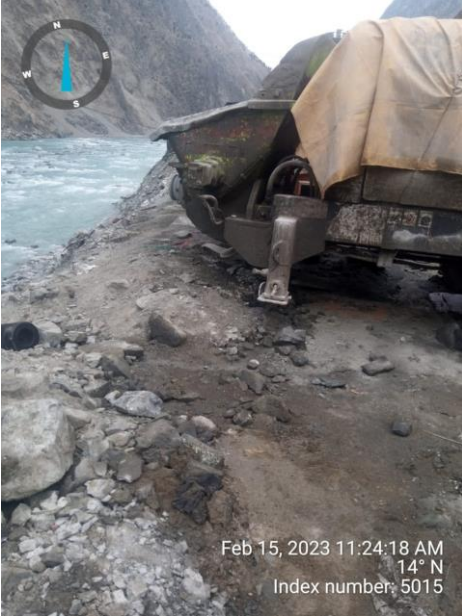
79.2	15-02-2023 CR-02 workshop.	Oil spill

<p>The contractor is instructed to use spill Kit or spill sheet during mechanical work and remove the oil spill from the site by replacing contaminated soil with fresh soil and store contaminated soil in a drum temporary then transport to the designated site.</p>	immediate		
79.3	15-02-2023 CR-02 near audit 1 sedimentation tank	Inadequate housekeeping

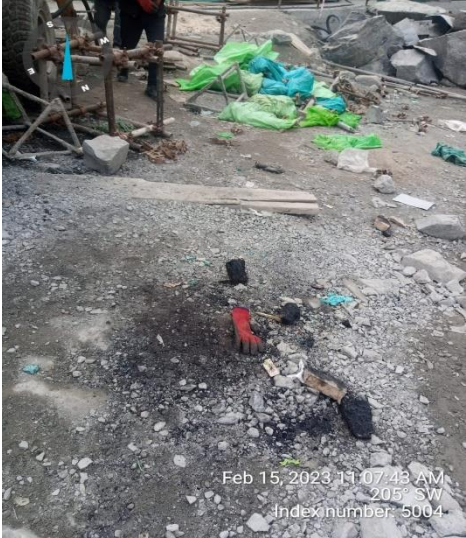
79.4	15-02-2023 CR-02 near audit 1 sedimentation tank	Open burning

The contractor is instructed to arrange awareness session with all work force to avoid open burning of solid waste.	immediate		
79.5	15-02-2023 CR-02 workshop	Improper disposal of waste bin. (Workshop waste)

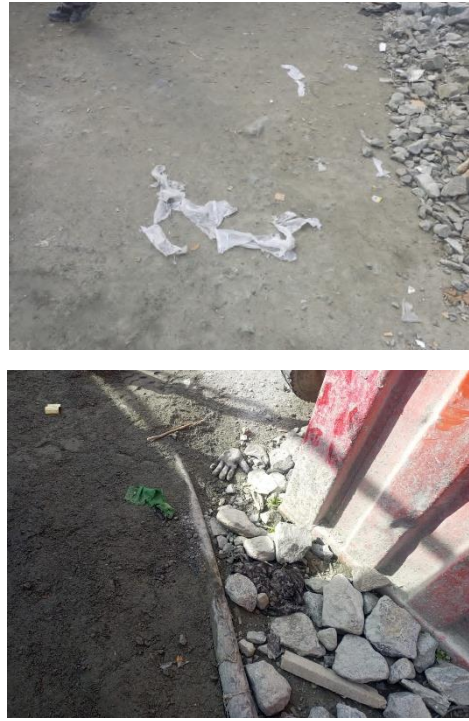
Sr. No	Date and Location of Inspection	EHS observations	Picture	Instructions to the Contractor	Timeline	Action Taken by the Contractor	Completion Date
80.1	16-02-2023 CR-02 HT office and workshop	Solid waste, littering

<p>The Contactor is instructed to place waste bins at the site.</p> <p>collect the solid waste from different place and put them into the bins at the site</p> <p>Impart training to all site specific staff regarding Waste management</p>	Immediate

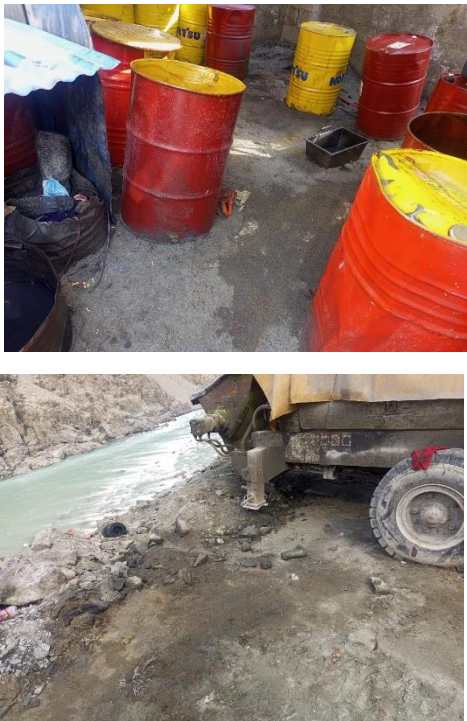
80.2	16-02-2023 CR-02 HT office and batching plant waste oil place	Oil spill

<p>The contractor is instructed to use spill kit or spill sheet during mechanical work. Oil spillage is strictly prohibited as per ECP's and remove the contaminated soil from the site and replacing it with fresh soil and store contaminated soil in a drum temporarily then transport to the designated storage site.</p>	immediate		
80.3	16-02-2023 CR-02 workshop	Inadequate housekeeping

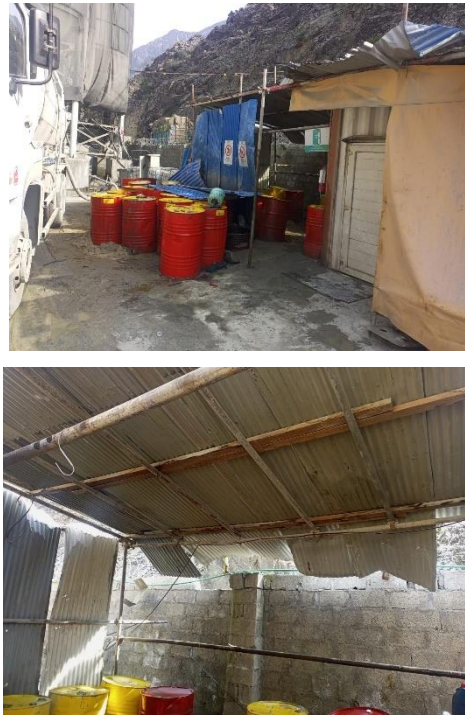
80.4	16-02-2023 batching plant waste oil place	Improper placement of fuel drums. And poor shelter.

The contractor is instructed to provide concrete pavement foundation and put each drum on a drip tray and extend the shelter and protect the drums from weathering.	Immediate		
80.5	16-02-2023 CR-02 toilets	Poor Hygienic Toilets

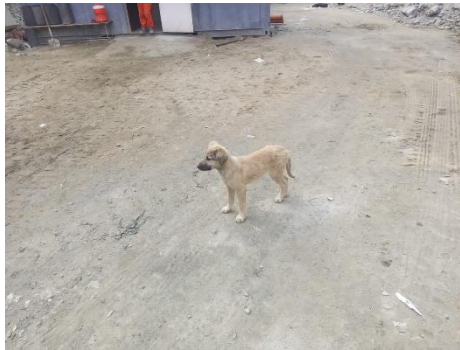
80.6	16-02-2023 CR-02 HT office	Animals

The contractor is instructed to stop the entrance of dogs at construction site. Animals which are PET or wild are not to be roaming on any construction site especially dogs (There is no rabies vaccine found in RHC Dasu nor DHQ Dasu.	immediate		
------	----------------------------------	---------	--	--	------------------	--	--

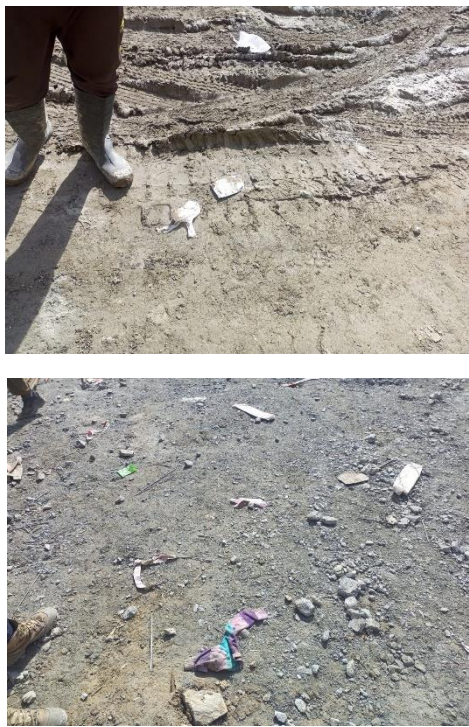
Sr. No	Date and Location of Inspection	EHS observations	Picture	Instructions to the Contractor	Timeline	Action Taken by the Contractor	Completion Date
81.1	17-02-2023 Coffer dam Sigloo near kitchen	Solid waste, littering

<p>The Contactor is instructed to place waste bins at the site.</p> <p>collect the solid waste from different place and put them into the bins at the site</p> <p>Follow SOP's provided in ECP's</p>	immediate

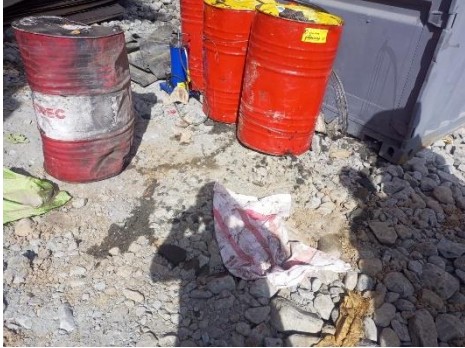
81.2	17-02-2023 Coffer dam Sigloo near workshop	Oil spill

<p>The contractor is instructed to use spill kit or spill sheet during mechanical work, storage of oil Drums and remove the contaminated sand/soil from the site by replacing the contaminated soil with fresh soil and store contaminated soil in a drum temporary then transport to the designated site.</p>	Immediate		
81.3	17-02-2023 Coffer dam Sigloo near workshop	Inadequate housekeeping

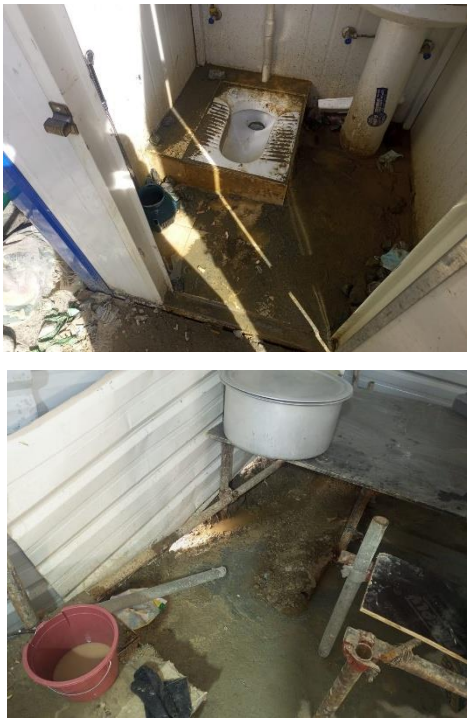
81.4	17-02-2023 Coffer dam Sigloo site toilets and kitchen	Poor hygienic toilets and kitchen

<p>The contractor is instructed to clean toilets on daily basis and paste a daily cleaning checklist on toilets and increase number of toilets. Ensure availability of water all the time at these toilets.</p> <p>Also ensure cleanliness in kitchen at every time as soon as possible.</p> <p>The grey water from Toilets must not enter the Indus River.</p>	immediate		
------	---	---	--	---	-----------	--	--

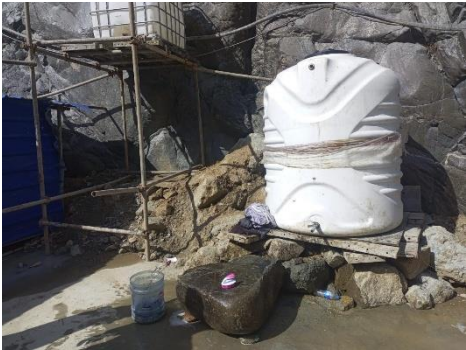
81.5	17-02-2023 Coffer dam Sigloo site labor camp	No drinking facility	clean water

The contractor is instructed to conduct water test on emergency basis and install a water filter near temporary camp at Coffer Dam Site and ensure provision of safe drinking water for workers on this site as per contractual provisions.	immediate		
------	---	-------------------------	----------------	---	---	------------------	--	--

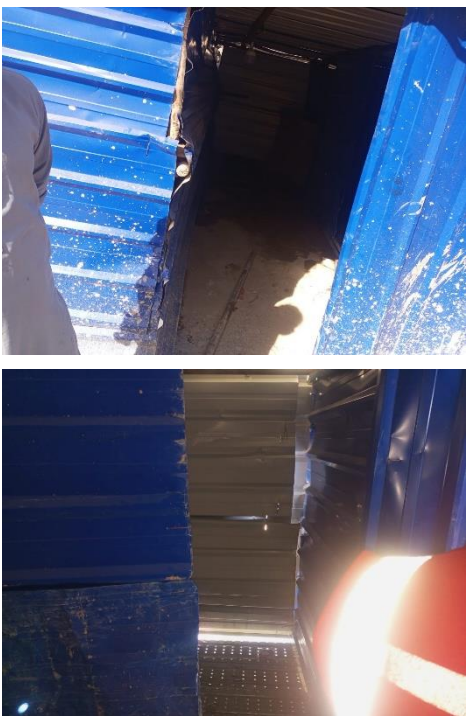
81.7	17-02-2023 Coffer dam Sigloo site labor camp	No hot water and no supply in washrooms

The contractor is instructed to provide hot water in washrooms and provide proper water supply on 24 hrs basis in each washroom as well.	immediate		
------	---	---	--	--	------------------	--	--

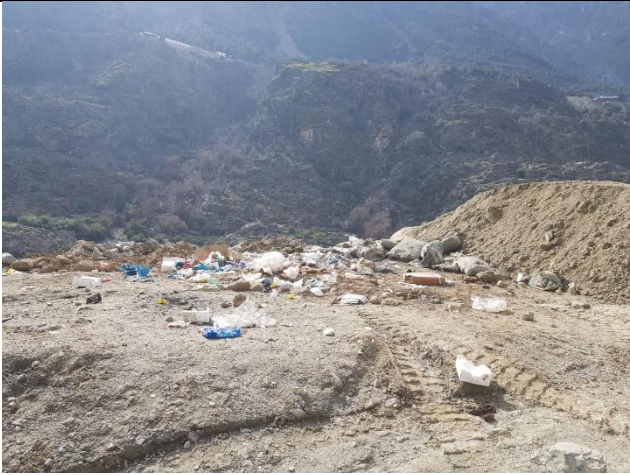
Sr. No	Date and Location of Inspection	EHS observations	Picture	Instructions to the Contractor	Timeline	Action Taken by the Contractor	Completion Date
82.1	18-02-2023 CT-2	Waste near CT-2

Contractor is instructed to keep the site clear and ensure Zero waste on site policy. It is further instructed that that waste bins should be installed at this site and all staff members of CGGC either Labor or Staff should be apprised these things in the induction training as well as refresher trainings.	Immediate		
82.2	18-02-2023 CR-02	Oil spill near Adit A

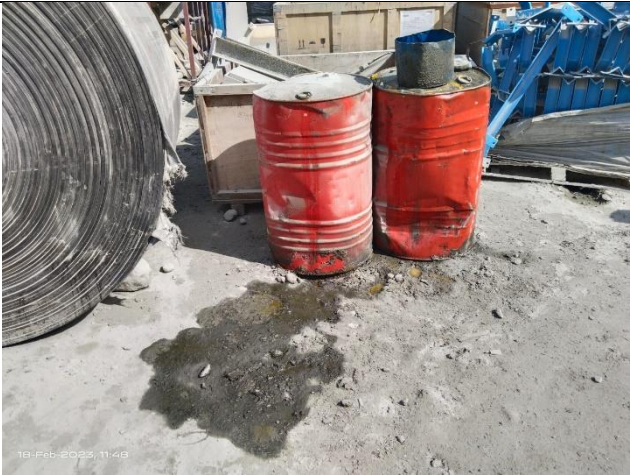
82.3	18-02-2023 Thoki Crushing Plant	Oil Spill

Contractor is Instructed to remove contaminated soil with replace the contaminated soil with clean and fresh Soil as per SOPs provided in ECPs.	Immediate

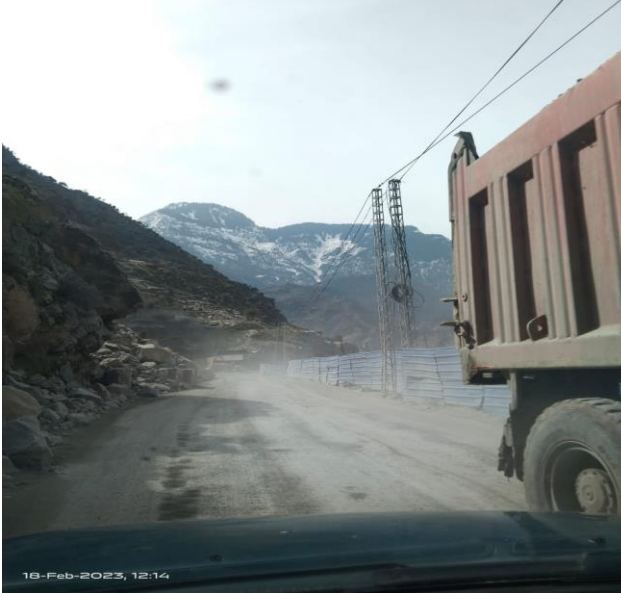
82.5	18-02-2023 Adit Tunnel A	Waste at Slope	 	Contractor is instructed to keep the slopes clean from the waste and clear the site with immediate effect. Also impart training/ awareness session for all staff of this site regarding littering and waste management clauses. If the staff is not complying impose fines on them to ensure smooth environmental compliance.	Immediate		
82.6	18-02-2023 Near Traffic diversion Tunnel along KKH	Dust

Contractor is instructed to keep to ensure water sprinkling on daily basis at least thrice a day.	Immediate

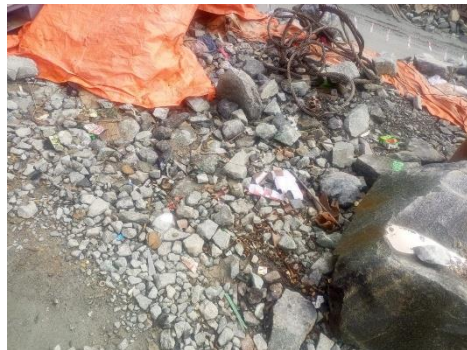
Sr. No	Date and Location of Inspection	EHS observations	Picture	Instructions to the Contractor	Timeline	Action Taken by the Contractor	Completion Date
83.1	03-03-2023 CR2 HT office	Solid waste, littering

<p>The Contactor is instructed to place waste bins at the site.</p> <p>collect the solid waste from different place and put them into the bins at the site</p> <p>After that dump the litter at designated site.</p>	immediate

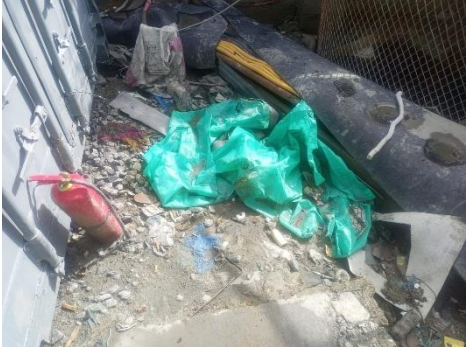
83.2	03-03-2023 uchar old crushing plant	Inadequate housekeeping

The contractor is instructed ensure good housekeeping at site.	immediate		
83.3	03-03-2023 uchar old crushing plant	Improper placement of fuel drums

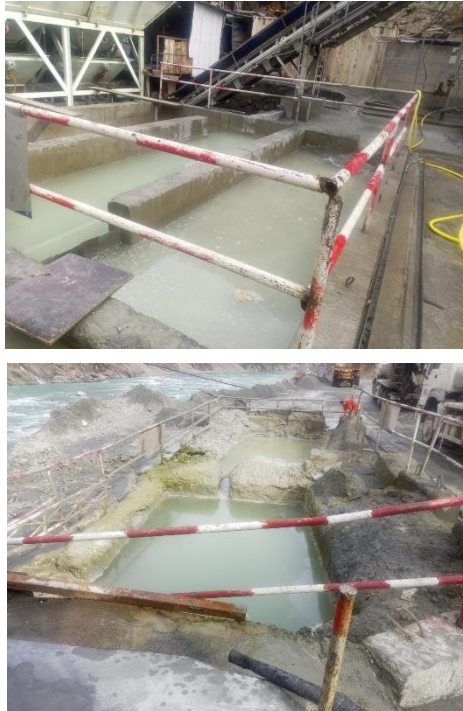
83.4	03-03-2023 batching plant CR2	Untreated water

<p>The contractor is instructed to remove sludge from the pound and install a permanent fresh water pipe that should be fix with one location and ensure addition of fresh water for all time as soon as possible.</p>	immediate		
------	-------------------------------------	--------------------	--	--	------------------	--	--

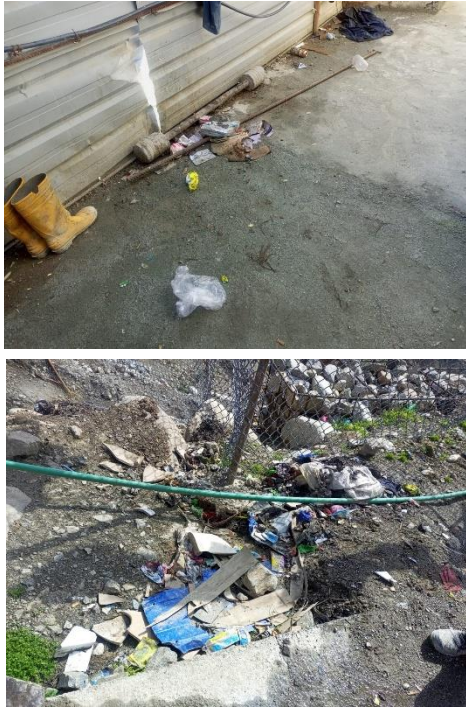
Sr. No	Date and Location of Inspection	EHS observations	Picture	Instructions to the Contractor	Timeline	Action Taken by the Contractor	Completion Date
84.1	04-03-2023 CT2 + switchyard labor camp	Solid waste, littering

<p>The Contactor is instructed to place waste bins at the site.</p> <p>collect the solid waste from different place and put them into the bins at the site</p> <p>After that dump the litter at designated site.</p>	immediate

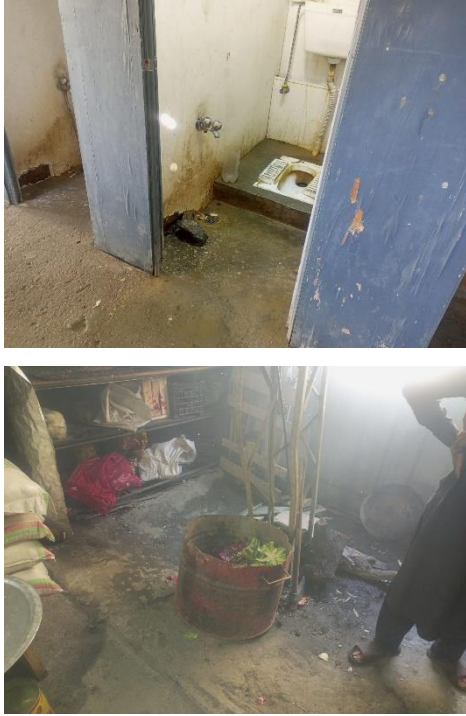
The contractor is instructed to use spill Kit or spill sheet during mechanical work and remove the oil spill from the site by replacing contaminated soil with fresh soil and store contaminated soil in a drum temporary then transport to the designated site.	immediate		
84.3	04-03-2023 CT2 + switchyard labor camp	Poor hygienic toilets and kitchen

The contractor is instructed to clean toilets on daily basis and paste a daily cleaning checklist on toilets and increase toilets. And also make ensure cleanliness in kitchen at every time as soon as possible.	immediate

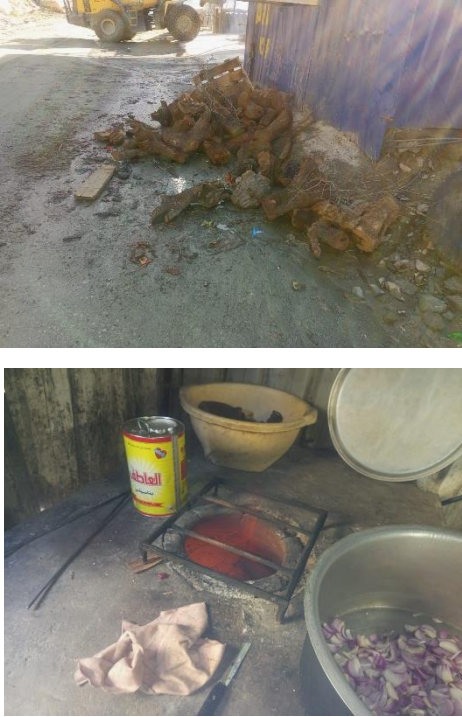
84.4	04-03-2023 CT2 switchyard labor camp +	Fuel woods

The contractor is instructed to provide LPG stove and oven for workers as soon as possible.	immediate		
84.5	04-03-2023 switchyard labor camp	Poor sewerage system

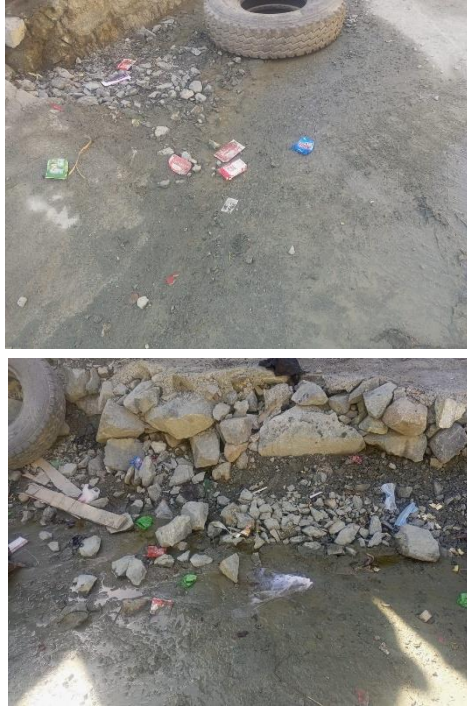
Sr. No	Date and Location of Inspection	EHS observations	Picture	Instructions to the Contractor	Timeline	Action Taken by the Contractor	Completion Date
85.1	11-03-2023 CT2 near kitchen	Solid waste, littering

<p>The Contactor is instructed to place waste bins at the site.</p> <p>collect the solid waste from different place and put them into the bins at the site</p> <p>After that dump the litter at designated site.</p>	immediate
