Dasu Hydropower Project

Subject: Dasu HPP –33rd ENVIRONMENTAL PROGRESS REPORT FOR THE PERIOD FROM JANUARY TO MARCH 2023

Environmental Quarterly Progress Report

Report Number: 33

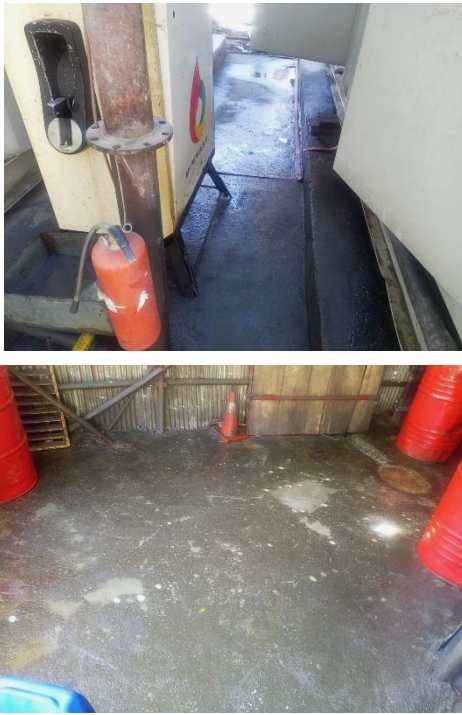
85.2	11-03-2023 CR9 generator room and CR9 work shop	Oil spill

<p>The contractor is instructed to use spill kit or spill sheet during mechanical work and remove the oil spill from the site by replacing contaminated soil with fresh soil and store contaminated soil in a drum temporary then transport to the designated site.</p>	immediate		
------	--	-----------	--	---	------------------	--	--

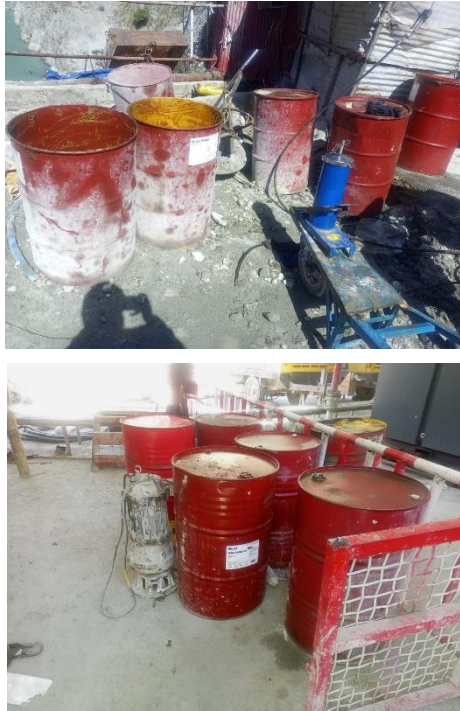
85.6	11-03-2023 CT-2 and CR9 Grease place	Improper placement of fuel drums.

The contractor is instructed to develop concrete banded palace for fuel storage place approximately lined should be 6 inches height as soon as possible	immediate		
85.7	11-03-2023 CR9 sedimentation pond	Sedimentation pond full with sludge

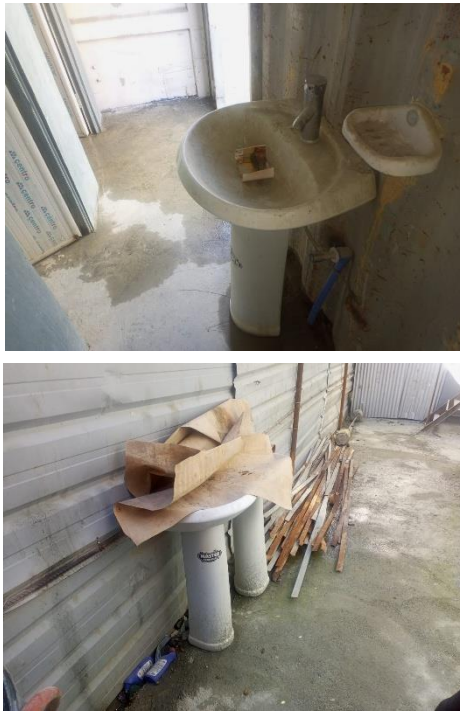
85.8	11-03-2023 CT-2 toilets	Poor sanitation facility

The contractor is instructed to make functional hand washing basin and keep clean at every time.	immediate		
85.9	11-03-2023 CT2 sedimentation pond	Extra pipe

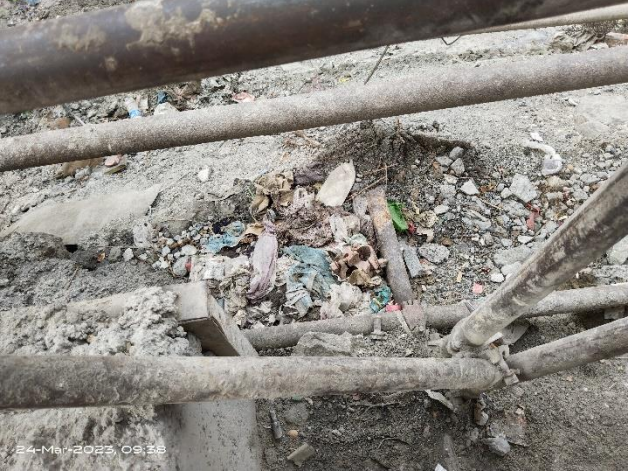
Sr. No	Date and Location of Inspection	EHS observations	Picture	Instructions to the Contractor	Timeline	Action Taken by the Contractor	Completion Date
86.1	24-03-2023 CR-9 Workshop	Solid Waste

It is instructed to the contractor to keep the site clear from solid waste .	Immediate

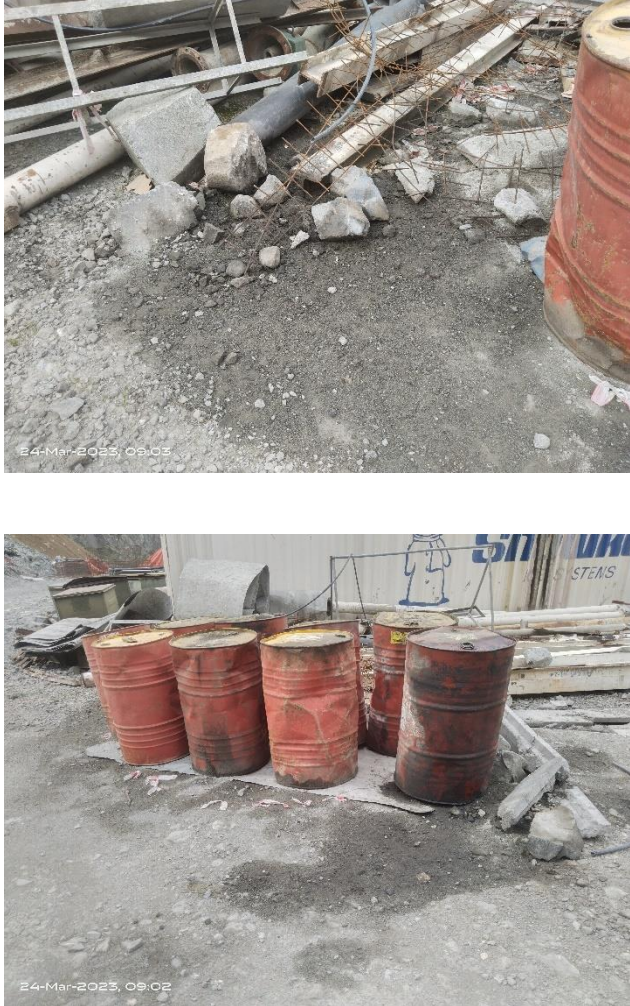
<p>86. 2</p>	<p>24-03-2023 CR-09 Batching Plant</p>	<p>Oil spill</p>

<p>The contractor is Instructed to remove contaminated soil and replace it with clean and fresh Soil as per SOPs provided in ECPs. Treat this issue as urgent and report to the Engineer's office.</p>	<p>Immediate</p>		
------------------	--	------------------	---	--	-------------------------	--	--

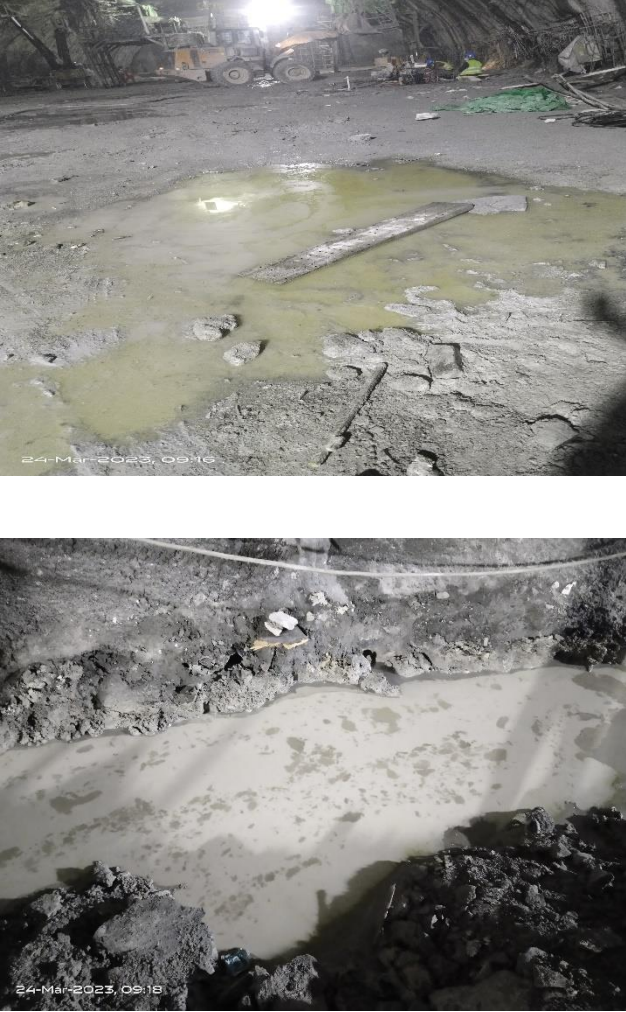
86. 3	24-03-2023 Power house	Oil Spill

<p>The top photograph shows a spill of yellowish-green liquid on a concrete floor. A yellow loader is visible in the background. The bottom photograph shows a spill of a similar liquid in a trench or excavation area, surrounded by dark soil.</p>	The contractor is Instructed to remove contaminated soil with clean and fresh Soil as per SOPs provided in ECPs submit incident report.	Immediate		
----------	---------------------------	-----------	---	---	------------------	--	--

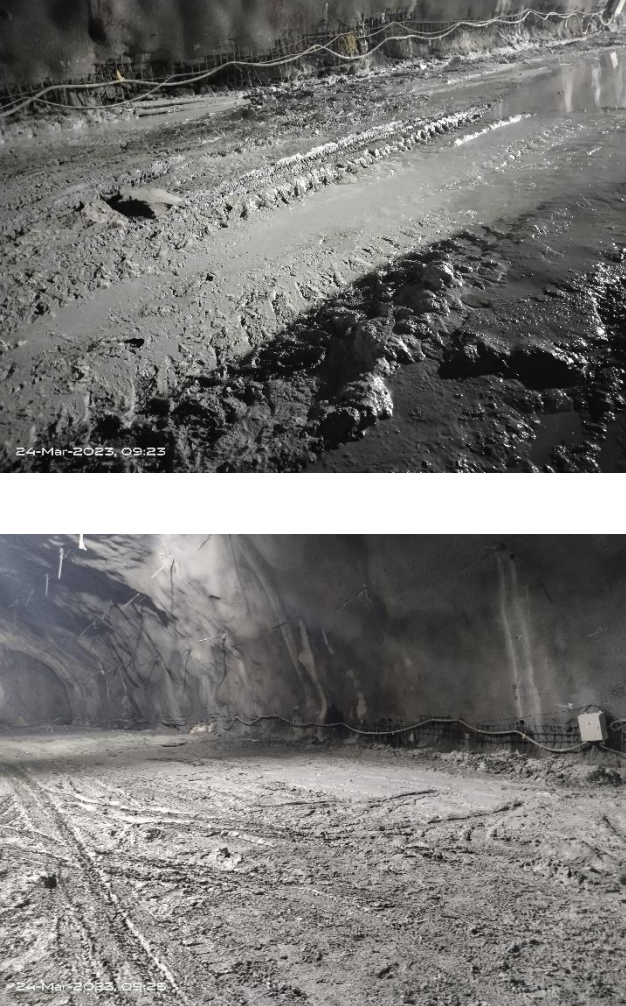
<p>86. 5</p>	<p>24-03-2023 Powerhouse and Sedimentation Pond CR-09</p>	<p>Sludge created in the Powerhouse.s</p>

<p>The contractor is instructed to remove the sludge from Powerhouse and from Outside the Sedimentation pond and dump into designated spoil disposal site.</p>	<p>Immediate</p>		
------------------	---	---	---	--	-------------------------	--	--

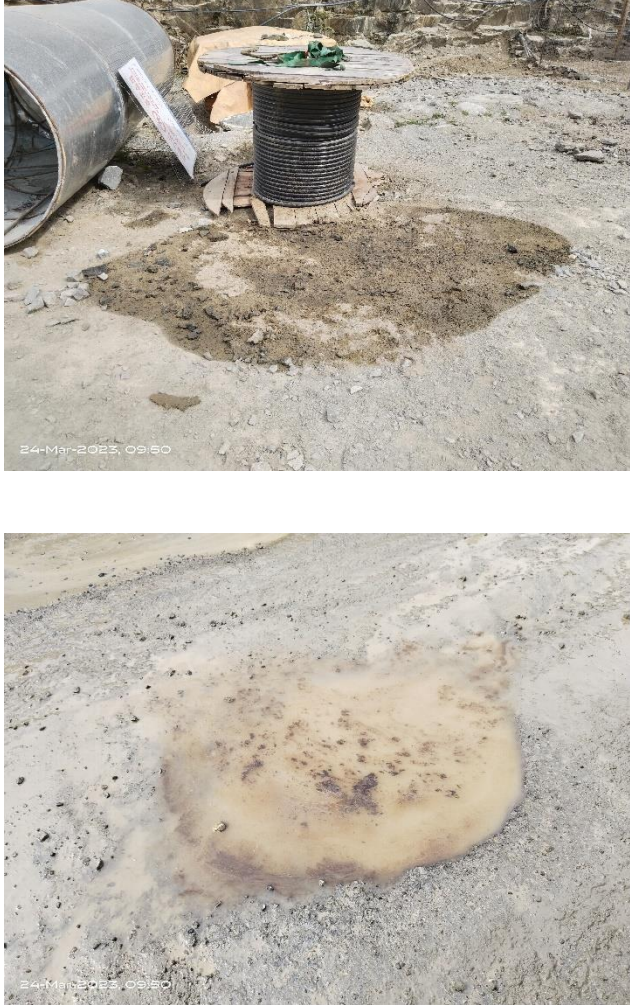
<p>86. 6</p>	<p>24-03-2023 CT-2</p>	<p>Oil Spill</p>

<p>The contractor is Instructed to remove contaminated soil with clean and fresh Soil as per SOPs provided in ECPs.</p>	<p>Immediate</p>		
------------------	----------------------------	------------------	---	---	-------------------------	--	--

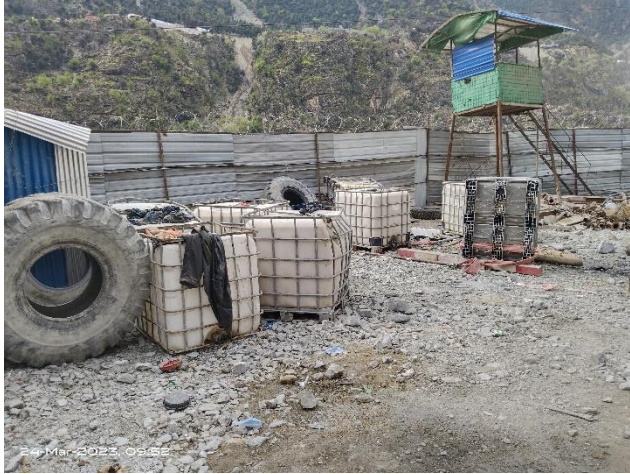
<p>86. 8</p>	<p>24-03-2023 CT-2</p>	<p>Improper Placement Chemical Tanks</p>

<p>It is instructed to the contractor to construct concrete platform under the chemical tanks and placed all the tanks on the platform with protection bund.</p>	<p>Immediate</p>		
------------------	----------------------------	--	--	--	-------------------------	--	--

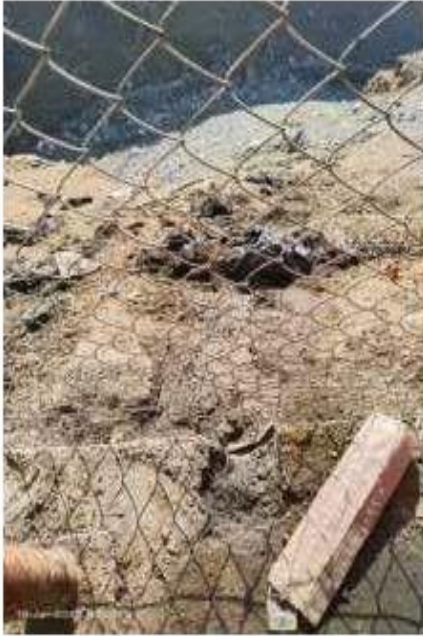
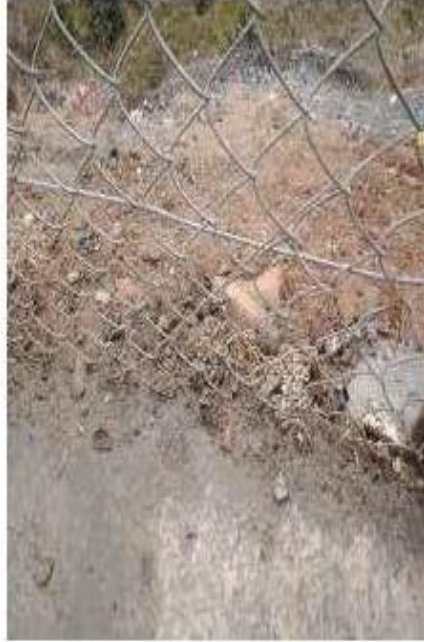
Sr. No	Date and Location of Inspection	EHS observations	Picture	Instructions to the Contractor	Timeline	Action Taken by the Contractor	Completion Date
40.1	19-01-2023 K4 Tunnel Portal	Fuel/ Oil Spills Spillage at slope

Contractor is instructed to replace the soil with clean and fresh soil immediate basis. And use spill kits for oil spill on the site. Dispose off the contaminated soil in a drum. Dispose of the contaminated soil as per SOPs provided in ECP	Immediate

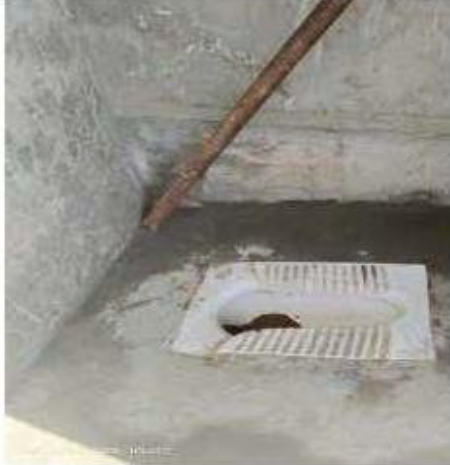
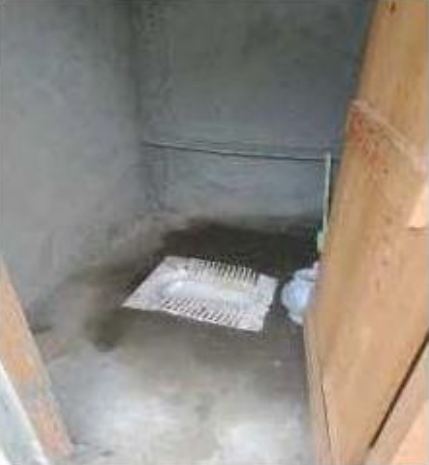
27-01-2023
40.4	19-01-2023 K4 Tunnel Camp	Untidy Washrooms

The Contractor is instructed to clean the washrooms and arrange water for flushing otherwise this will be of no use at all. A bucket and a mug or Muslim shower should be arranged ASAP.	Immediate

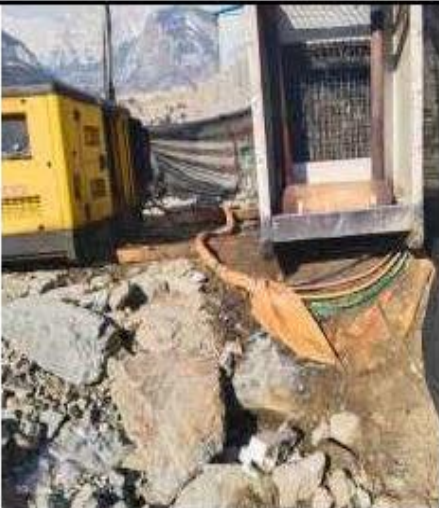
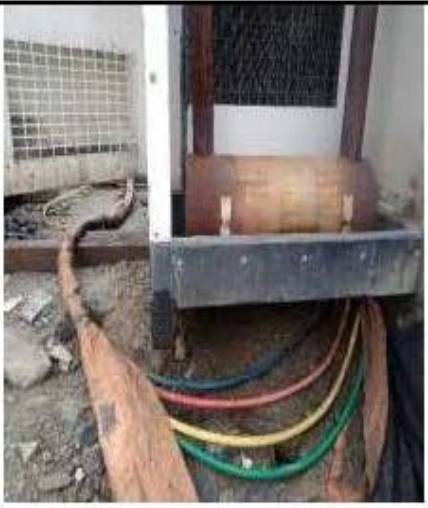
27-01-2023
40.5	19-01-2023 K4 Camp	Oil spill

This issue has so many times been instructed but either there is no capability or well to implement the protocol. The Contractor is instructed to clean the area as per the protocol and report.	Immediate

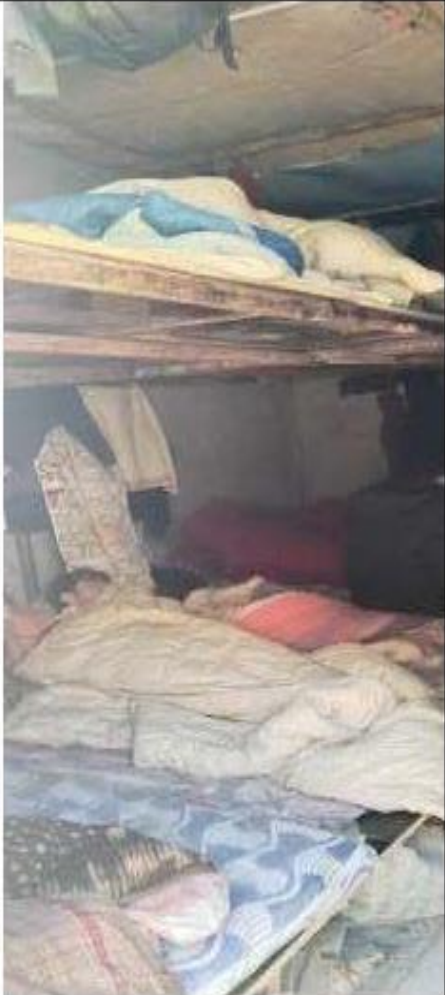
Sr. No	Date and Location of Inspection	EHS observations	Picture	Instructions to the Contractor	Timeline	Action Taken by the Contractor	Completion Date
40.6	19-01-2023 K9 camp	Overcrowded accommodation

<p>Contractor accommodate more than 10 Workers at each room.</p> <p>Contractor is instructed refer to IFC guidelines.</p> <p>Density standards are expressed either in terms of minimal volume per resident or of minimal floor space. Usual standards range from 10 to 12.5 cubic meters (volume) or 4 to 5.5 square meters (surface).</p> <p>If the above condition is met then 2 to 8 persons per room can be accommodated.</p> <p>The Contractor is instructed to increase the rooms and facilitate their workers for good productivity.</p>	Immediate	Accommodation over crowded issue has been communicated with higher management and waiting for their response to build more rooms	27-01-2023

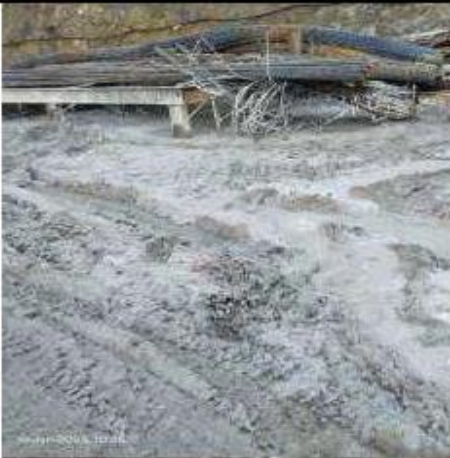
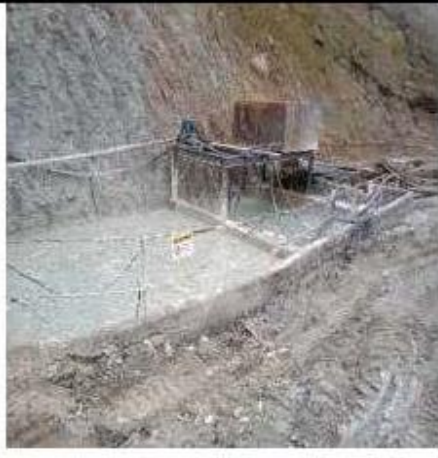
Sr. No	Date and Location of Inspection	EHS observations	Picture	Instructions to the Contractor	Timeline	Action Taken by the Contractor	Completion Date
40.7	19-01-2023 K9	Improper Sludge disposal

The Contractor is instructed to submit the disposal plan of the improperly designed sedimentation tank. Spreading sludge this is unacceptable. It should be hauled to the designated site only.	Immediate

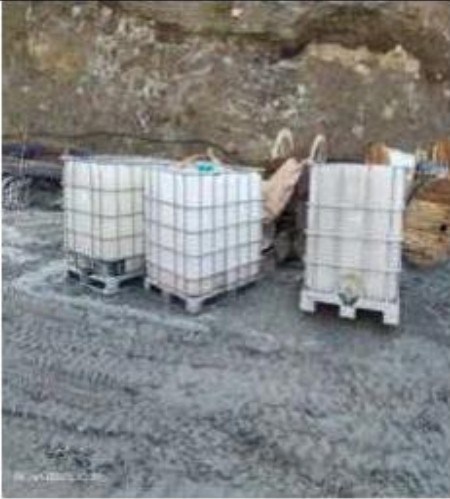
27-01-2023
40.8	19-01-2023 K9	Empty Chemical tanks

The Contractor is instructed to remove the empty chemical drums and send it to the vendor for reuse/refill/recycling.	immediate	Contractor is keeping empty chemical (sigunit) drums for temporarily. They are removing drums following their schedule

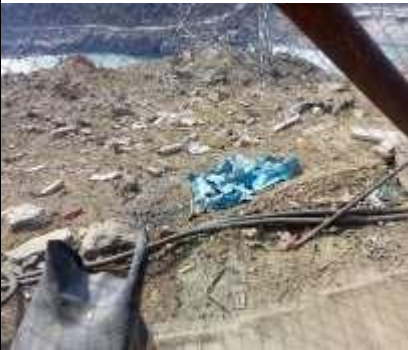
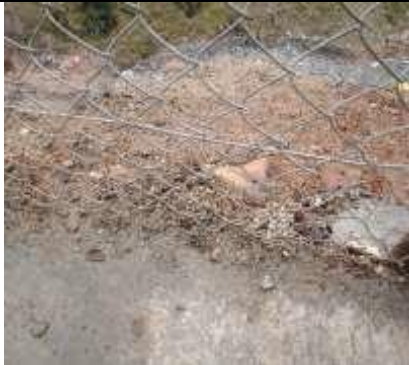
Sr. No	Date and Location of Inspection	Environment observations	Picture	Instructions to the Contractor	Timeline	Action Taken by the Contractor	Completion Date
41.1	21-01-2023 K-04 Tunnel steel plant slope + office slope	Littering

The Contactor is instructed to place waste bins at the site. collect the solid waste from different place and put them into the bins at the site Furthermore, It is also reminded that training to all staff should be done on regular basis like every fortnightly on waste management.	immediate

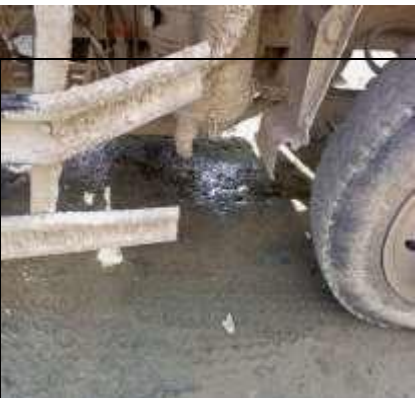
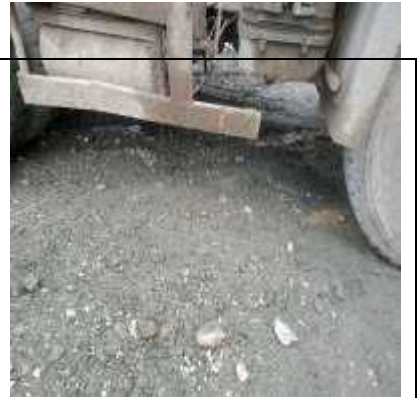
41.2	21-01-2023 K-04 Tunnel workshop	Oil spill

<p>The contractor is instructed to remove oil spill from site by replacing contaminated soil with fresh soil and store contaminated soil in a drum temporarily at a storage space with a impermeable base and a boundary wall/fence.</p>	Immediate

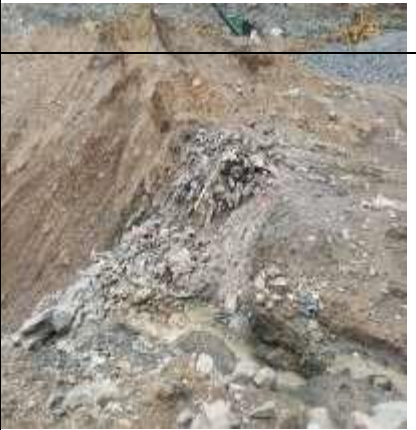
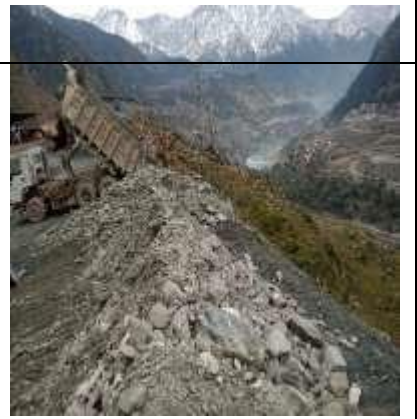
25-1-2023
41.3	21-01-2023 water filling station	Improper disposal of solid waste.

<p>The contractor is instructed to clean the slope and dispose off solid waste at designated dumping site which is approved by "The Engineer". Also impart training to all site staff and start imposing fines if the staff is</p>	Reminder

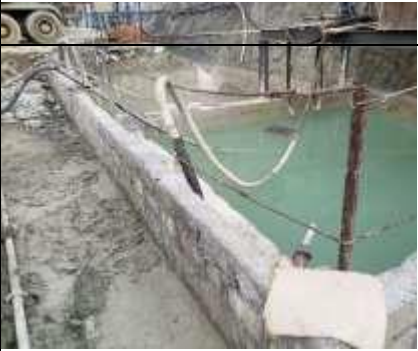
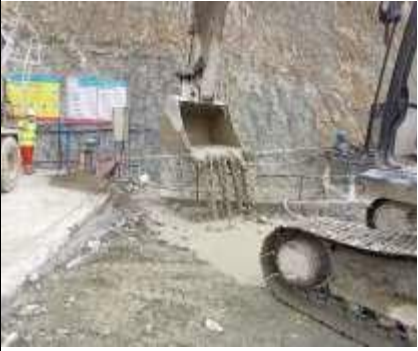
41.4	21-01-2023 K-09 sedimentati on pound	Improper disposal of sludge and no signage

<p>committing non-compliance.</p> <p>The contractor is instructed to add fresh water and install sediment traps before the sedimentation pond and install appropriate signage.</p> <p>Ensure disposal of waste water in a form which is compliant to NEQS and the sludge from the sedimentation pond at designated dumping site.</p>	Immediate

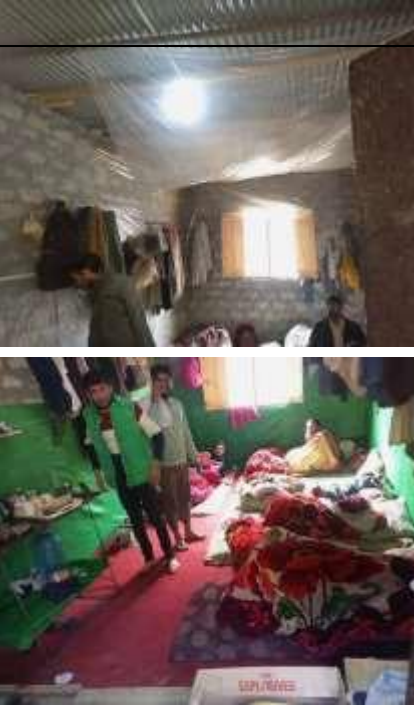
41.5	21-01-2023 K-09 labor camp + K4 labor camp	Sub-standard accommodation

<p>There are 16 rooms and more than 100 workers are at k4 and at k9 182 workers and 20 rooms each room contain 7,8 and 10 workers. The rooms are in capable of providing shelter from water during raining season and room is not having a proper roof. The contractor is instructed to provide proper bedding for each worker i.e., 1 bed for a single labor/staff and a closets in side every room. The rooms should have a proper roof rather than putting CGI sheets which do not stop rain water even.</p>	immediate	Accommodation over crowded issue has been communicated with senior management, we are waiting for their response to construct more new rooms	25-01-2023
------	---	----------------------------	--	---	------------------	--	------------

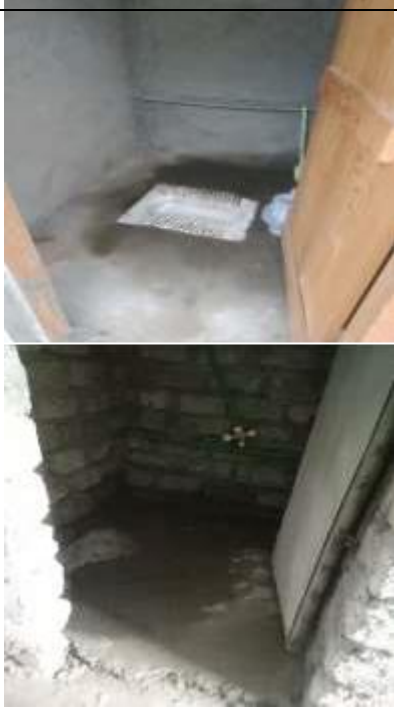
41.8	21-01-2023 K-09 labor camp + K4 labor camp	Poor Sanitation Facilities	 	<p>The contractor is instructed to ensure following instructions (as per ILO Standards): Adequate sanitary facilities should include a minimum of one toilet, one wash basin and one tub or shower for every six persons. They should be provided at a convenient location which prevents nuisances. Sanitary facilities provided should meet minimum standards of health and hygiene. They should also provide reasonable standards of comfort,</p>	immediate

<p>including hot and cold fresh running water. There should be separate sanitary facilities provided for men and for women. Sanitary facilities should have ventilation to the open air, independently of any other part of the accommodation. Soap and hygienic paper should be adequately stocked.</p>			
--	--	--	--	--	--	--	--

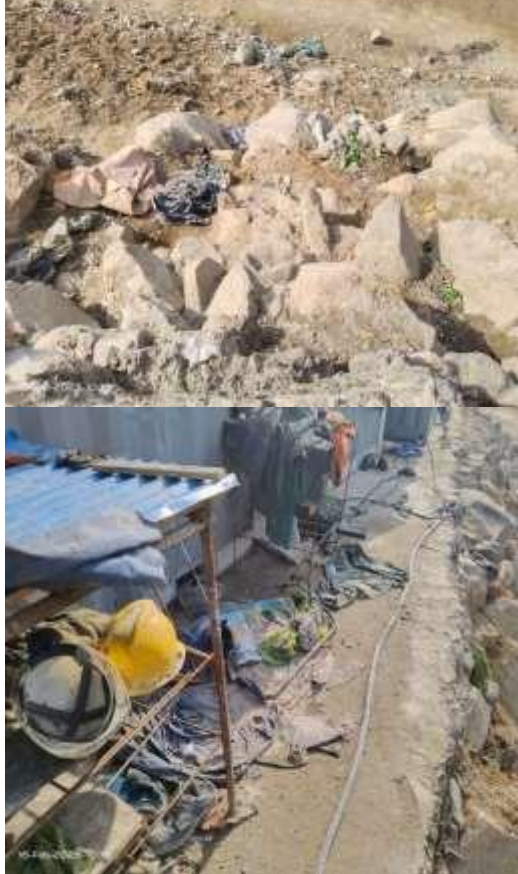
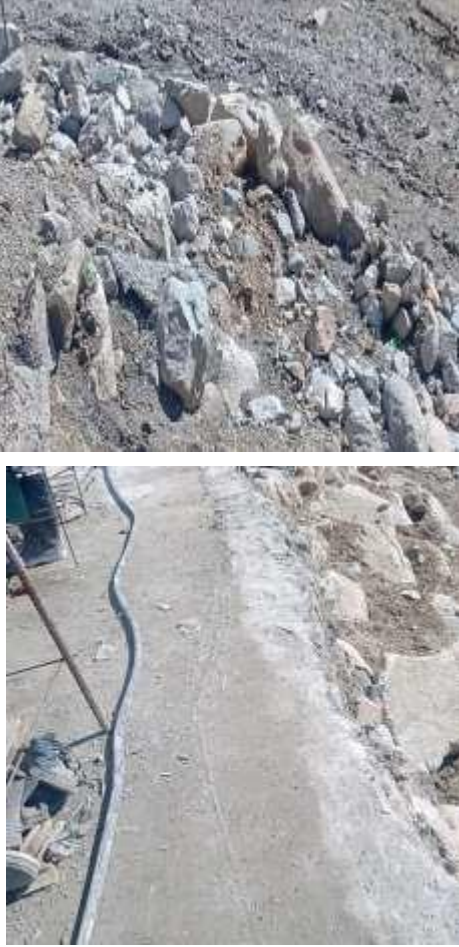
Sr. No	Date and Location of Inspection	EHS observations	Picture	Instructions to the Contractor	Timeline	Action Taken by the Contractor	Completion Date
42.2	16-02-2023 K9 Tunnel Portal	Waste at slope

Contractor is Instructed to keep the site clean and provide the proper waste bins at all sites. Also impart training for waste management to all site staff.	Immediate

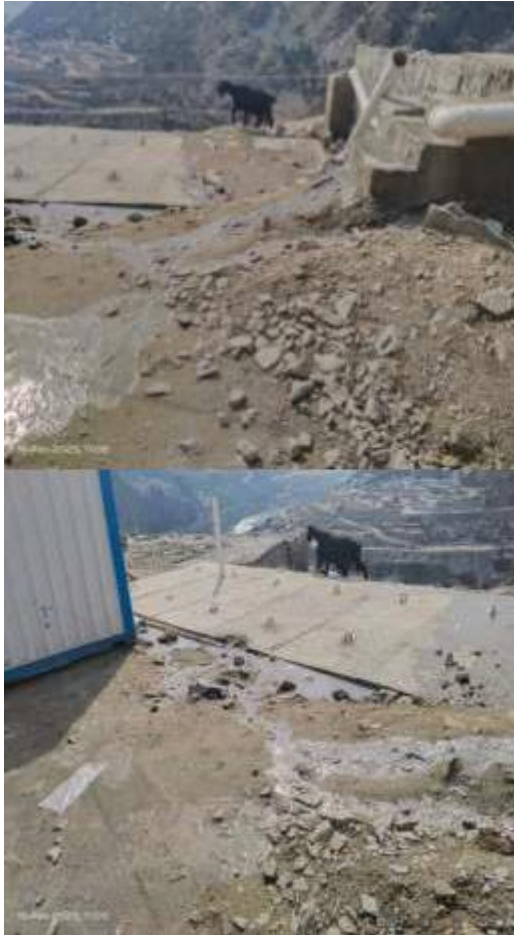
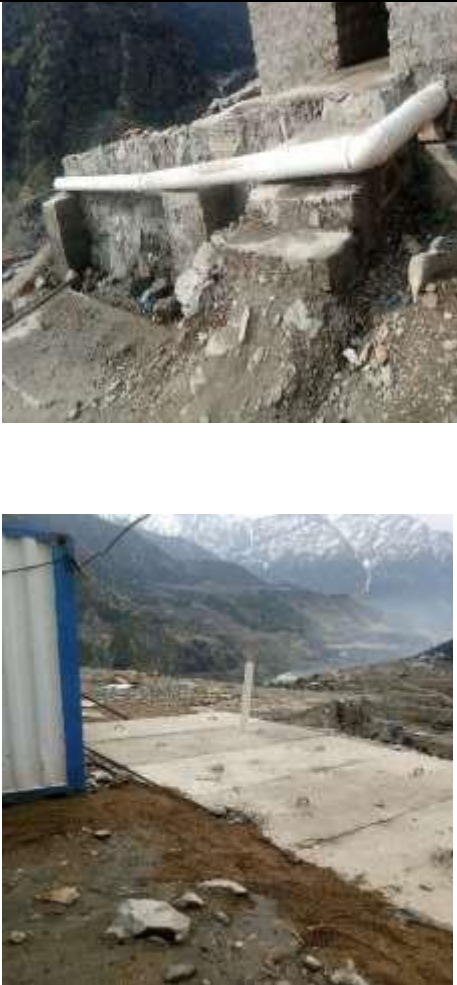
Sr. No	Date and Location of Inspection	EHS observations	Picture	Instructions to the Contractor	Timeline	Action Taken by the Contractor	Completion Date
42.3	16-02-2023 K4 Camp	Improper drainage

Contractor is instructed to keep proper drainage system at construction site and Camp immediately. Follow ECP's and EMP for addressing Water Supply and Drainage issues.

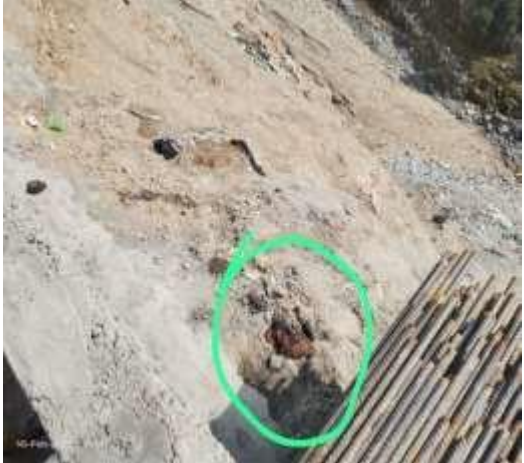
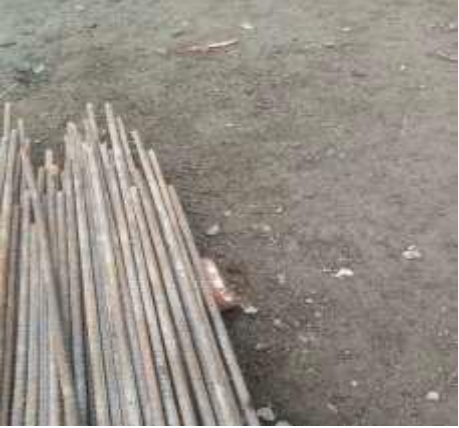
Sr. No	Date and Location of Inspection	EHS observations	Picture	Instructions to the Contractor	Timeline	Action Taken by the Contractor	Completion Date
42.4	16-02-2023 K4 Tunnel	Open defecation

Contractor is Instructed to construct / place portable Toilets at/ near Tunnel portal immediate.	Immediate

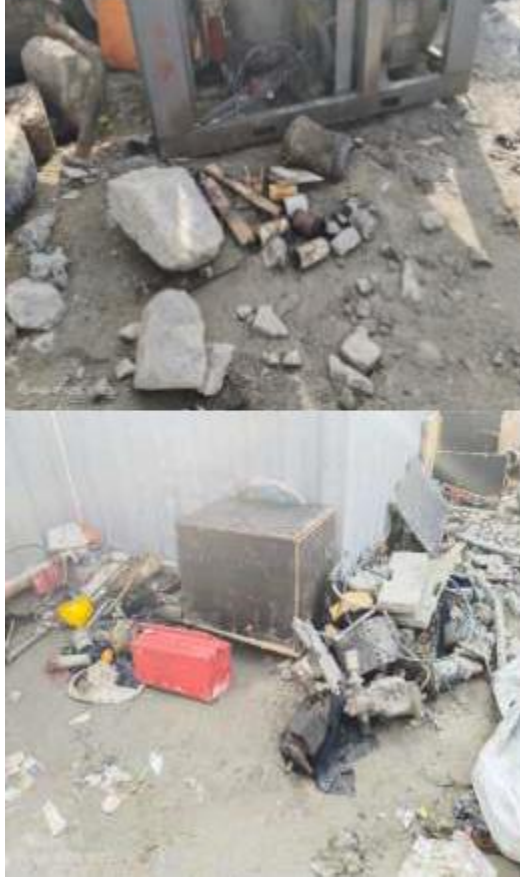
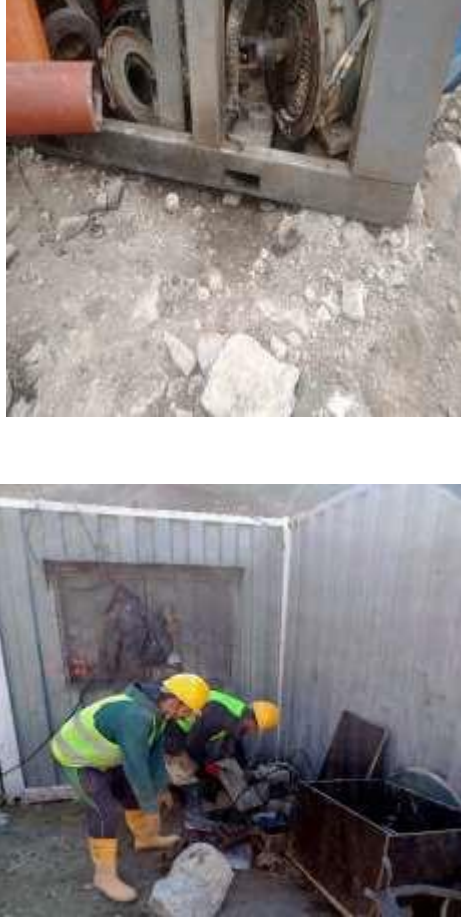
Sr. No	Date and Location of Inspection	EHS observations	Picture	Instructions to the Contractor	Timeline	Action Taken by the Contractor	Completion Date
42.6	16-02-2023 K9	Spare parts

<p>The top photograph shows a pile of rocks and debris on a dirt surface next to a metal structure. The bottom photograph shows a cluttered indoor or semi-enclosed area with various tools, a red toolbox, and other debris scattered on the ground.</p>	Contractor is instructed to remove the spare parts from site and arrange proper area for parts.

<p>The top photograph shows a close-up of a worker in a yellow safety vest and orange boots cleaning up debris. The bottom photograph shows two workers in safety gear (yellow and green vests, yellow hard hats) working together to clear a cluttered area inside a structure.</p>	20-02-023

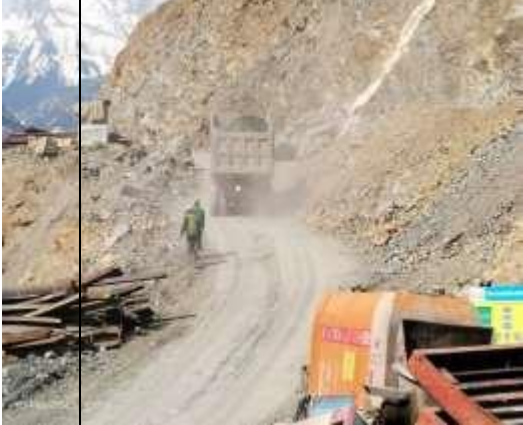
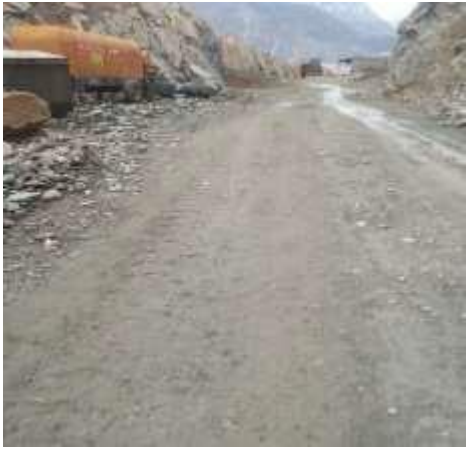
Sr. No	Date and Location of Inspection	EHS observations	Picture	Instructions to the Contractor	Timeline	Action Taken by the Contractor	Completion Date
42.9	16-02-2023 K4	Dust

Instructed the contractor to ensure the water sprinkling each site on dust.

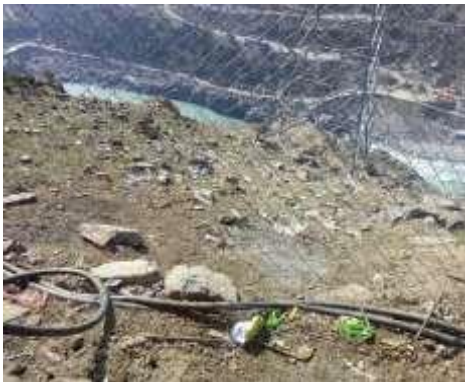
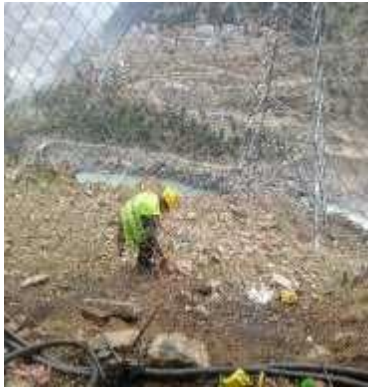
Sr. No	Date and Location of Inspection	EHS observations	Picture	Instructions to the Contractor	Timeline	Action Taken by the Contractor	Completion Date
43.1	18-02-2023 K-04 tunnel steel plant slope + office slope	Littering

The Contactor is instructed to place waste bins at the site. collect the solid waste from different place and put them into the bins at the site Follow SOP's provided in ECP's.	immediate

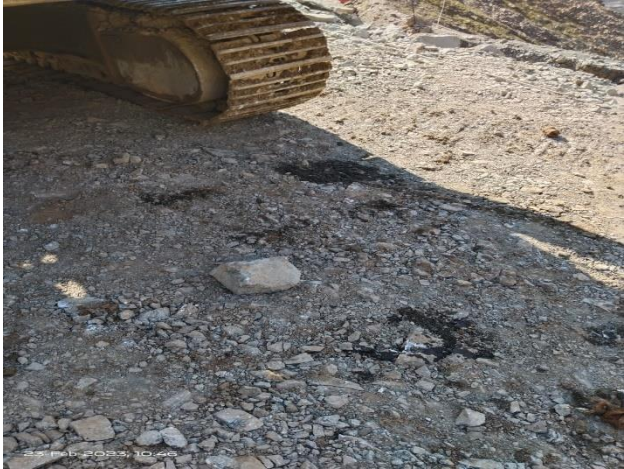
Sr. No	Date and Location of Inspection	EHS observations	Picture	Instructions to the Contractor	Timeline	Action Taken by the Contractor	Completion Date
44.1	23 -02-2023 Kaigah Tunnel	Fuel/ Oil Spills

Contractor is instructed to replace the soil with clean and fresh soil immediate basis. And use spill kits for oil spill on the site. Dispose of the toxicities Soil in a drum. Dispose of the contaminated soil as per SOPs provided in ECP	Immediate

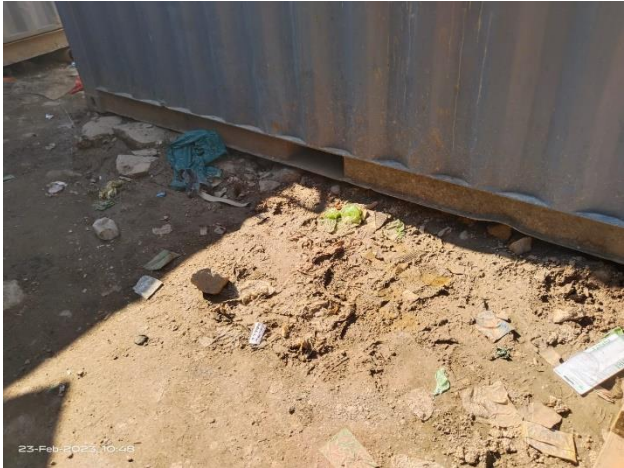
44. 2	23-02-2023 Kaigah Tunnel Portal	Waste, Littering	 	Instructed the contractor to keep clean the site and provide the proper waste bins at all sites.	Immediate

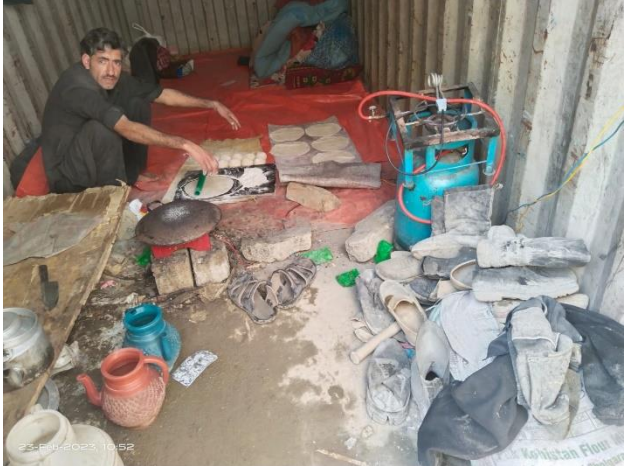
44. 4	23-02-2023 Kaigah Tunnel Portal	Unhygienic Kitchen as well living room

Contractor is instructed to construct a Separate kitchen and maintain clean and hygienic	ASAP

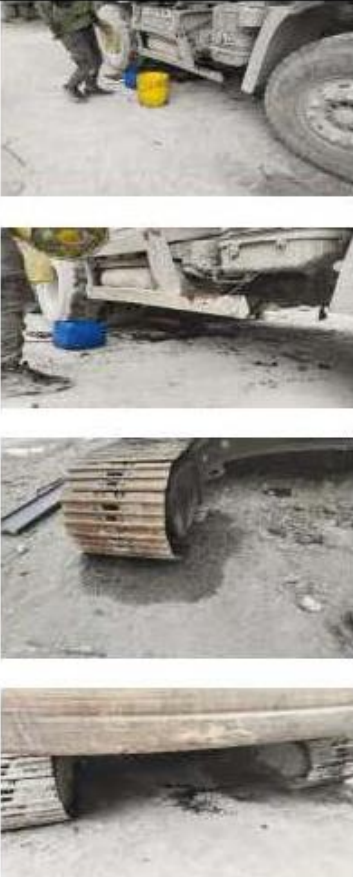
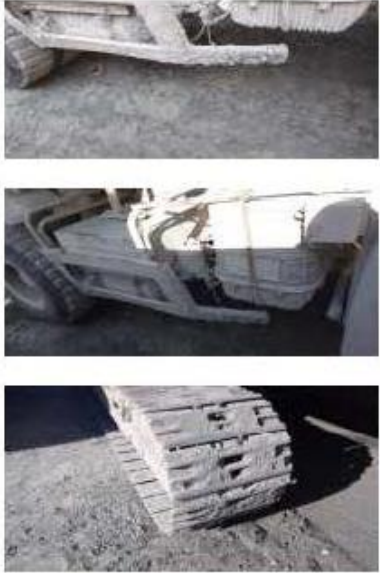
Sr. No	Date and Location of Inspection	EHS observations	Picture	Instructions to the Contractor	Timeline	Action Taken by the Contractor	Completion Date
45.1	25 -03-2023 K4	Fuel/ Oil Spills

<p>Contractor is instructed to replace the soil with clean and fresh soil immediate basis. And use spill kits for oil spill on the site.</p> <p>Dispose of the toxicities Soil in a drum.</p> <p>Dispose of the contaminated soil as per SOPs provided in ECP</p>	Immediate	<p>The oil spills were removed from the sites and disposed of the contaminated soil replace with fresh soils.</p>

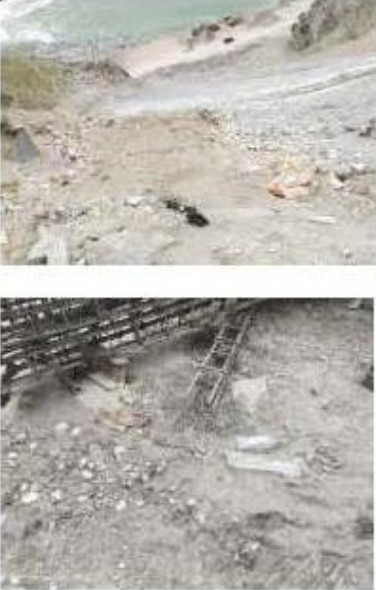
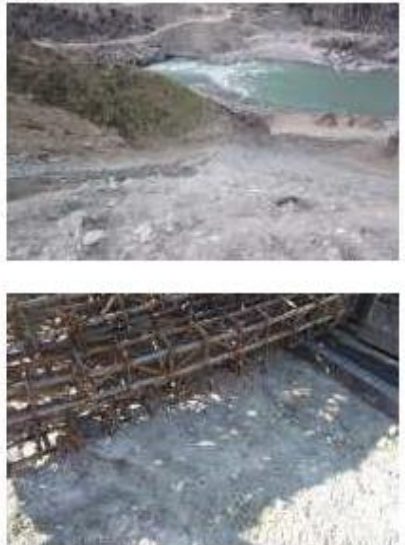
45.2	25-02-2023 K4 Tunnel Portal	Waste, Littering

Instructed the contractor to keep clean the site and provide the proper waste bins at all sites.	Immediate	<p>The sites have cleaned and waste bins provided at different locations at site.</p>

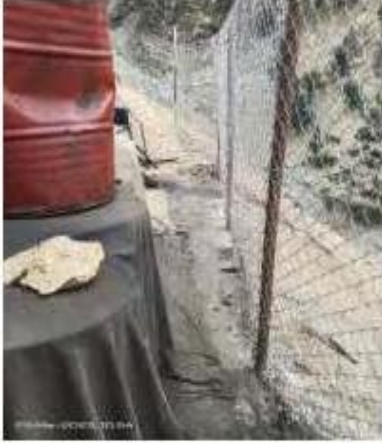
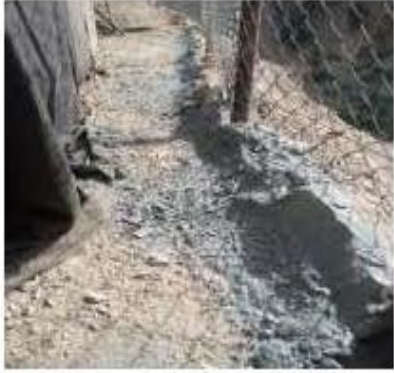
Sr. No	Date and Location of Inspection	EHS observations	Picture	Instructions to the Contractor	Timeline	Action Taken by the Contractor	Completion Date
45.3	25-03-2023 K4 Tunnel Portal	Oil storage

Contractor is instructed to construct the banded platform for Oil storage.	Immediate	Constructed the bund and platform for Oil storage

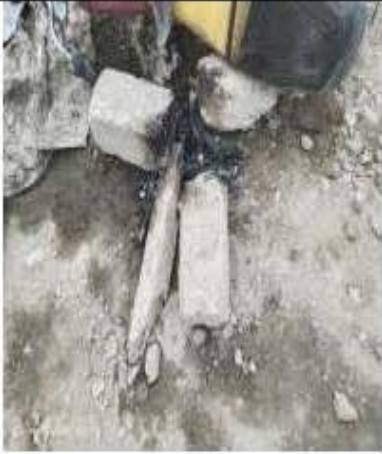
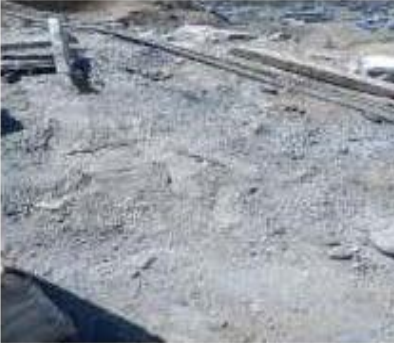
27-03-2023
45.4	25-03-2023 K9 Tunnel Portal	Open Burning

Instructed the contractor to stop Wood burning at site.	ASAP	The spot has been cleaned and instructed to all labours to avoid wood burning at working sites.

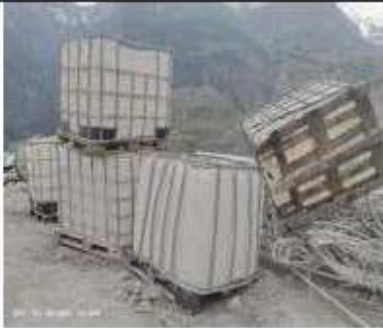
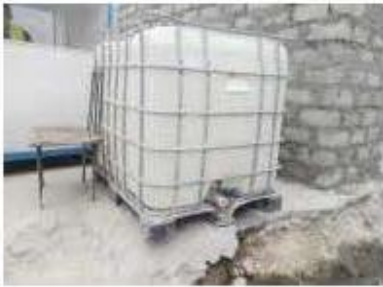
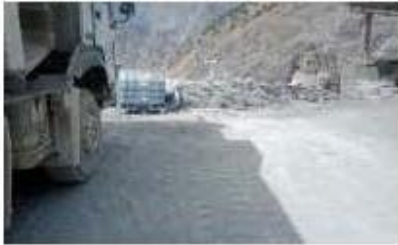
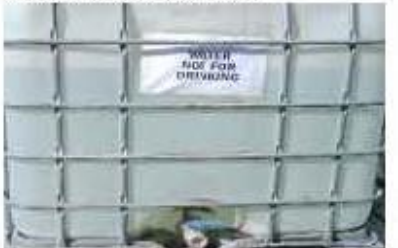
Sr. No	Date and Location of Inspection	EHS observations	Picture	Instructions to the Contractor	Timeline	Action Taken by the Contractor	Completion Date
44.5	23-02-2023 K9 Tunnel Portal	Improper placement of Chemical Tanks

Instructed the contractor to remove the Chemical Tanks from site and replace at proper storage ASAP. Need to construct proper platform for Empty tanks.	Immediate	<p>The empty Chemical Tanks removed from the site</p>

<p>Tank is keeping to fill water for construction purpose temporarily. So, label pasted on the tank</p>

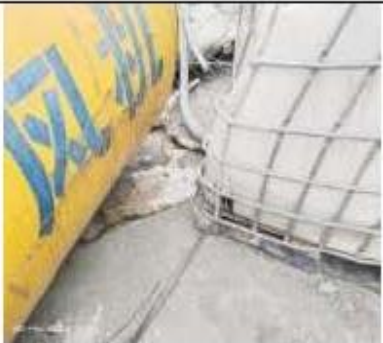
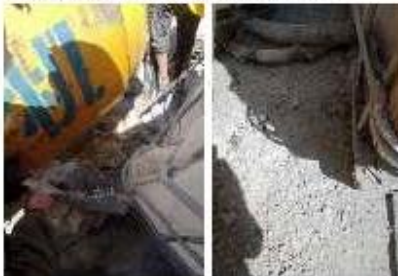
45.6	25-03-2023 K9 Tunnel Portal	Chemical Spill

Contractor is instructed to replace the soil with clean and fresh soil immediate basis. And use spill kits for oil spill on the site. Dispose of the toxicities Soil in a drum. Dispose of the contaminated soil as per SOPs provided in ECP	ASAP	<p>The chemical were removed and treated by fresh soil on the site.</p>

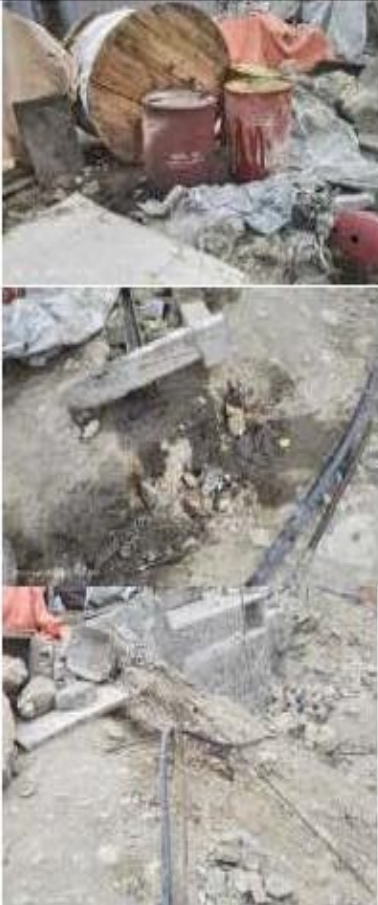
Sr. No	Date and Location of Inspection	EHS observations	Picture	Instructions to the Contractor	Timeline	Action Taken by the Contractor	Completion Date
45.7	5-03-2023 K9 Tunnel Portal	Oil spills

<p>Contractor is instructed to replace the soil with clean and fresh soil immediate basis. And use spill kits for oil spill on the site.</p> <p>Dispose of the toxicities Soil in a drum.</p> <p>Dispose of the contaminated soil as per SOPs provided in ECP</p> <p>Construct a banded fuel oil storage at site and store properly.</p>	ASAP	<p>The oil spillage was removed and replace with clean and fresh soil on the site.</p>

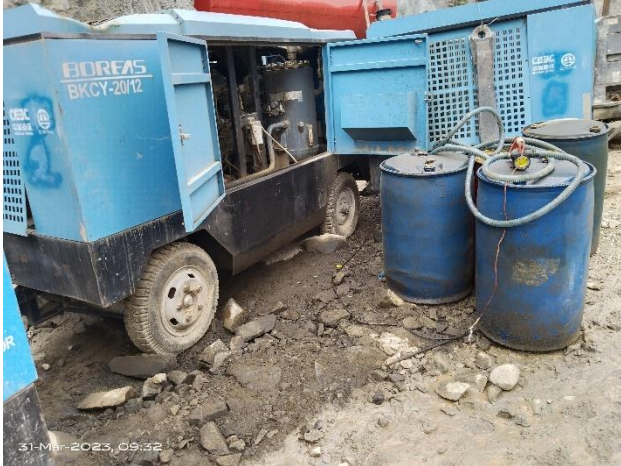
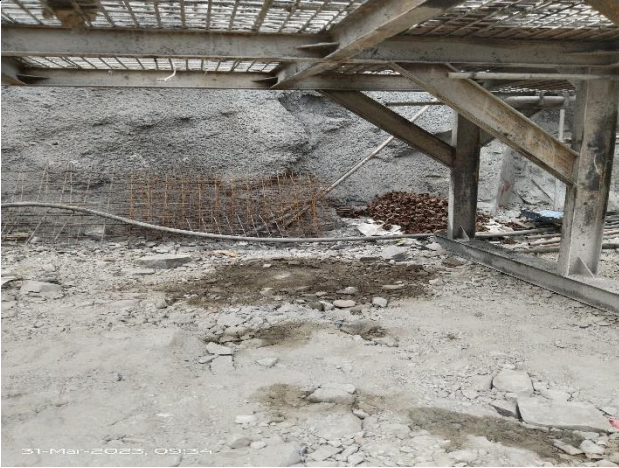
Sr. No	Date and Location of Inspection	EHS observations	Picture	Instructions to the Contractor	Timeline	Action Taken by the Contractor	Completion Date
46.1	31 -03-2023 Logro Tunnel B	Fuel/ Oil Spills

<p>The table contains two photographs of a construction site. The top photograph shows a dirt slope with a pile of dark, possibly organic or mineral, material. A yellow bag and some other debris are visible. The timestamp is '31-Mar-2023, 09:32'. The bottom photograph shows a similar dirt slope with a pile of dark material. The timestamp is '31-Mar-2023, 09:35'. The background of both photos shows a large-scale construction project with concrete structures and a river.</p>				
--	--	--	---	--	--	--	--

<p>Contractor is instructed to replace the soil with clean and fresh soil immediate basis. And use spill kits for oil spill on the site.</p> <p>Dispose of the toxicities Soil in a drum.</p> <p>Dispose of the contaminated soil as per SOPs provided in ECP</p>	Immediate

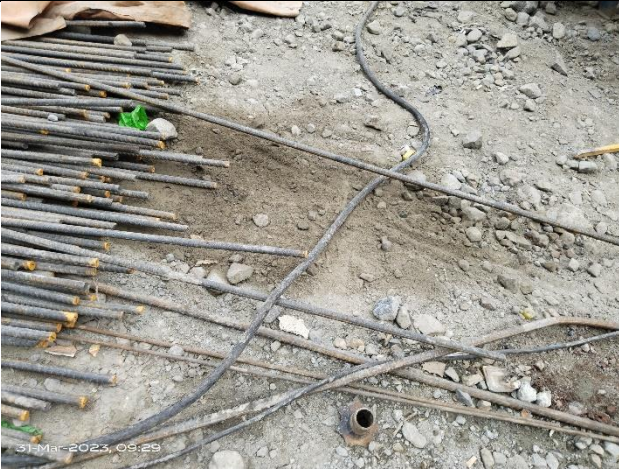
46.2	31-03-2023 Logro Tunnel B	Waste, Littering

Instructed the contractor to keep clean the site and provide the proper waste bins at all sites.	Immediate

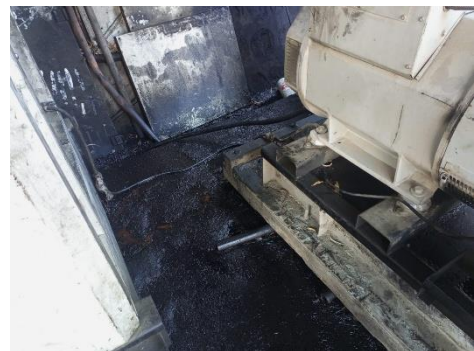
Sr. No	Date and Location of Inspection	EHS observations	Picture	Instructions to the Contractor	Timeline	Action Taken by the Contractor	Completion Date
18.1	26-01-2023 Zaal Camp (Chinese Side)	Oil spill

The contractor is instructed to remove the spill by replacing with fresh soil and soil After that dispose of the toxicity as per ECPs and SOPs.	Immediate

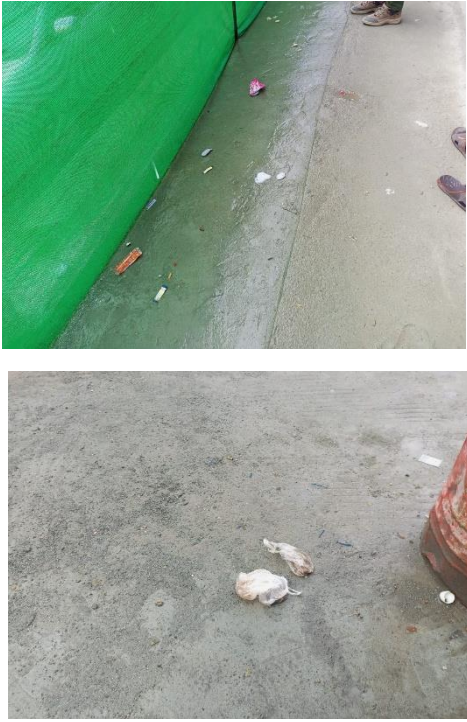
18.2	26-01-2023 zal pakistani camp	Littering

<p>The contractor is instructed to increase waste bins in camp and dispose off littered materials in those waste bins as per SOP's provided in ECP's.</p> <p>Contractor is instructed to conduct refresher training sessions for all labor and staff on Waste Management.</p>	Immediate		
18.3	26-01-2023 zal pakistani camp	Poor hygienic condition

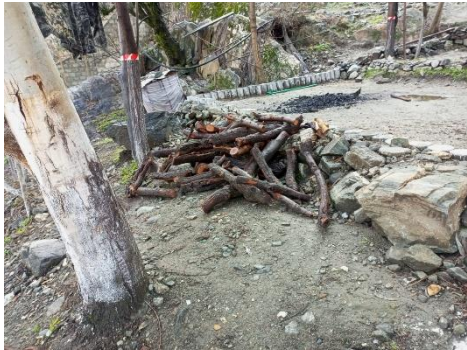
18.4	26-01-2023 Zaal Camp	Fuel wood

<p>The contractor is instructed to remove fuel woods and close all wood burning spots with immediate effect, because every kind of wood burning is strictly prohibited.</p>	Immediate		
------	-------------------------	-----------	--	---	------------------	--	--
