Dasu Hydropower Project

Subject: Dasu HPP –33rd ENVIRONMENTAL PROGRESS REPORT FOR THE PERIOD FROM JANUARY TO MARCH 2023

Environmental Quarterly Progress Report

Report Number: 33

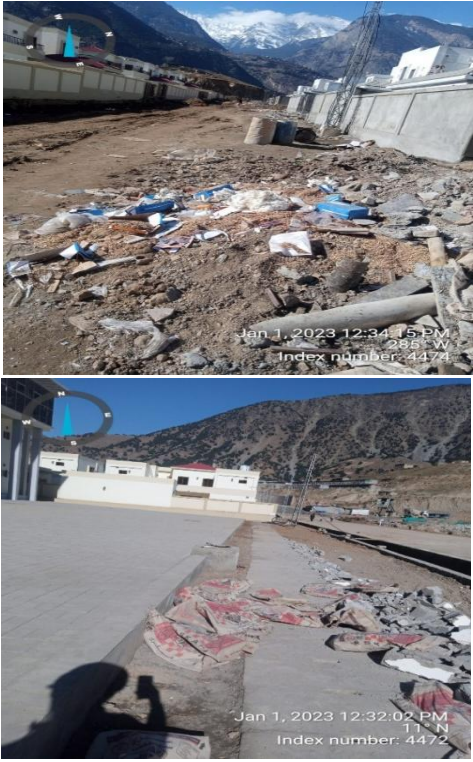
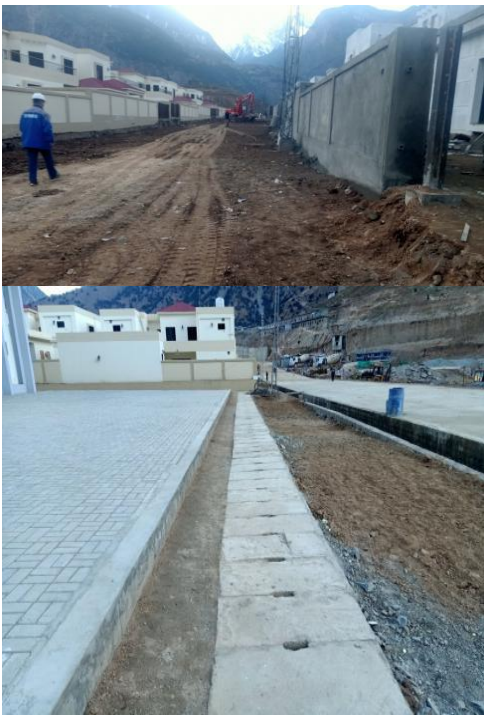
Sr. No	Date and Location of Inspection	EHS observations	Before Rectification Picture	Action Taken by the Contractor	After Rectification picture
40.1	01-01-2023 Wapda colony chuchang	Littering of solid waste

Collected the scattered waste from site and disposed off at designated site, also conducted awareness session regarding safe disposal of waste and use of waste bins

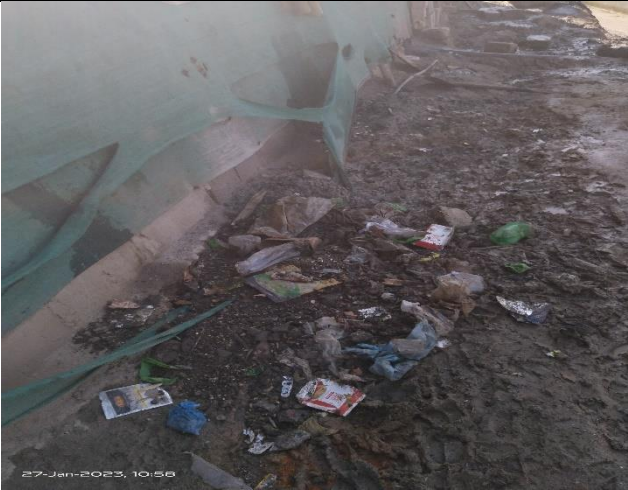
Sr. No	Date and Location of Inspection	EHS observations	Picture	Instructions to the Contractor	Timeline	Action Taken by the Contractor	Completion Date
41.1	27-01-2023 WAPDA Colony Labor camp	Littering

Contractor is instructed to remove the littering from site and keep clean the site.	Immediate

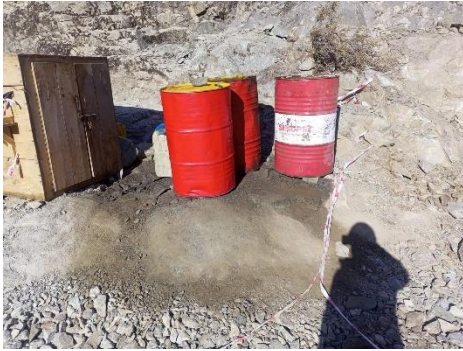
Sr. No	Date and Location of Inspection	EHS observations	Picture	Instructions to the Contractor	Timeline	Action Taken by the Contractor	Completion Date
17.1	04-01-2023 Gayal access road	Improper placement of fuel drums

The contractor is instructed to construct the concrete pavement storage area for fuel drums and place dip ray for each drums to avoid further soil contamination.	Reminder

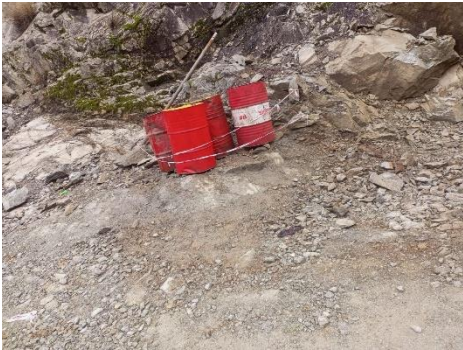
Sr. No	Date and Location of Inspection	EHS observations	Picture	Instructions to the Contractor	Timeline	Action Taken by the Contractor	Completion Date
18.1	25-01-2023 Gayal access road	Improper placement of fuel drums

The contractor is instructed to construct the concrete pavement storage area for fuel drums and place dip tray for each drums to avoid further soil contamination.	Reminder

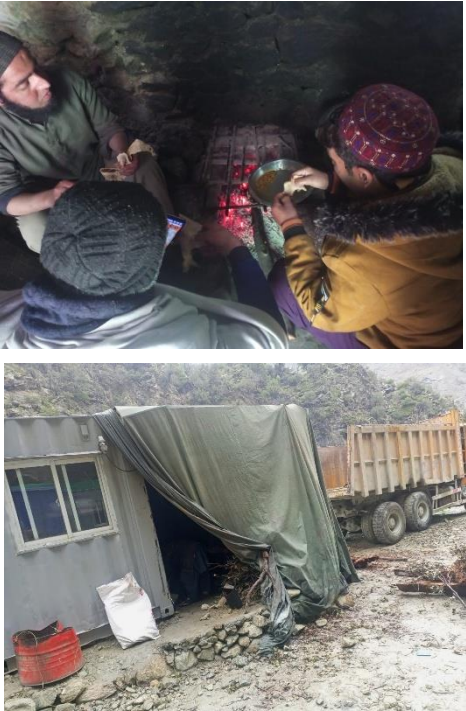
18.2	25-01-2023 labor camp kandia bypass	Poor camp management

<p>During routine supervision it was observed that</p> <ol style="list-style-type: none"> 1 there is poor kitchen which make by tent 2 No proper mess hall. 3 no waiters for serve food 4 no cook helper 5 no cleaner for camp <p>the contractor is instructed to provide adequate facilities for workers as soon as possible.</p>	Immediate

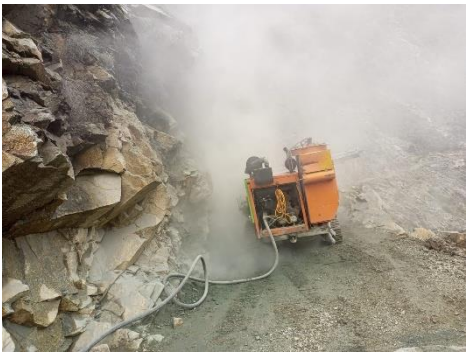
18.4	25-01-2023 Gayal access road	Heavy dust

<p>the contractor is instructed to ensure maintenance of equipment regularly and ensure wet drilling and provide appropriate mask for crawling machine operator</p>	<p>Reminder</p>

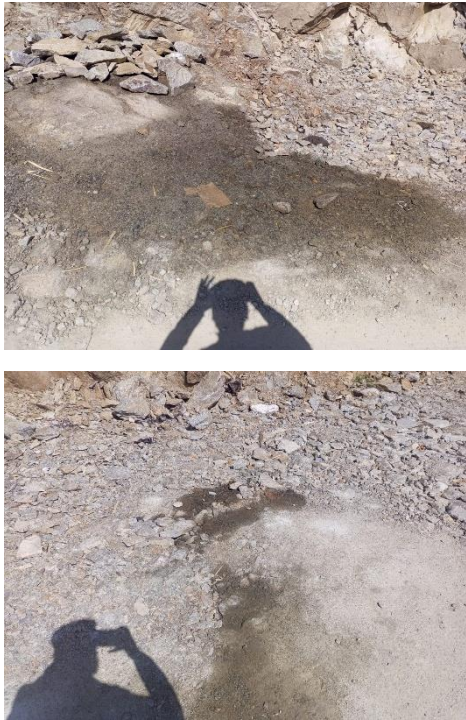
Sr. No	Date and Location of Inspection	EHS observations	Picture	Instructions to the Contractor	Timeline	Action Taken by the Contractor	Completion Date
19.1	10-03-2023 Gayal access road	Oil spill

<p>The contractor is instructed to remove the spill by replacing with fresh soil and soil</p> <p>After that dispose of the toxicity as per ECPS and SOPs. And provide shelter for fuel storage area as soon as possible.</p>	Reminder 1

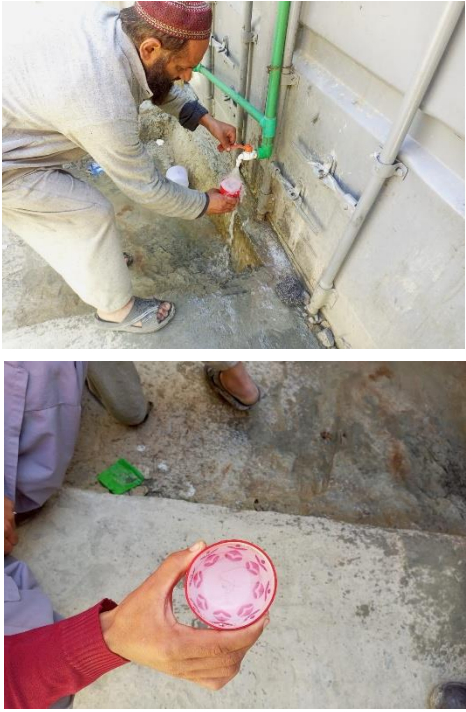
19.4	10-03-2023 kandia bypass labor camp	No save drinking water

<p>The top photograph shows a man in a grey shirt and a red cap crouching next to a wall with green and white pipes. He is using a tube to collect water into a small container. The bottom photograph shows a person's hands holding a pink bowl with a floral pattern, which appears to contain water.</p>	<p>During routine supervision it was observe that workers are using tube water for drinking the contractor is instructed to conduct water test with in 15 days and submit to engineers</p>	Immediate

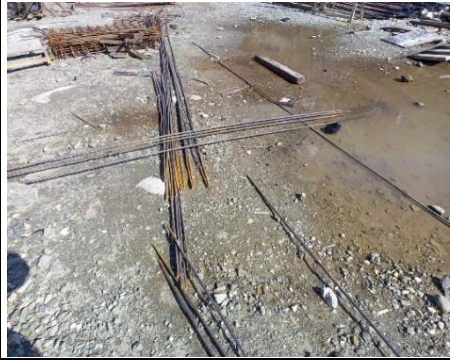
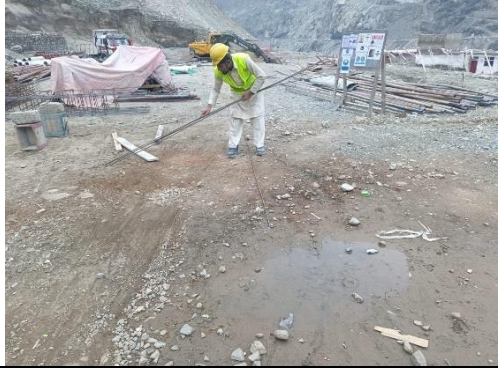
Sr. No	Date and Location of Inspection	EHS observations	Picture	Instructions to the Contractor	Timeline	Action Taken by the Contractor	Completion Date
2.1	26-01-2022 EM-01, steel workshop	Inadequate housekeeping

The contractor is instructed to maintain good housekeeping on site and manage construction material properly as per SOPs provided in the ECP's	immediate	The EM01 contractor has done housekeeping of the site.

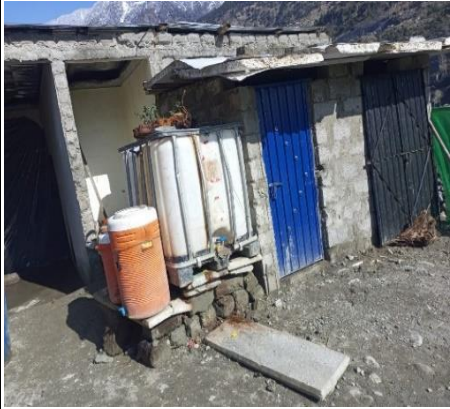
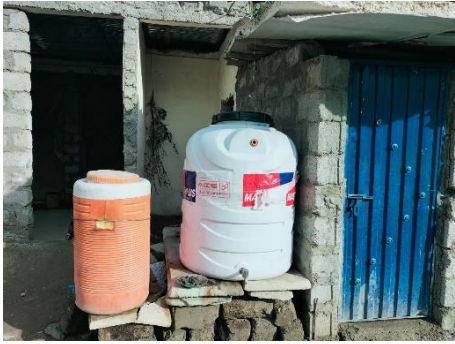
02-02-2022
2.2	26-01-2022 EM-01 kitchen	Chemical drums

The contractor is instructed to avoid use of chemical drums for human consumption, remove the drum, and provide a water tank for workers with immediate effect.	immediate	The EM01 contractor removed the chemical tanks and provided a new tank for utilization of water.

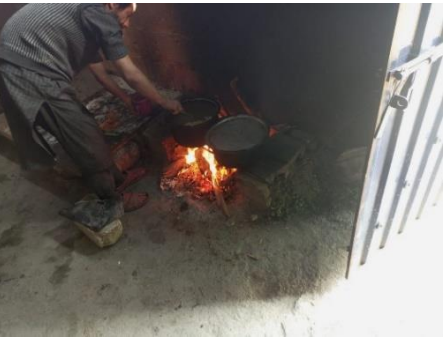
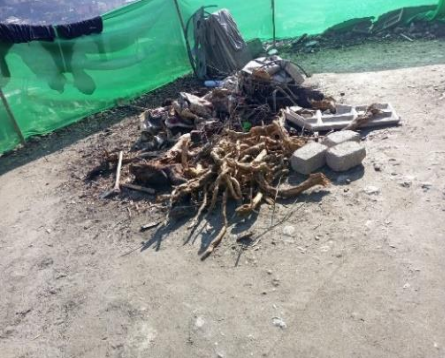
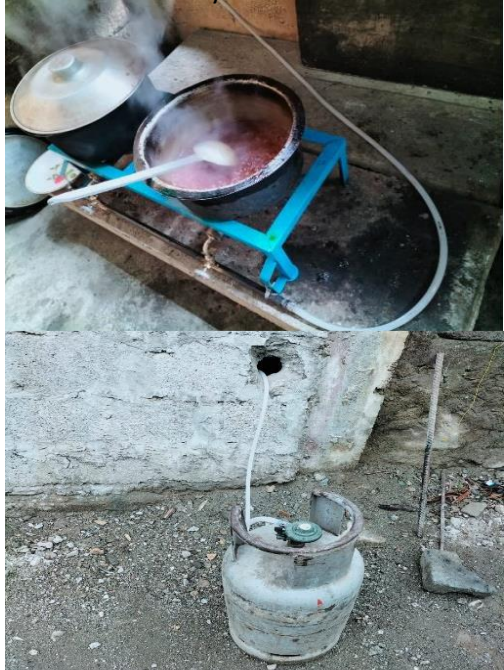
2.3	26-01-2022 EM-01 kitchen	Fuel wood

<p>The contractor is instructed to provide LPG cylinders and gas stoves for cooking purposes and avoid burning woods because as per ECP's it is strictly prohibited to burn wood as fuel either for cooking or heating purposes.</p>	Immediate	<p>The Contractor replaced burning of fuel wood with LPG Cylinder.</p>

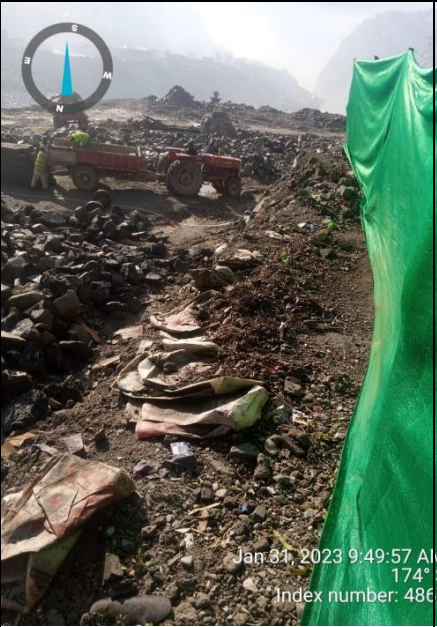
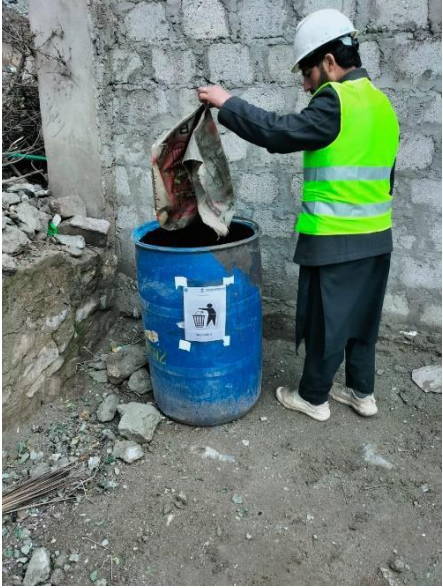
Sr. No	Date and Location of Inspection	EHS observations	Picture	Instructions to the Contractor	Timeline	Action Taken by the Contractor	Completion Date
3.1	31-01-2023 EM-01 Slope of labor camp.	Littering, solid waste

The contractor is Instructed to keep waste bins on site and collect Littered, solid waste and dispose of properly as per ECPs.	immediate

<p>The EM01 contractor provided waste bins at site for management of waste.</p>	07-02-2023

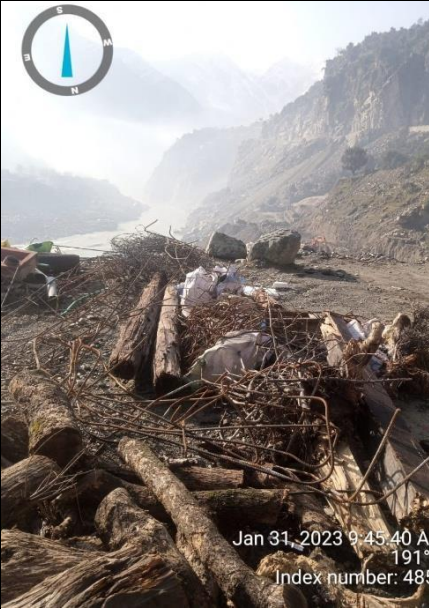
3.2	31-01-2023 EM-01 camp	Inadequate housekeeping

The contractor is instructed maintain good housekeeping on site and manage construction material properly also follow SOPs and ECP.	Immediate	The waste seen in the image belong to effected family of EM01 camp. The EM01 contractor will ask the family owner to relocate the waste ASAP.	Continue
-----	--------------------------	-------------------------	---	---	------------------	---	----------

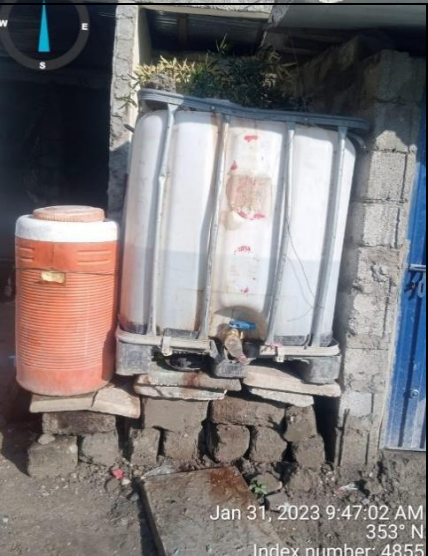
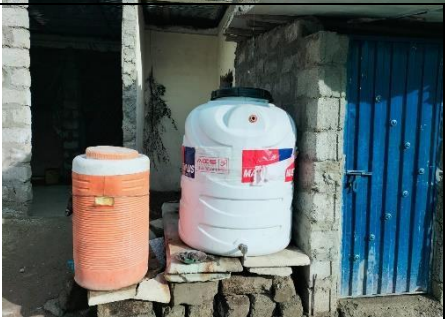
3.3	31-01-2023 EM-01 labor camp.	Chemical drums

<p>The contractor is instructed to install New water tank for the work force because the labor is also using this used chemical tank for drinking purpose. Use of Chemical tank is strictly prohibited for Humans as it can seriously affect the health of work force.</p>	Reminder

<p>The EM01 contractor removed chemical tanks with new tank for utilization of water.</p>	10-02-2023
-----	---------------------------------	----------------	---	--	-----------------	---	------------

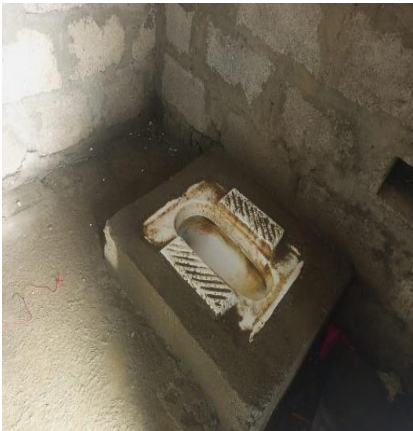
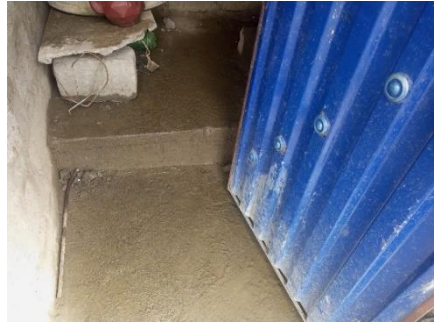
During routine supervision, it was observed that EM-01 labor camp having only one washroom is functional having no water connection no adequate welfare facilities. Camp having almost 15-20 labors accommodated. It is instructed to the contractor to provide adequate welfare facilities to the workforces as	Immediate

per SOPs and ECPs.			
4.3	30-03-2023 EM-01 labor camp	Improper fuel storage area

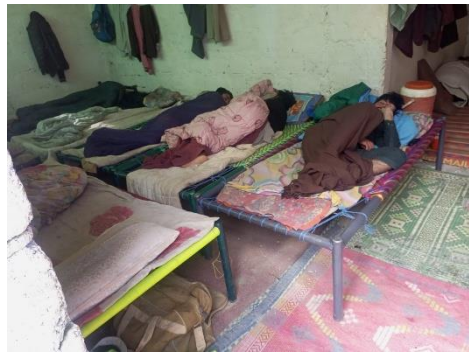
The contractor is instructed to provide shelter for fuel storage place and built proper paved or lined place for fuel storage	immediate		
4.4	30-03-2023 EM-01 labor camp	Poor accommodation

The contractor is instructed to keep proper distance between beds and follow ECPs and SOPs	immediate

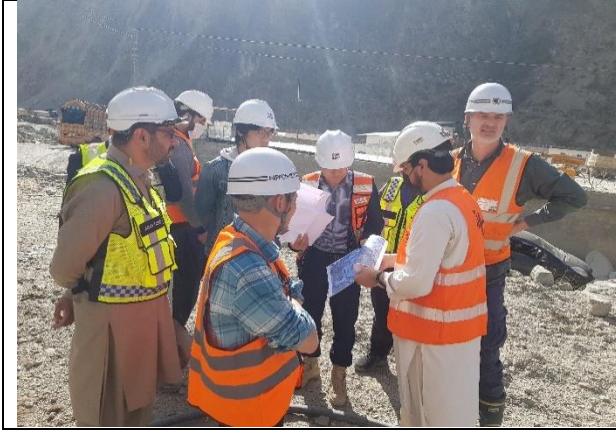
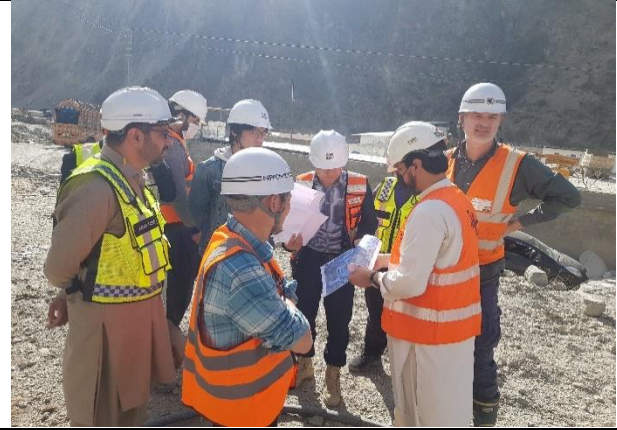
Sedimentation Tank Visit to Uchar Thoki Crushing Plant on 27th of March 2023

One of the major issues discussed in different meetings was the sedimentation tank of Uchar Thoki Crusher Plant as DHC had observed that the Uchar Thoki Crusher Plant was releasing waste water with High pH and High turbidity. Therefore three special meetings were conducted on 09th of March 2023, 25th of March 2023 and 27th of March 2023. The first meeting was conducted at the site of Uchar Thoki Crusher Plant in which contractor was guided by DHC Environment Section to construct two new sedimentation tanks for increasing the retention time of the waste water. These new sedimentation tanks were intended to lower down the pH level of the waste water being released by the plant. The second and third meeting chaired by D.G (SS) WAPDA followed by a detailed on site visit by Mr. Asayama (RE MW-01), Mr. Ali Ozbek (Technical Advisor MW-01) and Environment Section of DHC along with Mr. Feng Hui (Planning Director CGGC) and Mr. Yang (Environment Section CGGC). At site there were different options discussed with the contractor and finalized a sketch for the two newly proposed sedimentation tanks to lower down the pH Level and turbidity of the waste water.
